# Bridge Analysis Report

**October 2023**

FM No. 449007-1-22-01

Bridge No. 870083;-549;-084;-550

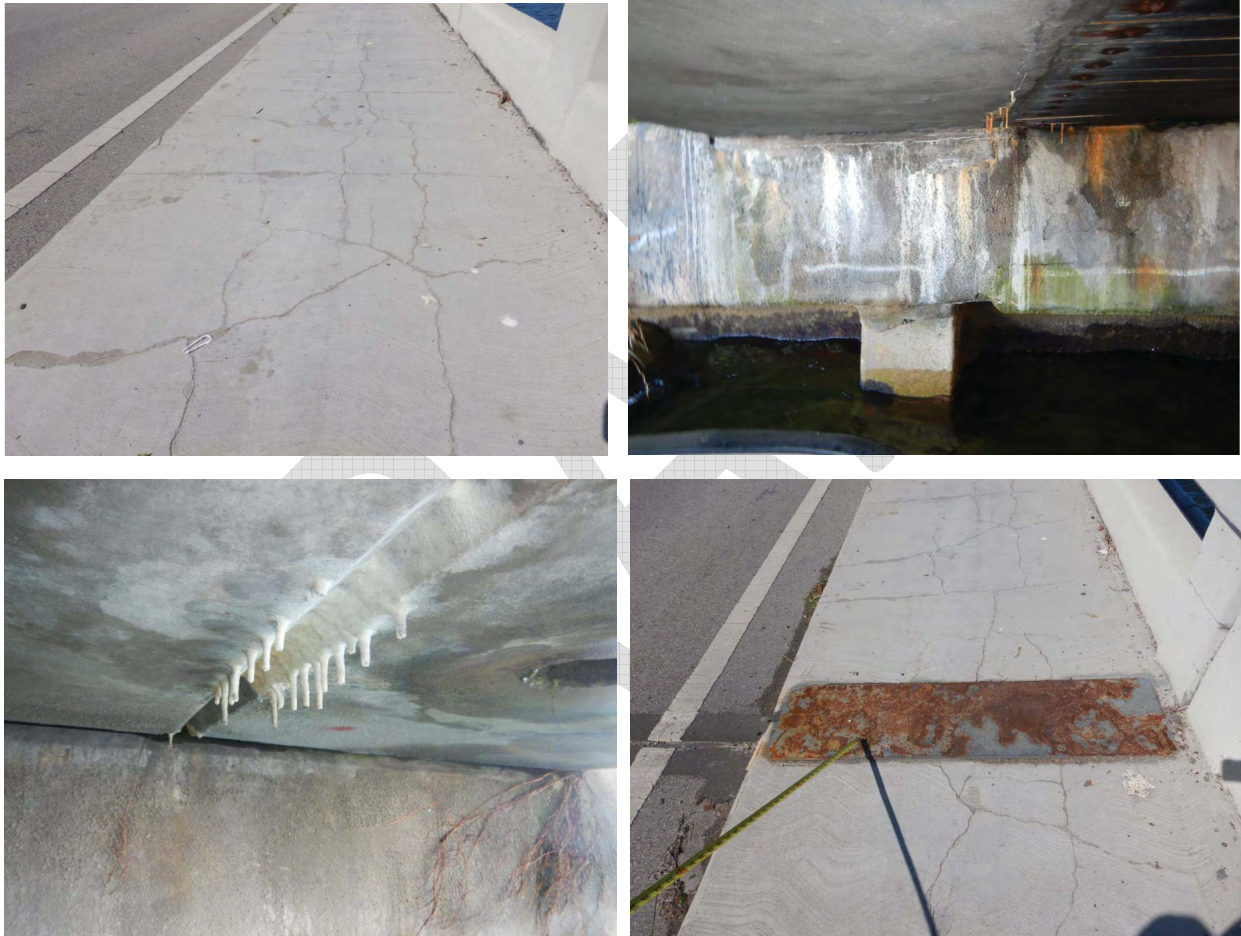
**Figure 2.2 | Representative Photos of Damage at Bridge 870083 (October 2020)**

There is efflorescence with some rust staining underneath the area between the exterior and first interior slab unit throughout all spans but there is no evidence of relative movement between the slab units due to failure of the post-tensioning.

There are several miscellaneous deficiencies noted in the latest routine inspection report dated 10/29/2020. These include clogged drainage scuppers, numerous locations with delamination on the underside of deck panels, map cracking throughout previously repaired areas of the sidewalk, corroded sidewalk joint cover plates, and multiple locations with delaminated joint headers.

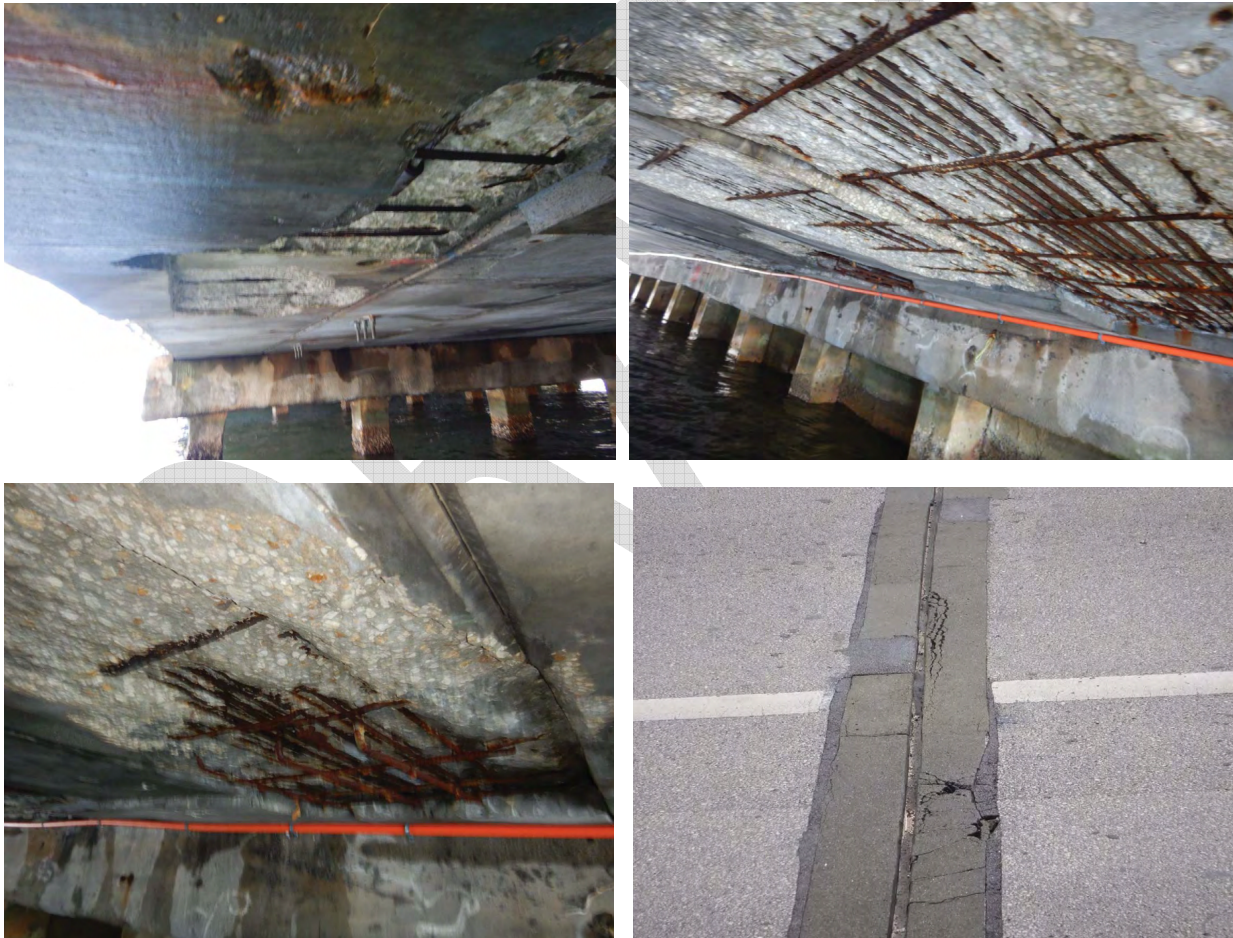
**Figure 2.3 | Representative Photos of Damage at Bridge 870084 (October 2020)**

There is efflorescence with some rust staining underneath the area between the exterior and first interior slab unit throughout all spans but there is no evidence of relative movement between the slab units due to failure of the post-tensioning.

There are several miscellaneous deficiencies noted in the latest routine inspection report dated 10/28/2020. These include numerous locations with delaminated and/or spalled concrete on the underside of deck panels with exposed corroded reinforcement, delaminated joint header at multiple locations, delaminated areas on bent caps, and numerous locations of horizontal cracking on the bent caps.

The spalling concrete with exposed corroded reinforcement on the deck underside is particularly extensive. In most cases, the deficiency was observed for the first time in 2020 or had increased in severity since the previous inspection.

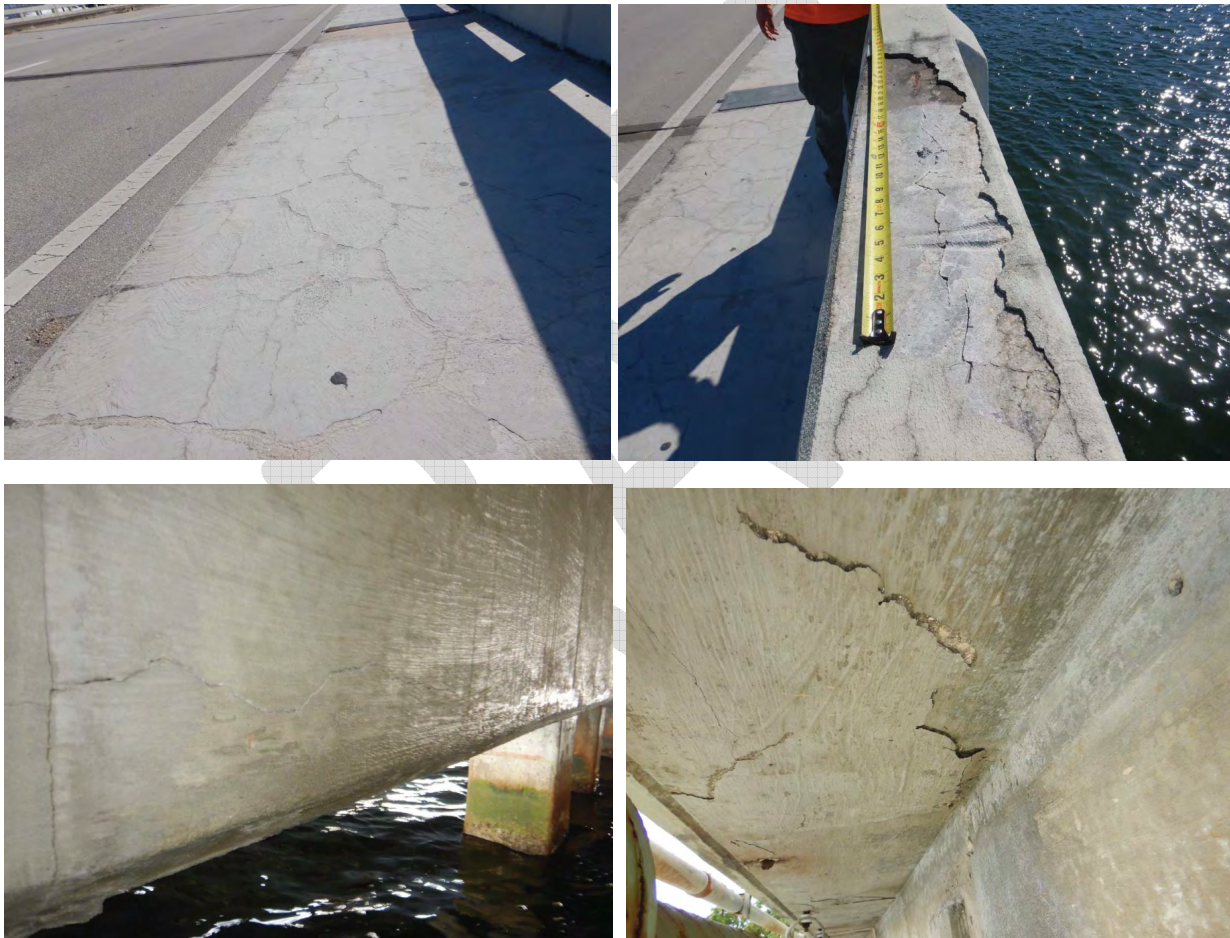
**Figure 2.4 | Representative Photos of Damage at Bridge 870549 (October 2020)**

There is efflorescence with some rust staining underneath the area between the exterior and first interior slab unit throughout all spans but there is no evidence of relative movement between the slab units due to failure of the post-tensioning.

There are several miscellaneous deficiencies noted in the latest routine inspection report dated 10/29/2020. These include delaminated concrete on the underside of the deck, corroded hardware on the carbon fiber reinforcement strips, map cracking in the sidewalk, corroded sidewalk joint cover plates, damaged pourable joint seal, delaminated joint header in numerous locations, multiple locations of delaminated concrete at the piles and bent caps, and delamination and cracking in the concrete bridge railing.

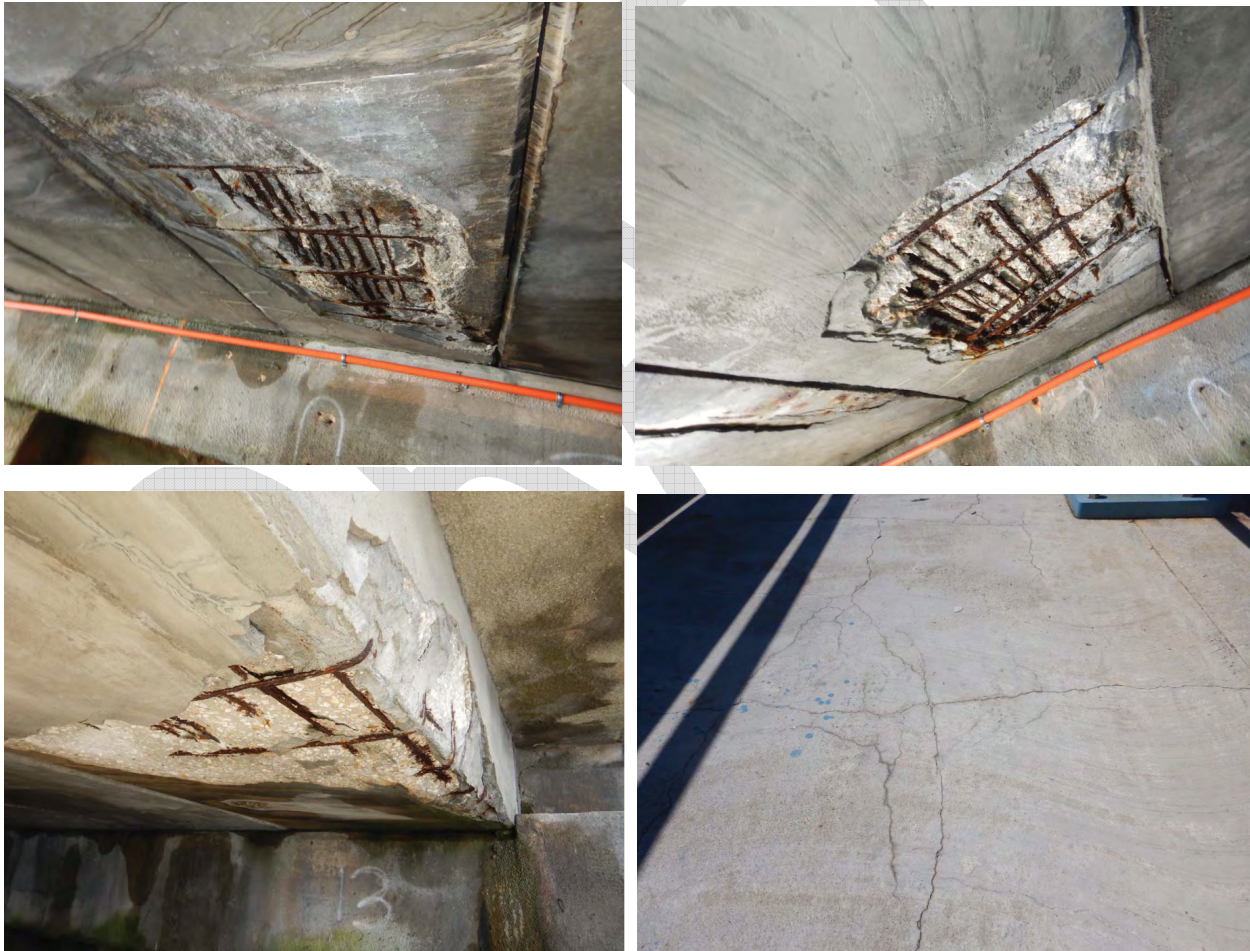
**Figure 2.5 | Representative Photos of Damage at Bridge 870550 (October 2020)**

There is efflorescence with some rust staining underneath the area between the exterior and first interior slab unit throughout all spans but there is no evidence of relative movement between the slab units due to failure of the post-tensioning.

There are several miscellaneous deficiencies noted in the latest routine inspection report dated 10/29/2020. These include map cracking on the sidewalk, numerous locations of delaminated and spalled concrete on the deck underside with exposed corroded reinforcement, numerous locations of corroded sidewalk joint cover plates, numerous locations of delaminated joint headers, cracks in piles, delamination in bent caps, and cracking in concrete railing.

The spalling concrete with exposed corroded reinforcement on the deck underside is particularly extensive. In most cases, the deficiency was observed for the first time in 2020 or had increased in severity since the previous inspection.
