**DRAFT CONTAMINATION SCREENING EVALUATION REPORT**  
**Florida Department of Transportation**  
**District 6**  
**VENETIAN CAUSEWAY**  
**(Venetian Way)**  
**Project Development and Environment (PD&E) Study**  
**from North Bayshore Drive to Purdy Avenue**  
**Miami-Dade County, Florida**  
**FM No. 422713-2-22-01**  
**Efficient Transportation Decision Making (ETDM): 12756**

December 14, 2018

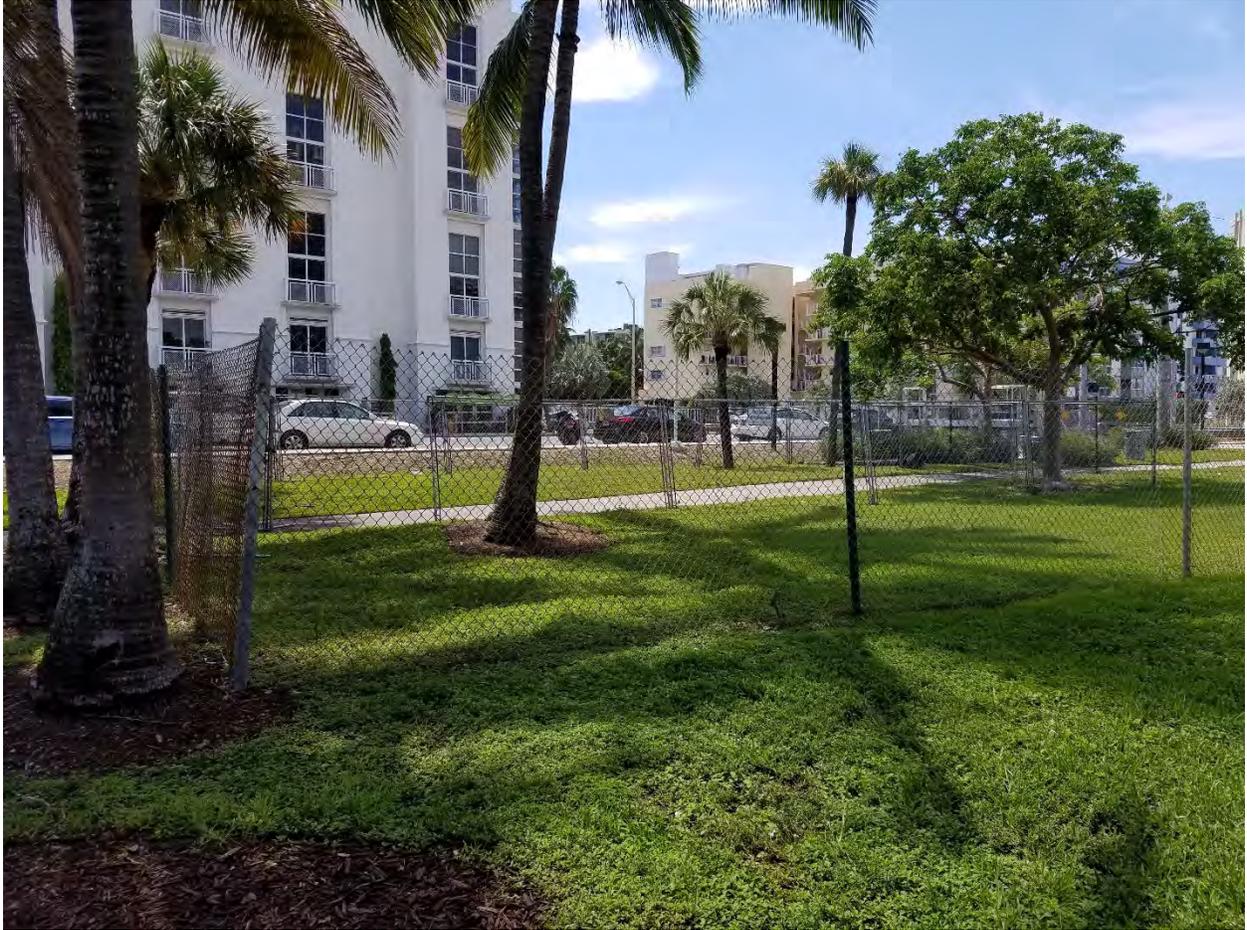
Site #4, Chevron property, facing southeast from Site #5. The fenced-off work area in Site #5 Maurice Gibb Park, is visible in the foreground.

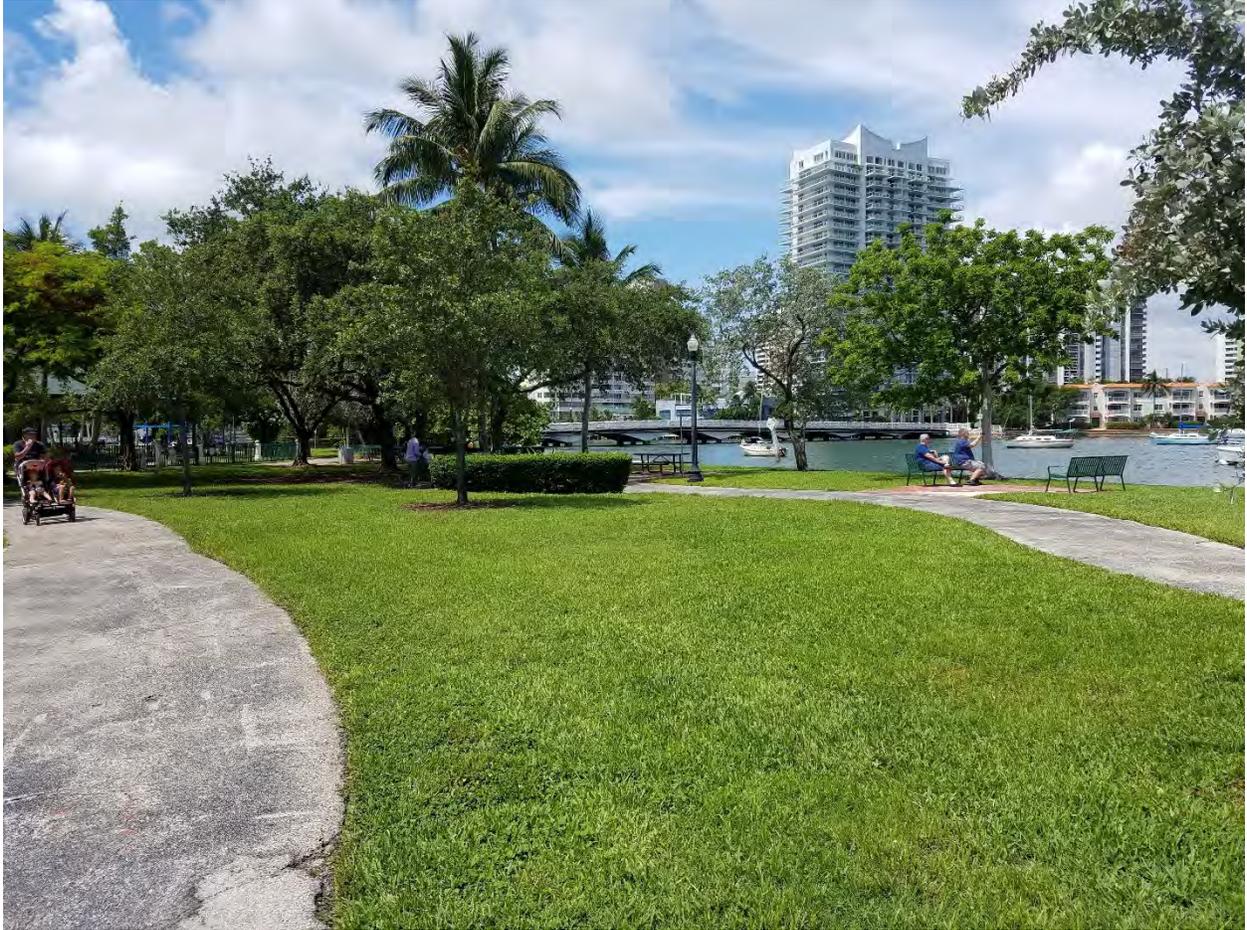
Site #5 Maurice Gibb Park facing south

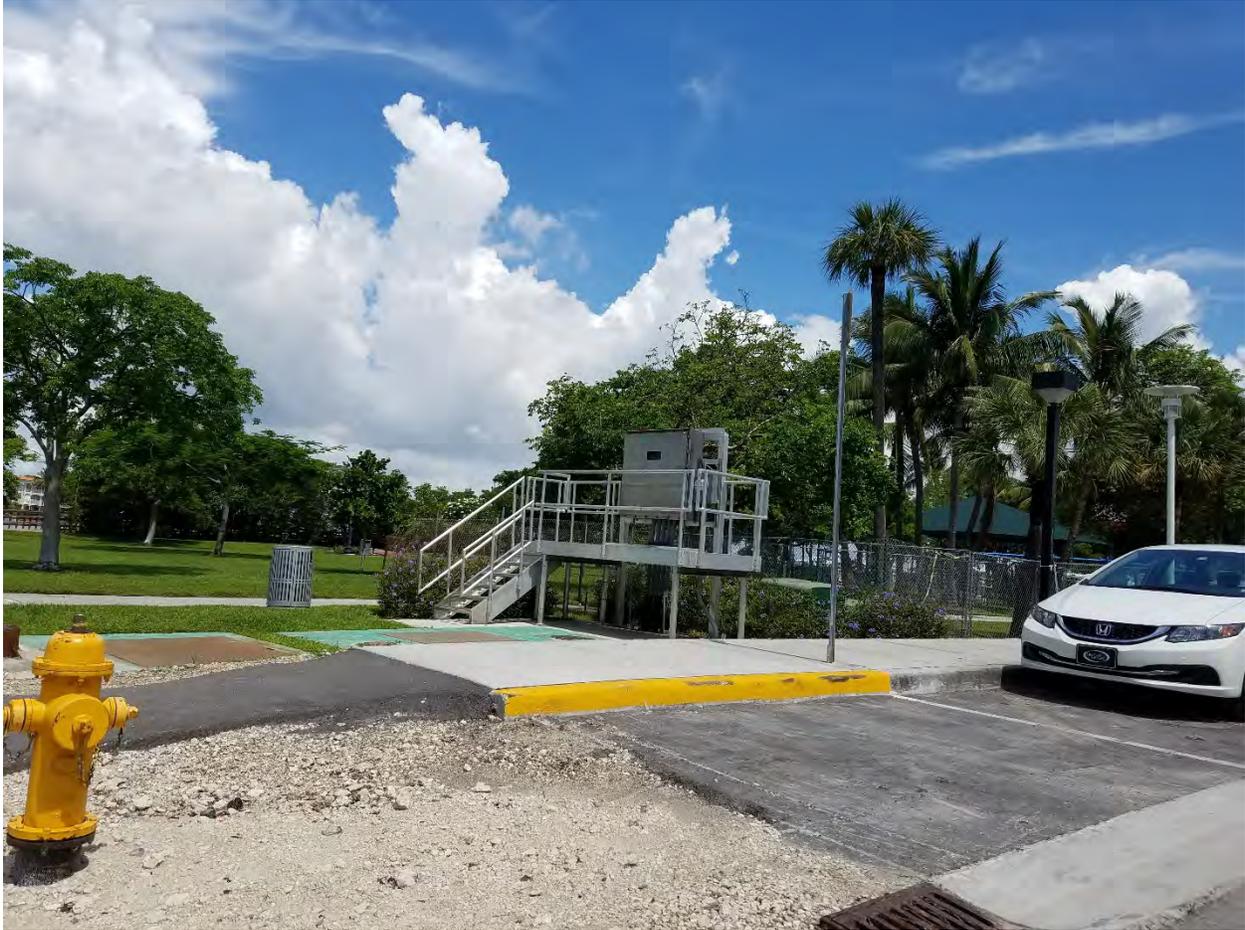
Site #5 Maurice Gibb Park facing west showing lift station and fenced-off work area in the background (right-hand side of photograph)

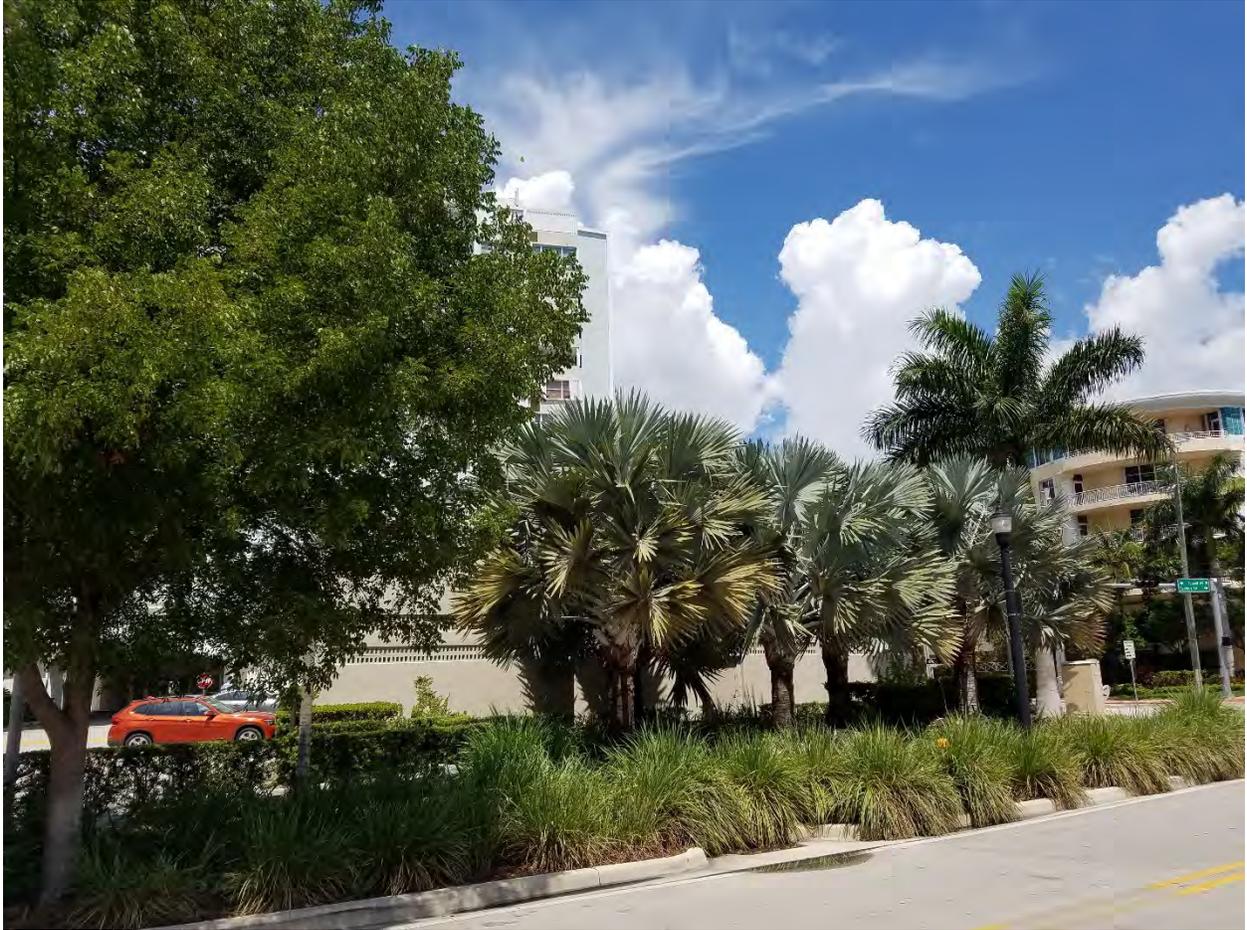
Site #10, approximate former location of Terrance Towers storage tank area.

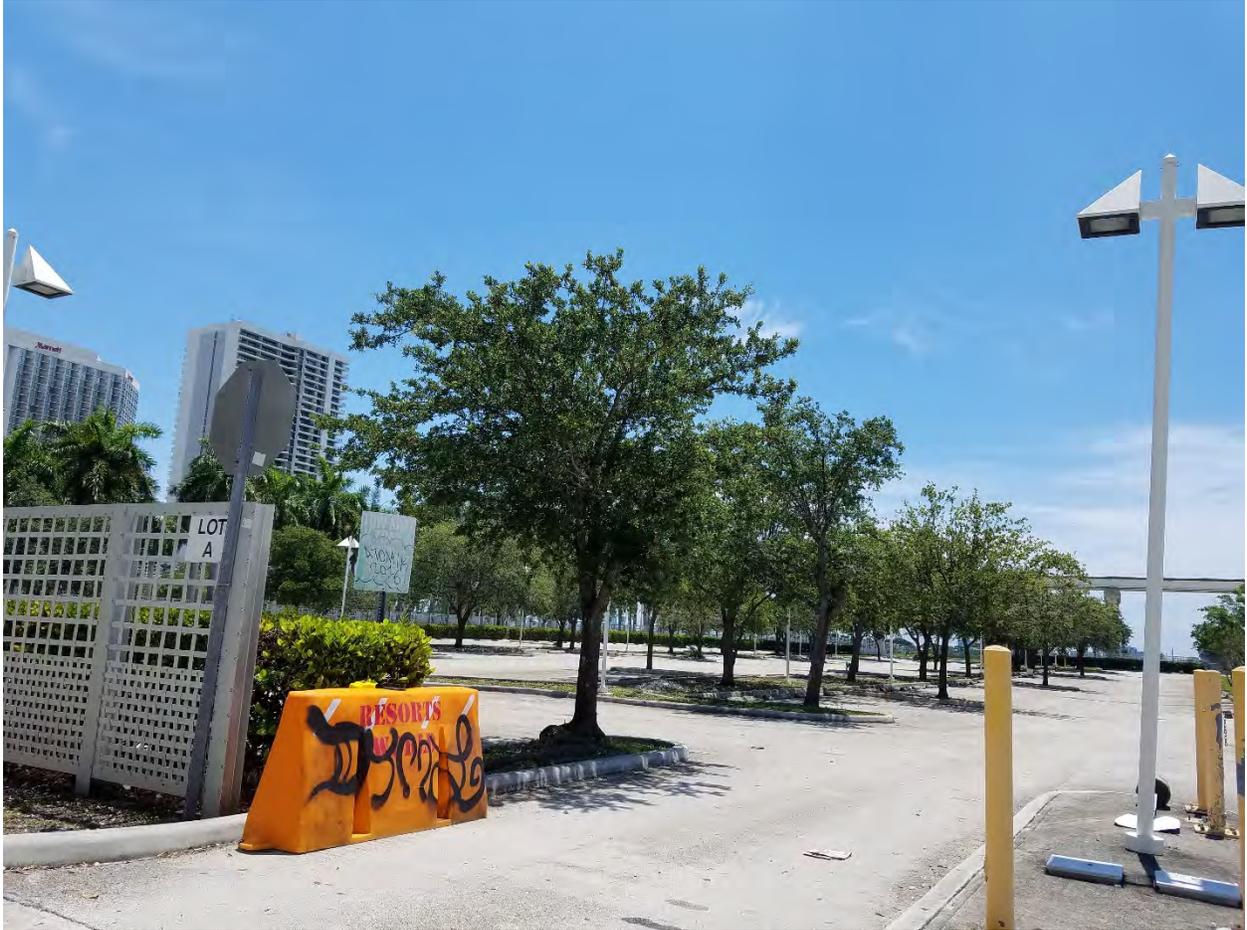
Site #18, Resorts World Miami Brownfield location, facing northeast. Site #16, Marriott Hotel and Marina Biscayne is visible in the background on the left-hand side of the photograph.
