CONTAMINATION SCREENING EVALUATION REPORT

Florida Department of Transportation

SR 826 / Palmetto Expressway Express Lanes

Limits of Project: US 1 / South Dixie Highway to SR 836 / Dolphin Expressway

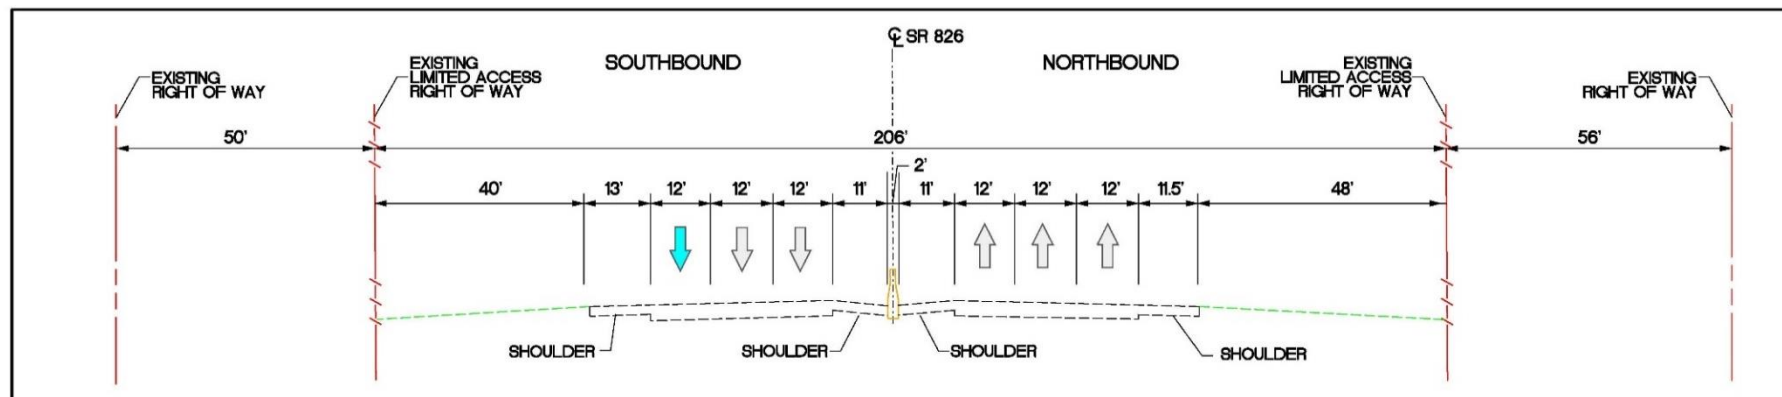
Figure 2 - 1: Existing Roadway Typical Section between US 1 and SR 874

SR 826, between US 1 and SR 874, consists of five to six 12-foot wide general use lanes (three lanes in the northbound direction and two to three lanes in the southbound direction) with 12-foot wide auxiliary lanes at selected locations, 11.5-foot to 13-foot wide paved outside shoulders, 11-foot wide paved inside shoulders, a 2-foot wide median barrier wall, and outside barrier walls. Between SR 874 and SR 836 the corridor consists primarily of twelve 11-foot to 14-foot general use lanes (six lanes in each direction), 8-foot to 10.5-foot wide outside shoulders, 11-foot wide paved inside shoulders, a 2-foot wide median barrier wall, and outside barrier walls. The two typical sections for SR 826 are depicted below in [Figure 2-1](#) and [Figure 2-2](#).

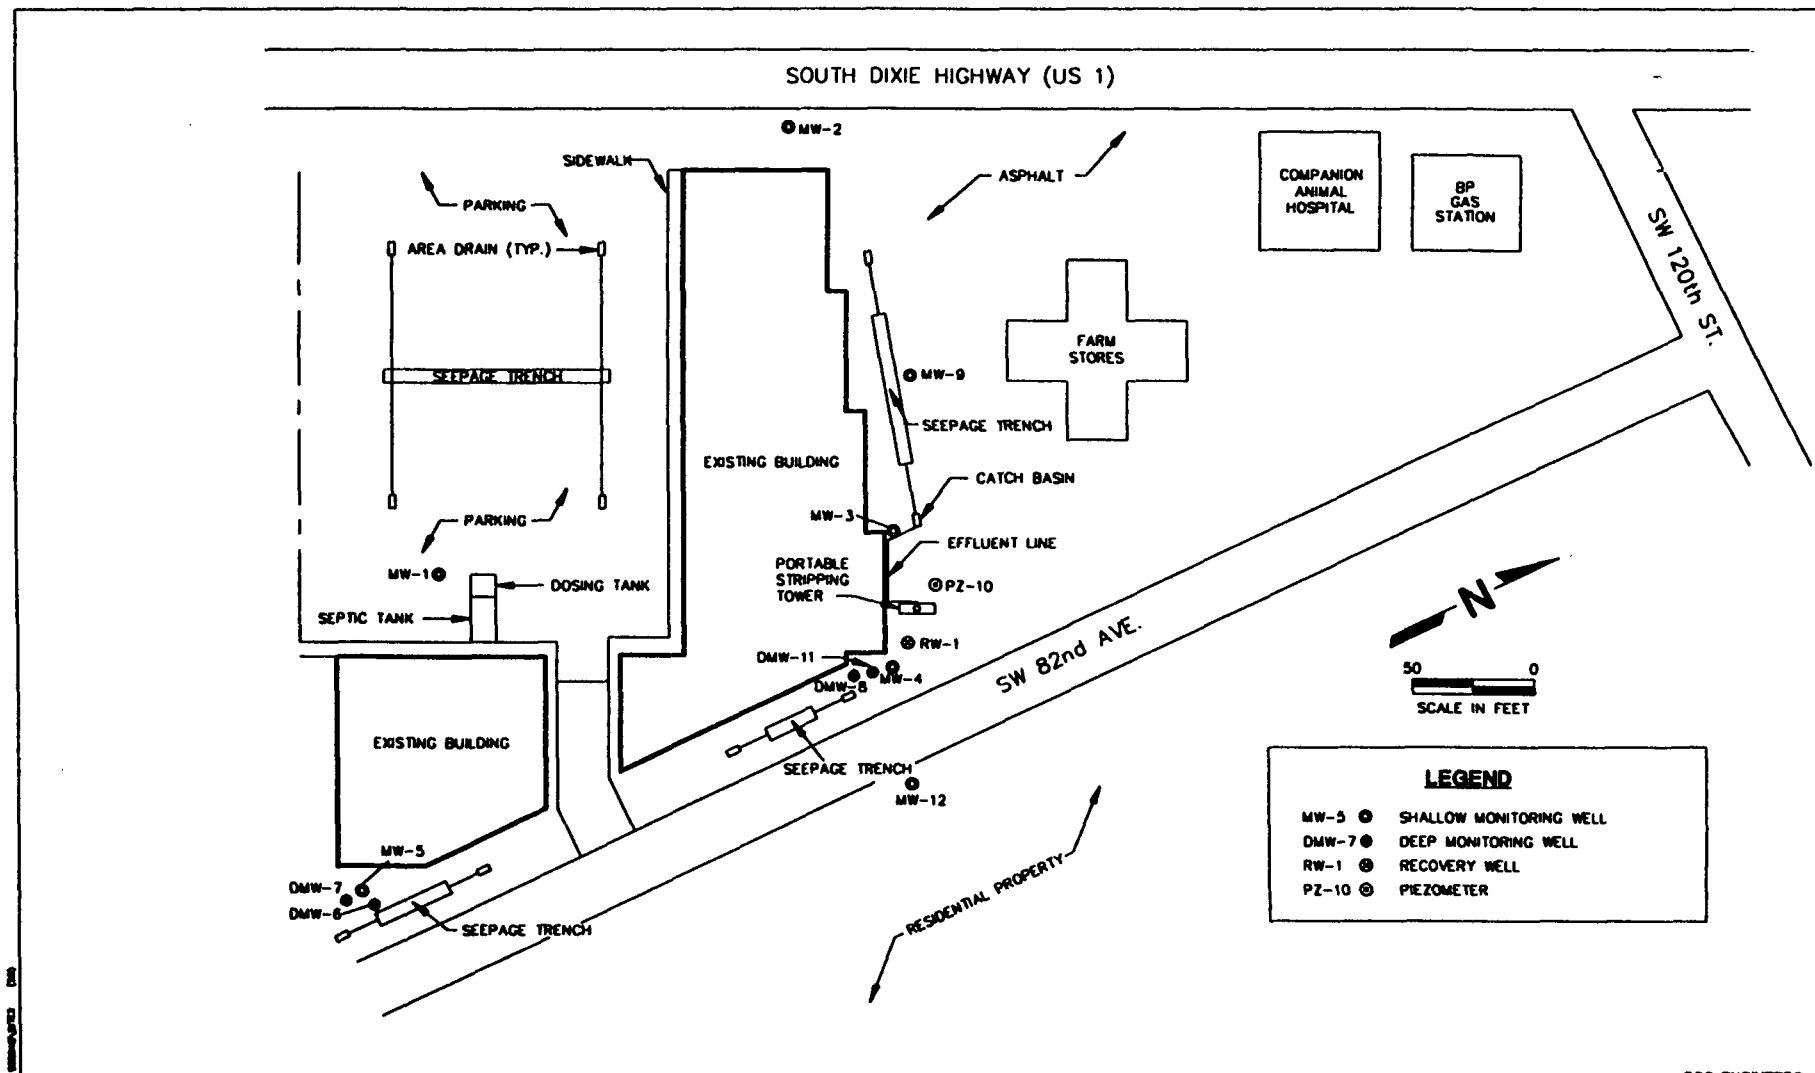
Figure 1. Well Location Site Map, Suniland South Shopping Center, Miami, Florida.

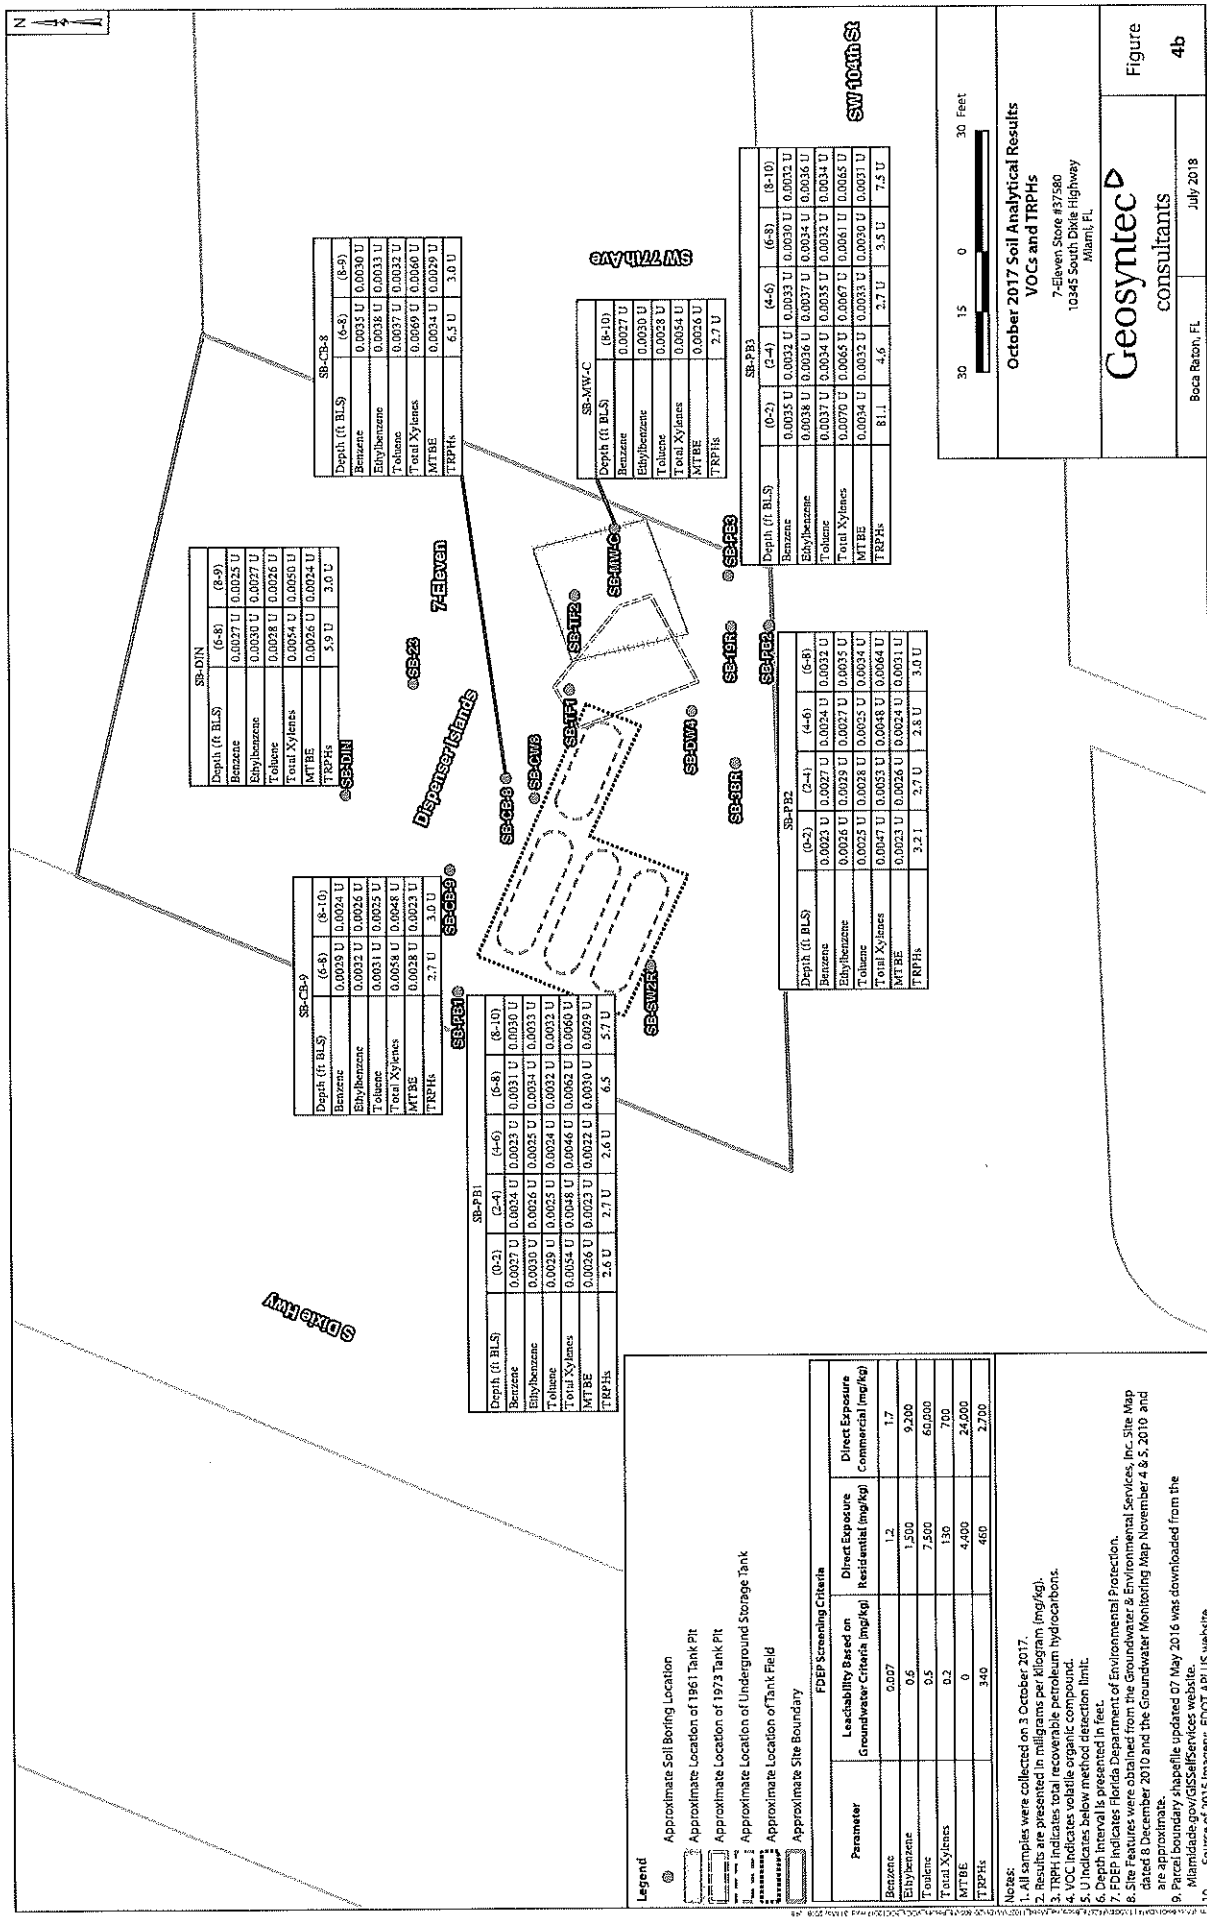
October 2017 Soil Analytical Results
VOCs and TRPHs

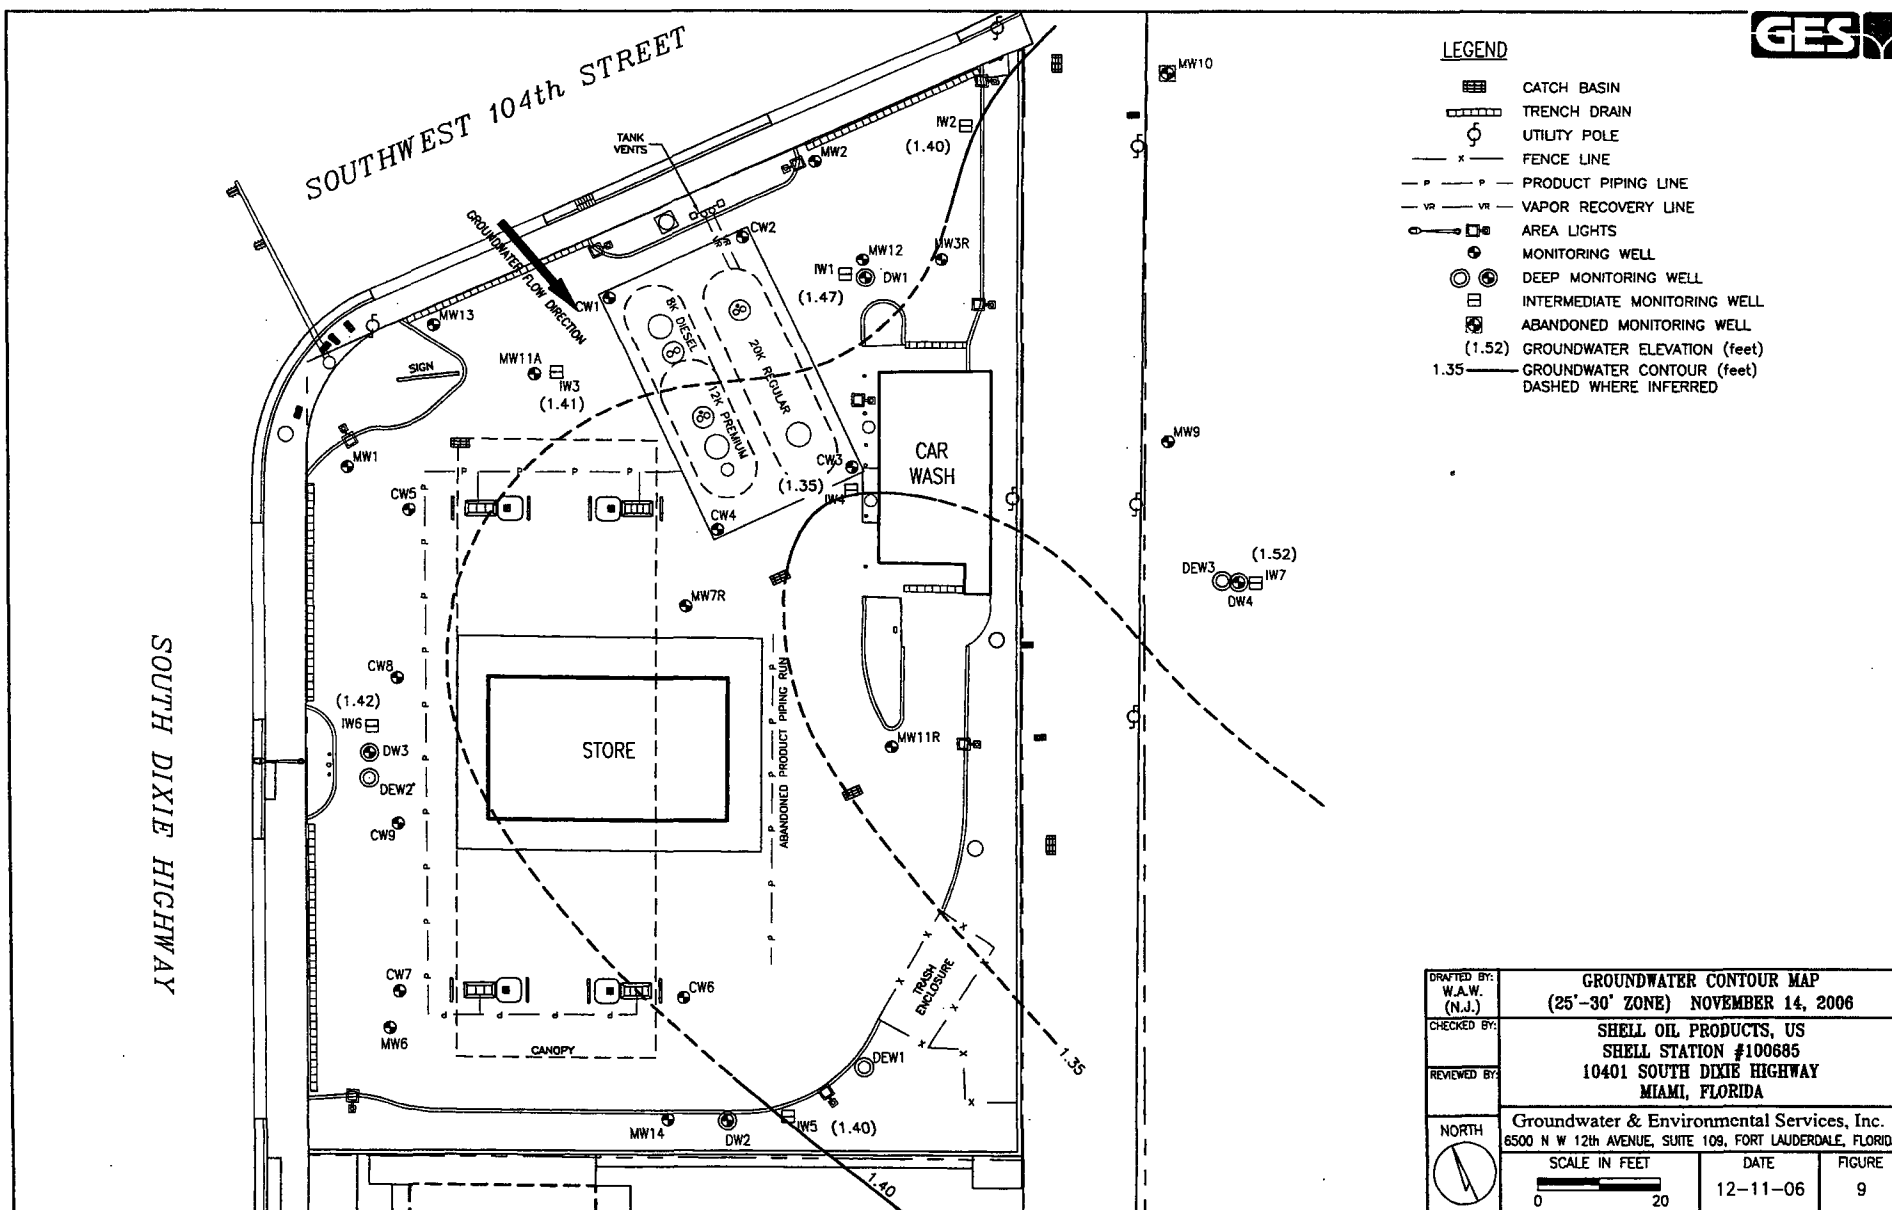
| DRAFTED BY: W.A.W. (N.J.) CHECKED BY: REVIEWED BY: | GROUNDWATER CONTOUR MAP (25'-30' ZONE) NOVEMBER 14, 2006 | | |
