PROJECT DEVELOPMENT & ENVIRONMENT STUDY
SR 997 | SW 177TH AVENUE | KROME AVENUE SOUTH
From SW 296th Street (Avocado Drive) to SW 136th Street (Howard Drive)

CORRIDOR ANALYSIS REPORT

March 2011

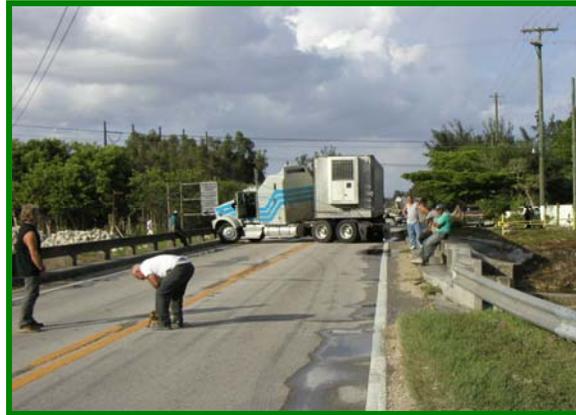
High truck volumes and differential speeds contribute to severe crashes along the corridor.

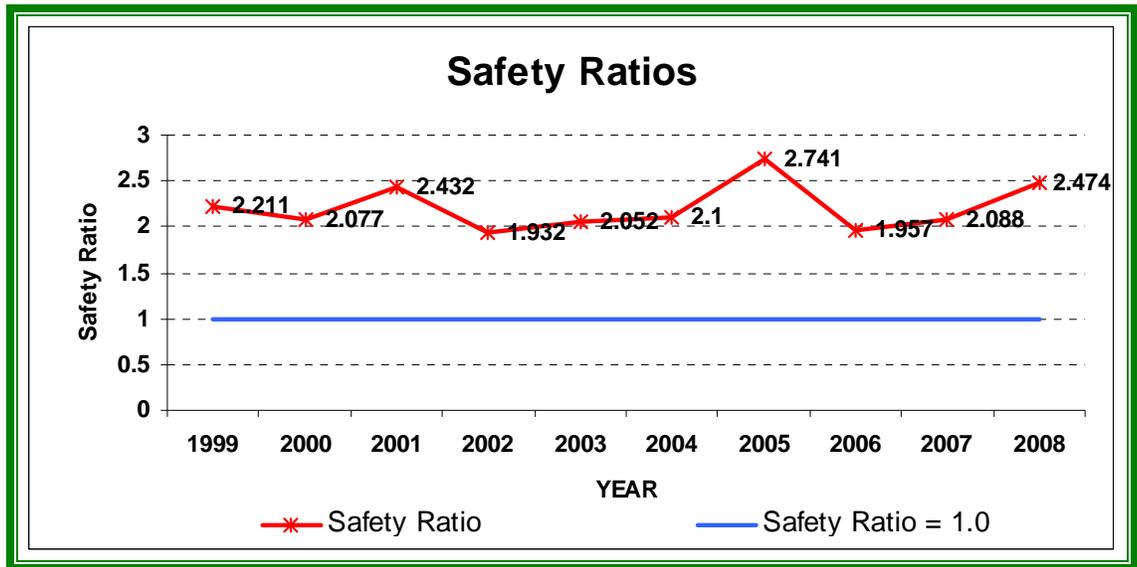
EXHIBIT 2.1

A Safety Ratio higher than 1.0 is an indicator that a particular segment/location of a state roadway had experienced crash rates higher than statewide averages for similar roadways. The calculated Safety Ratio along the entire study segment of Krome Avenue has remained at or above twice the statewide average for the past ten years. A total of 1,154 crashes were reported along the corridor over the ten year period. A total of 27 fatalities in 21 fatal crashes were reported during this period with 57% of all crashes resulting in injuries. **Table 2-1** presents statistics for the entire study corridor in terms of injuries and fatalities. It should be noted that there were various construction projects within the study area from 2003-2004 and again during 2007.

Within the study area of Krome Avenue are many sections which have appeared in the High Crash Segment lists for every one of the ten analysis years (1999 – 2008). The manually calculated Safety Ratios (weighted averages) for the entire study segment of Krome Avenue for the ten analysis years are presented graphically in **Exhibit 2.1** below.

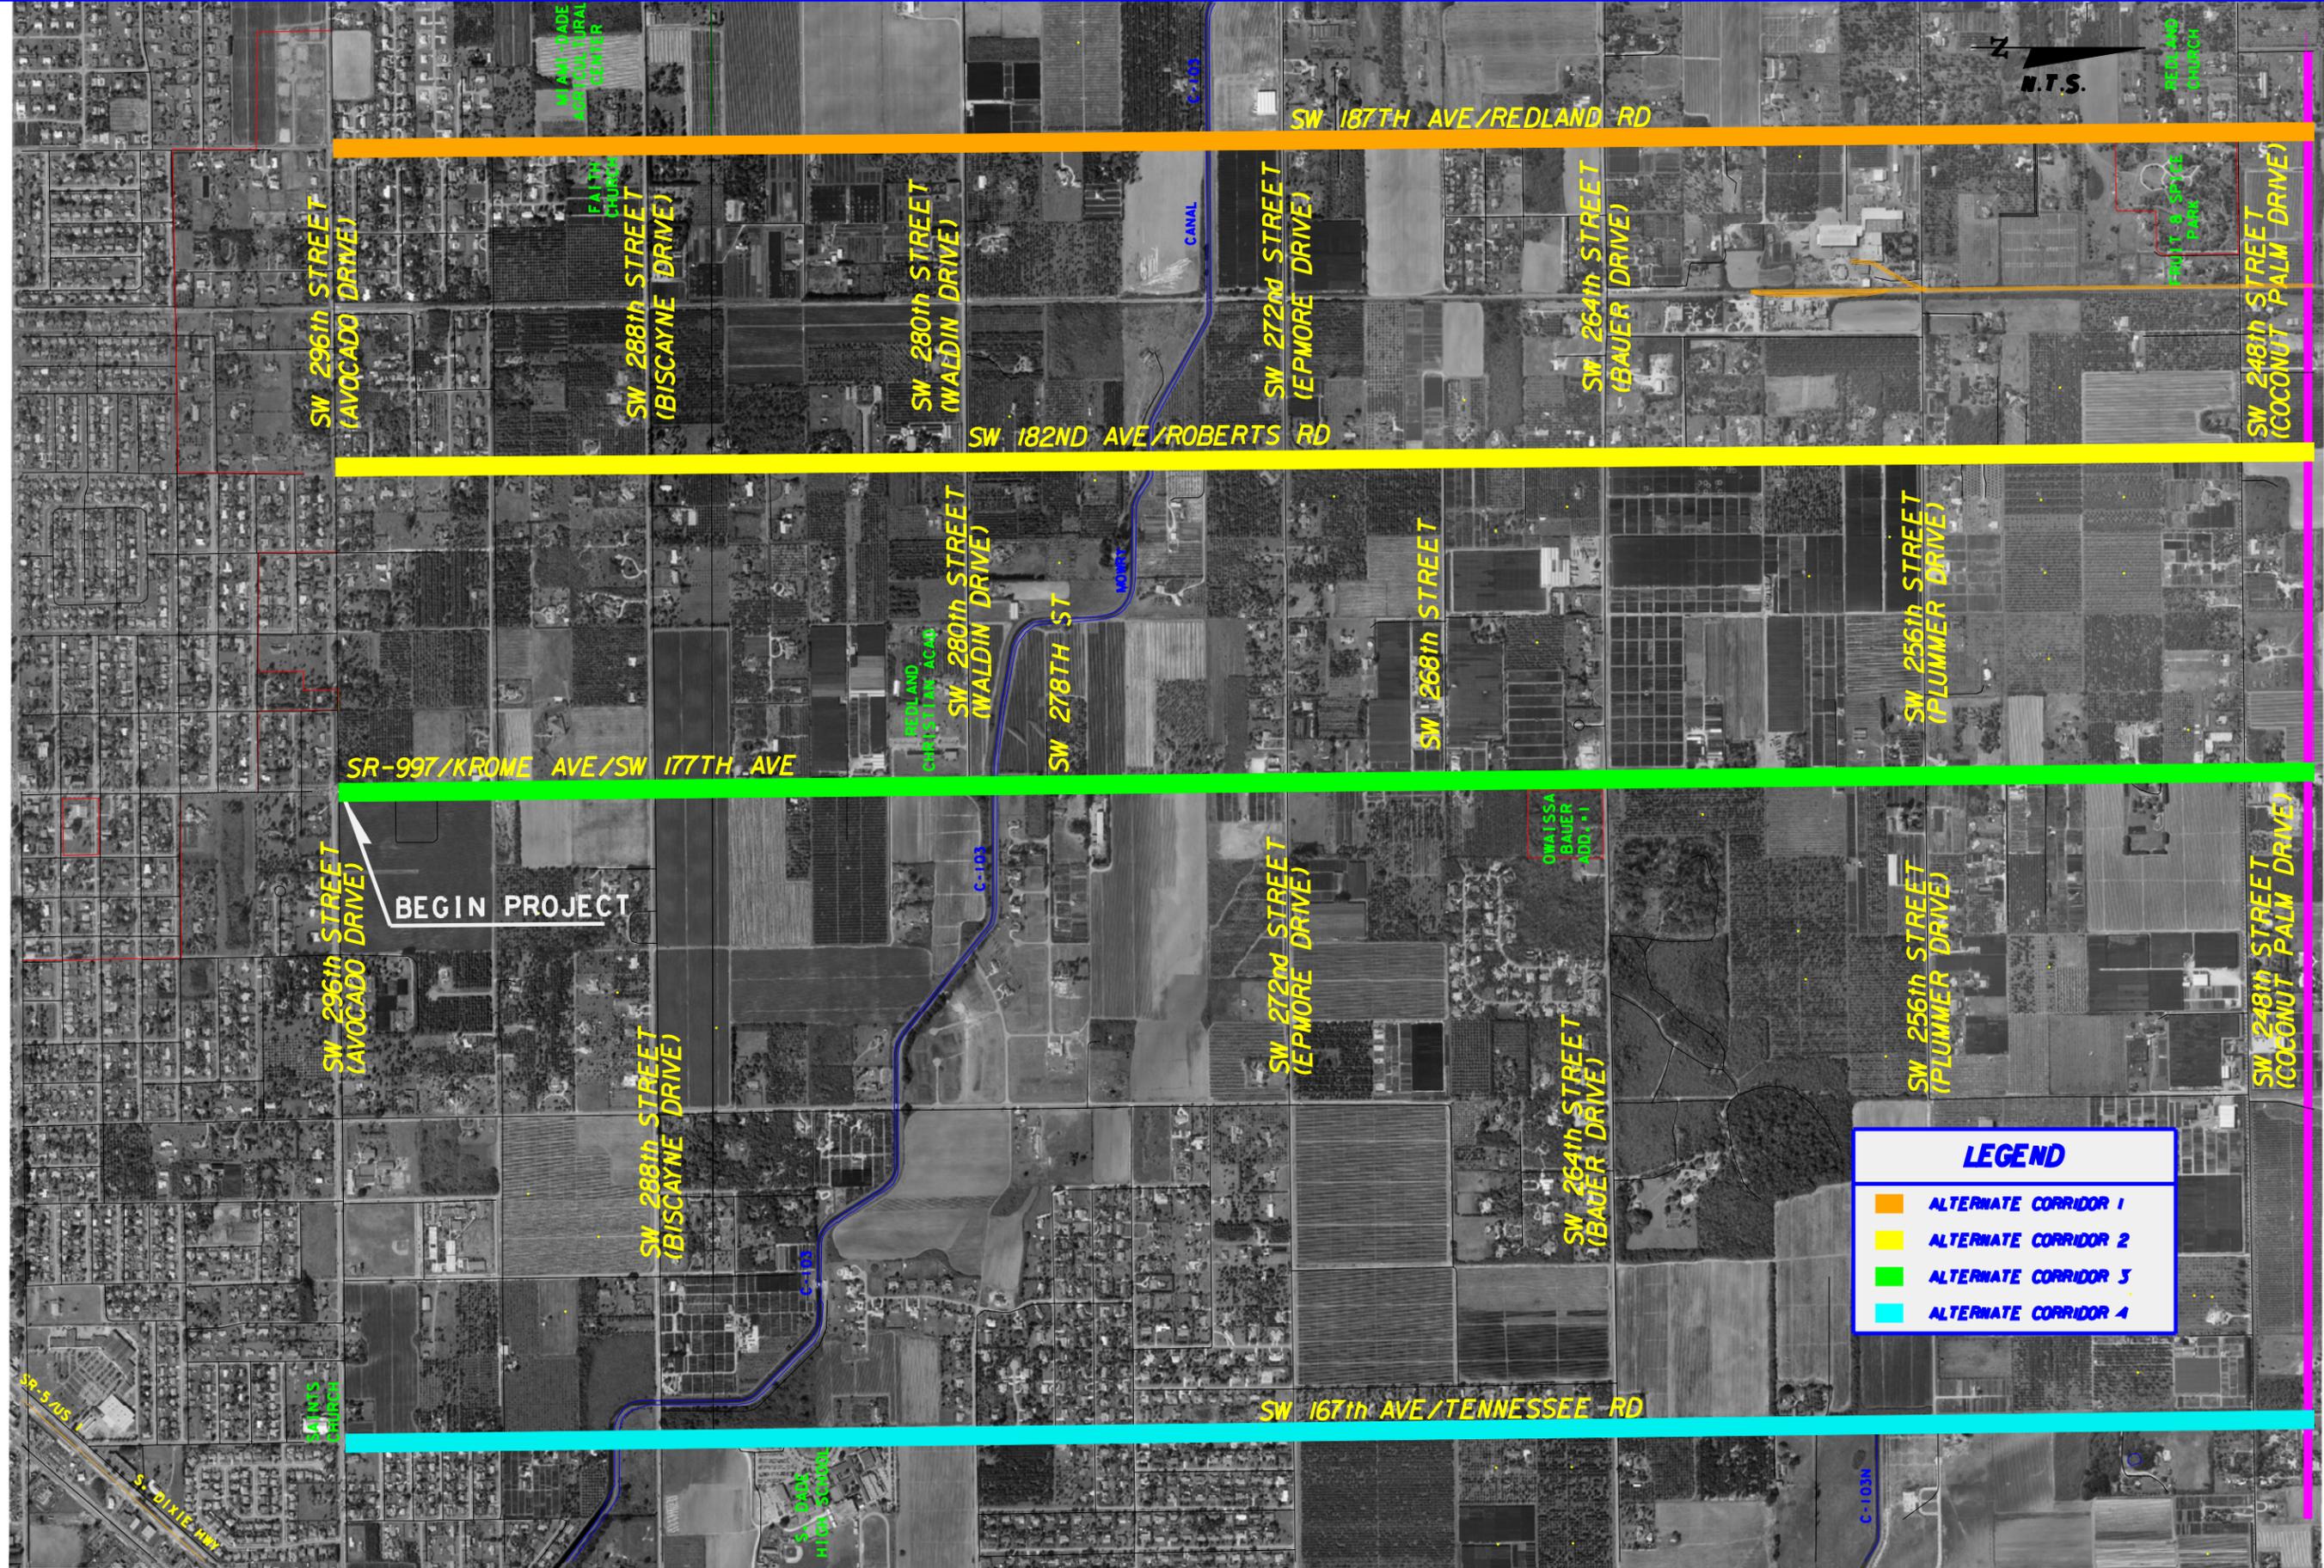
FIGURE 3.0-A

ALTERNATE CORRIDORS

Exhibits 3.0 – A through C, illustrate the four alternate corridors. The three exhibits (A thru C) show the four alternate corridors in their relative locations traversing the project area, including the respective terminal points of each existing corridor facility. The four (4) alternate corridors were selected, using data analysis and engineering judgment, as the most likely area facilities to provide reasonable solutions to the safety and operational deficiencies on the Krome Avenue facility. The subsequent qualitative analysis will screen each of the corridors and identify the most viable (reasonable and feasible) corridor among the alternates.

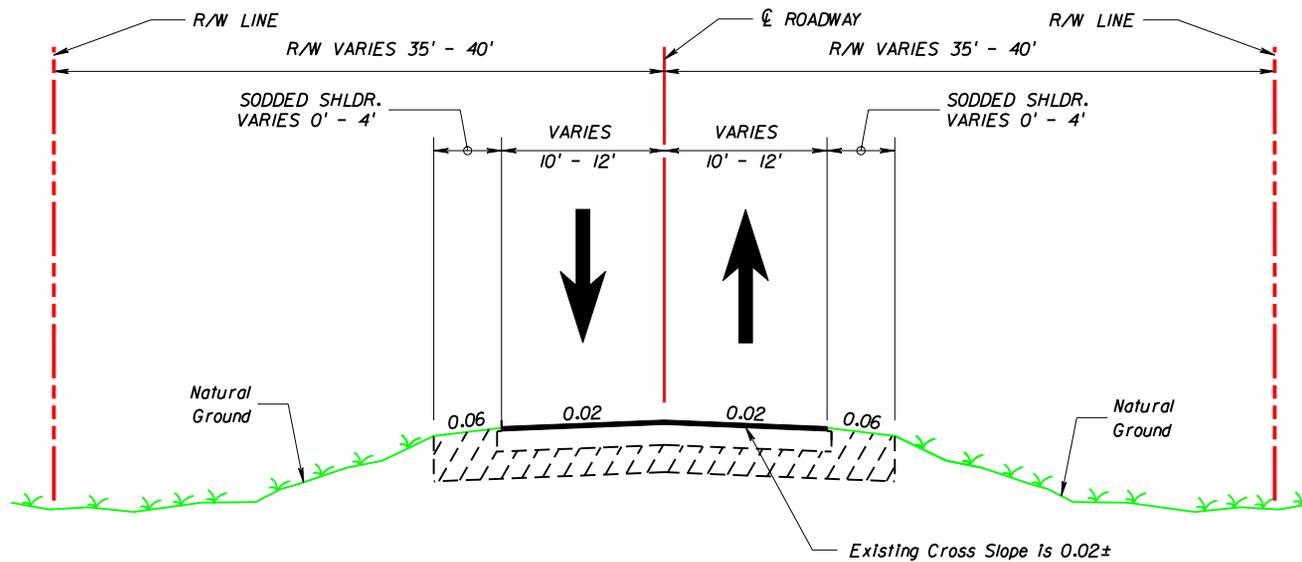
**EXISTING TYPICAL SECTION
ALTERNATE CORRIDOR 1
SW 187th AVENUE/REDLAND ROAD**

This corridor alternate consists of a two-lane undivided typical section with no paved shoulders. The lanes vary from 10' to 12' in width with sodded swales on both sides. The right-of-way varies from 70' to 80' in width. The posted speed limit varies from 30 to 40 MPH. *Exhibit 3.1-A* at the end of this section illustrates the typical section of the SW 187th Avenue/Redland Road corridor.

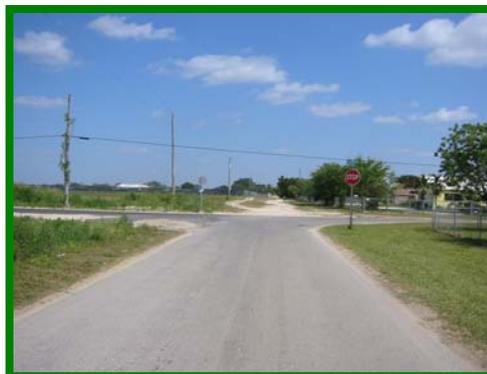
Paved roadway ends at SW 224th Street

North of SW 224th Street the existing typical section changes to an unimproved 2-lane / dirt road. The roadway crosses the following major intersections: 8) 216th Street/Hainlin Mill Drive, and 9) SW 200th Street/Quail Roost Drive. It continues north as a minor (pseudo-private) roadway, and is known as Ferry Avenue (running down the middle of a large well established residential and trailer park area) for the segment north of SW 200th Street and south of the C-102/Princeton Canal (approx. SW 196th Street). The road stops at this point as there is no existing bridge crossing at the C-102/Princeton Canal. SW 182nd Avenue picks up again on the north side of the C-102/Princeton Canal (approx. SW 196th Street) and from that point the corridor is comprised of discontinuous intermittent paved, dirt or gravel roadway segments interspersed among agricultural or unimproved parcels of land, until it reaches the northern project terminus at SW 136th Street.

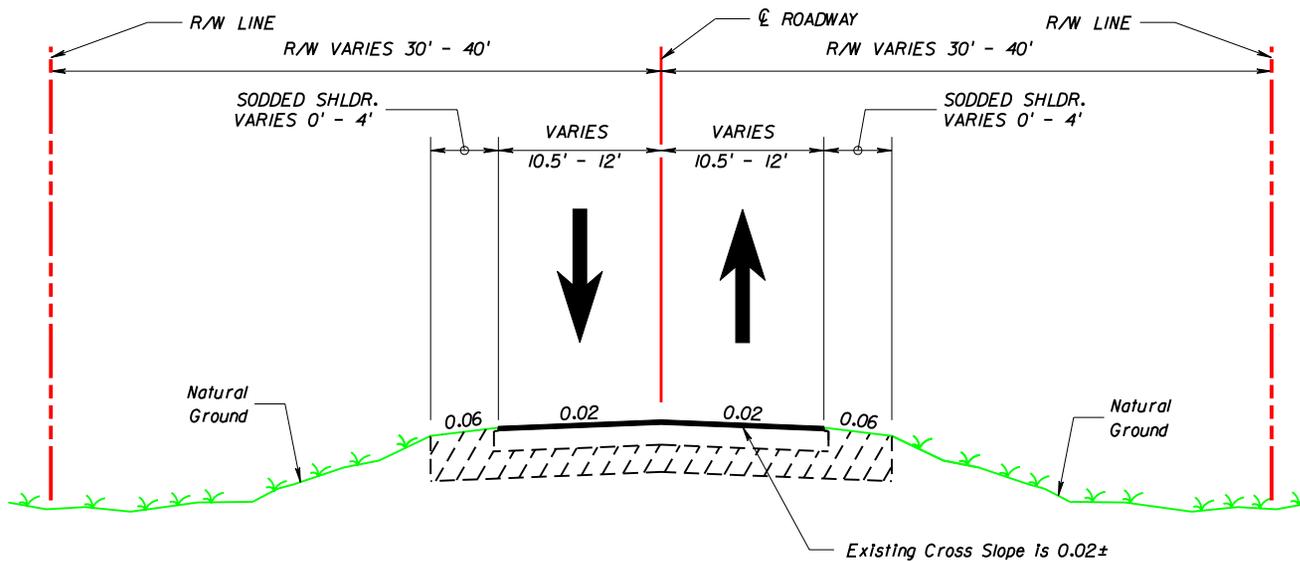
**EXISTING TYPICAL SECTION
ALTERNATE CORRIDOR 2
SW 182nd AVENUE/ROBERTS ROAD**

This corridor alternate consists of a two-lane undivided typical section with no paved shoulders. The lanes vary from 10.5' to 12' in width with sodded swales on both sides. The right-of-way varies from 60' to 80' in width. The posted speed limit varies from 30 to 40 MPH. **Exhibit 3.1-B** at the end of section illustrates the typical section of the SW 182nd Avenue/Roberts Road corridor.

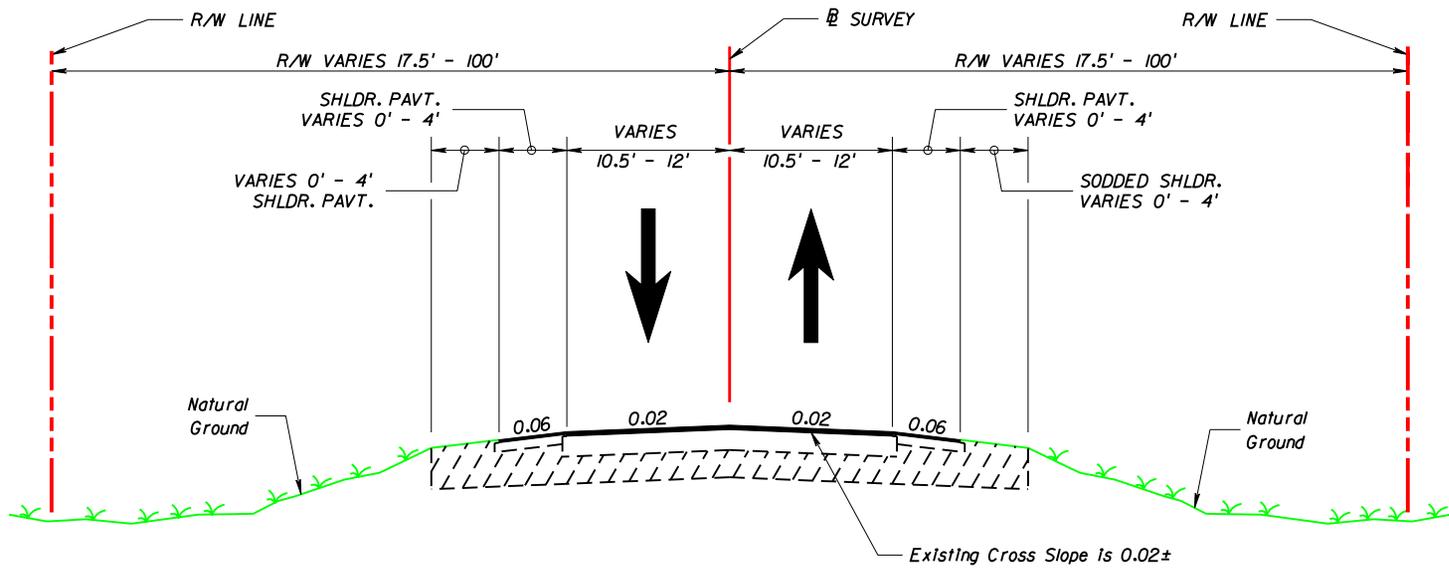
**EXISTING TYPICAL SECTION
ALTERNATE CORRIDOR 3
SR - 997/ KROME AVENUE/ SW 177TH AVENUE**

This corridor alternate typical section varies slightly consisting primarily of two lanes, varying in width from 10.5 feet to 12 feet; paved shoulders ranging from zero (0) feet to four (4) feet; and roadside swales. The right-of-way varies from 35' to 200' in width. The existing speed limit is posted at 45 MPH along the Krome Avenue corridor. The corridor typical section is illustrated in *Exhibit 3.1-C* at the end of section. The existing Krome Avenue corridor traverses a rural farming and residential community. The rural land uses include numerous agricultural fields and herbaceous, ornamental, and fruit tree nurseries. The agricultural fields include seasonal "self-pick" fields with fruit/vegetable stands. There are many nurseries found scattered along much of the southern stretch of Krome Avenue; most are open to the public with direct access onto Krome Avenue.

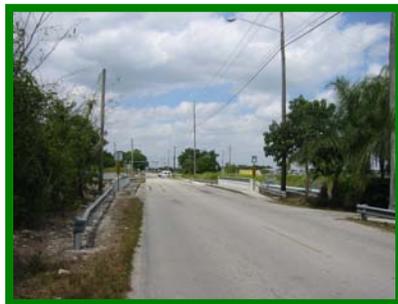
Bridge crossing the C-103 Canal

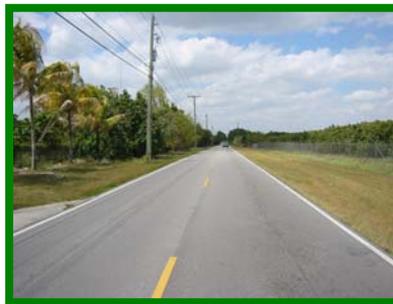
Roadway typical section

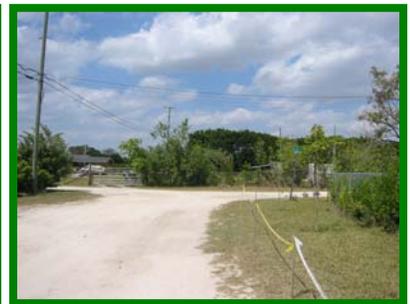
Roadway ends at SW 195th Street

North of SW 195th Street the SW 167th Avenue corridor is comprised of discontinuous intermittent paved, dirt or gravel roadway segments. The segments are interspersed among agricultural or unimproved parcels of land, until the road reaches the northern terminus at SW 136th

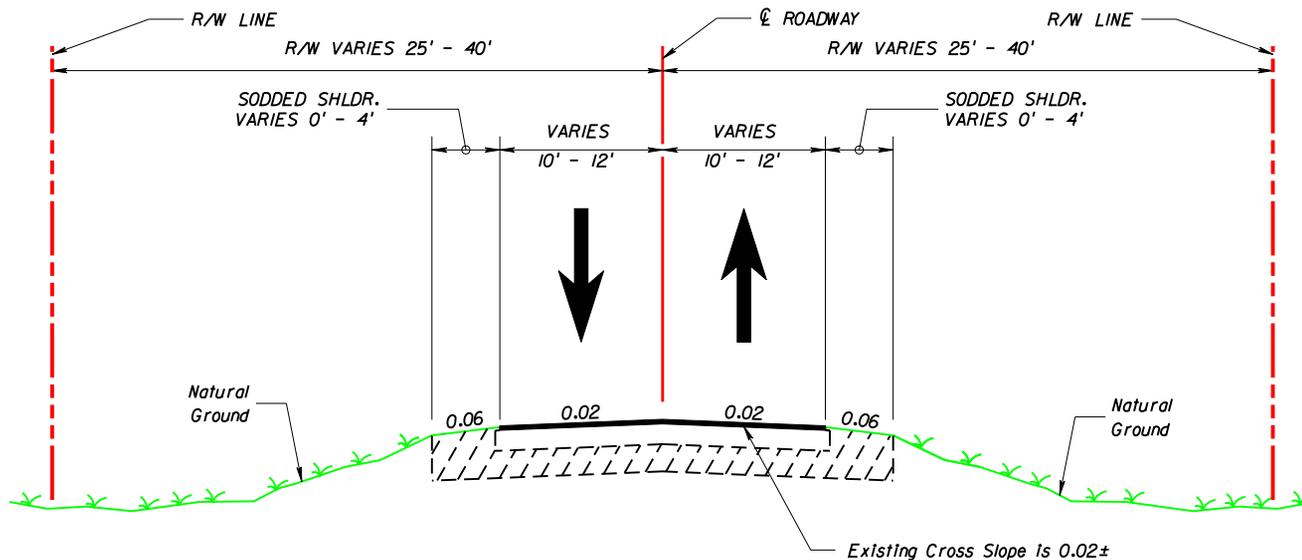
**EXISTING TYPICAL SECTION
ALTERNATE CORRIDOR 4
SW 167th AVENUE/TENNESSEE ROAD**

This corridor alternate consists of a two-lane undivided typical section with no paved shoulders. The lanes vary from 10' to 12' in width with sodded swales on both sides. The right-of-way varies from 50' to 80' in width. The posted speed limit varies from 35 to 40 MPH. *Exhibit 3.1-D* at the end of this section illustrates the typical section of the SW 167th Avenue/Tennessee Road corridor.
