**GEOTECHNICAL REPORT
PROJECT DEVELOPMENT & ENVIRONMENTAL STUDY**

**SR 997 / Krome Avenue / SW 177 Avenue (South)
from SW 296th Street to SW 136th Street**

REPORT OF A SOIL SURVEY - ROADWAY

**SR 997/KROME AVENUE PD&E STUDY
FROM SW 296TH STREET TO SW 136TH STREET
FLORIDA DEPARTMENT OF TRANSPORTATION
DISTRICT 6
MIAMI-DADE COUNTY, FLORIDA
FM No. 249614-4-22-01**

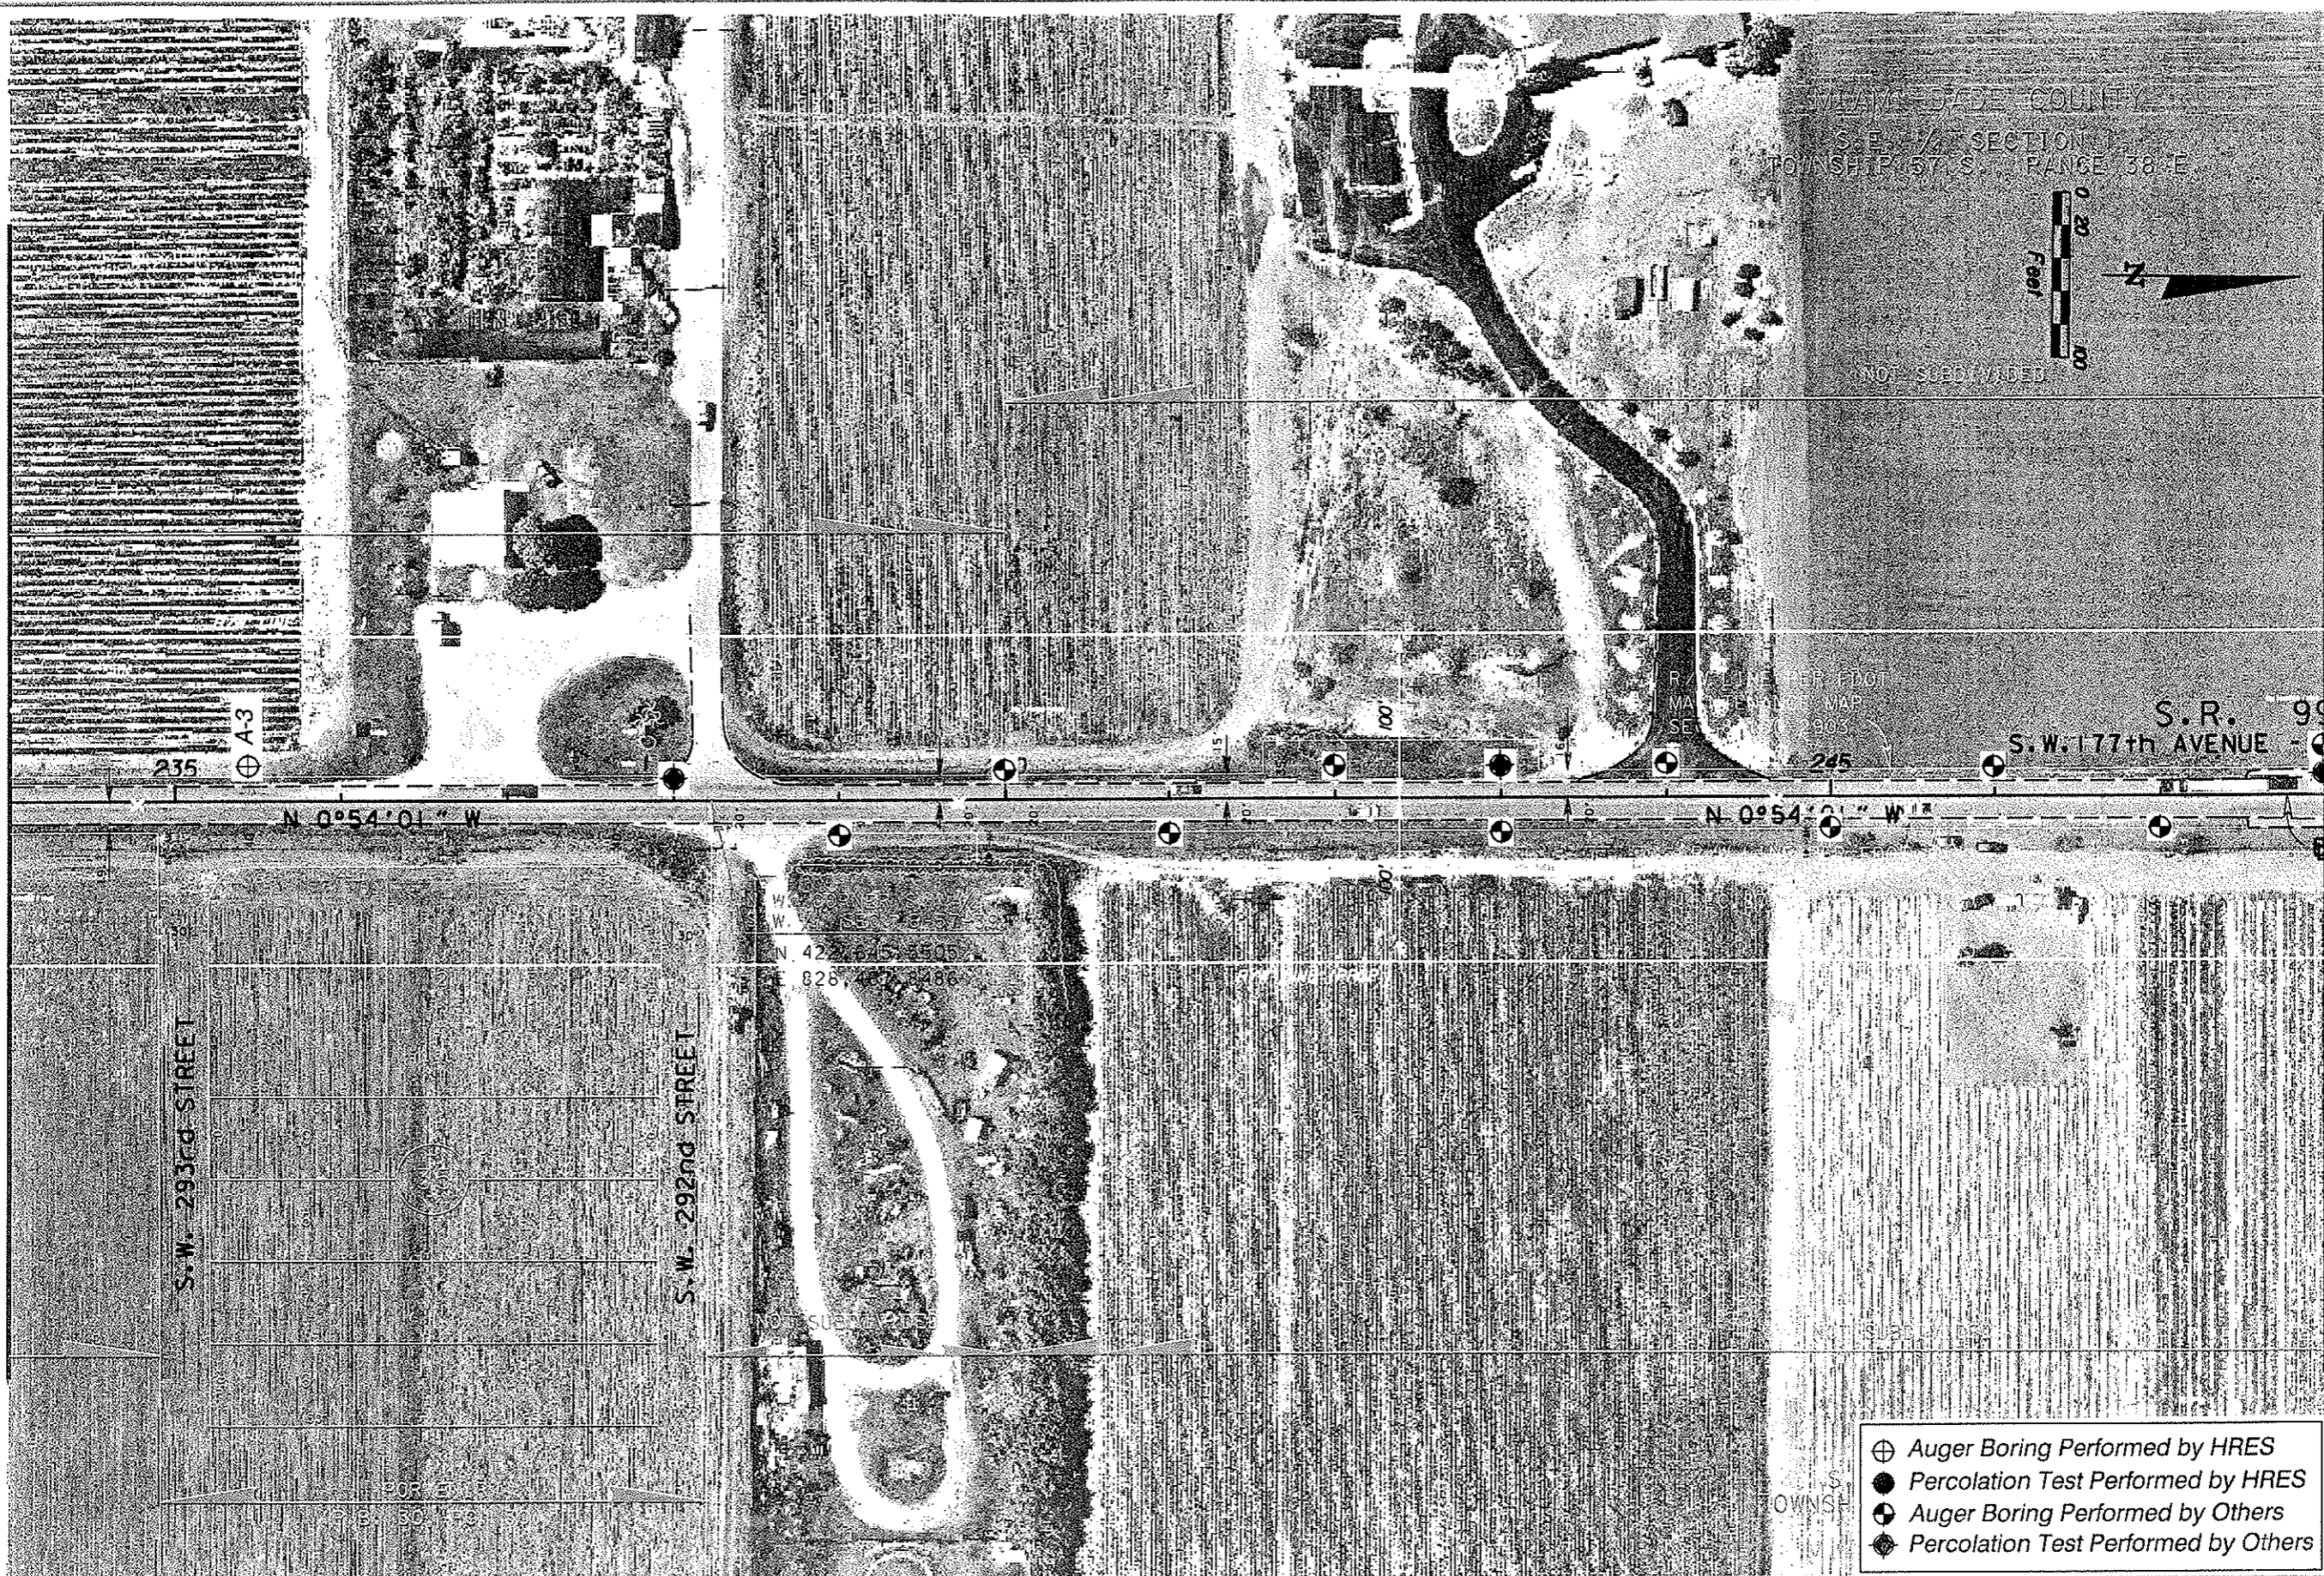
- ⊕ Auger Boring Performed by HRES
- Percolation Test Performed by HRES
- ⊙ Auger Boring Performed by Others
- ⊗ Percolation Test Performed by Others

Approximate boring locations are provided in the Summary of Auger Borings and Percolation Test Locations in Appendix A. The Soils Information Tables in Appendix A summarize the approximate boundary between soil/rock types. In some instances, the transition between material types may be gradual. A brief description of the exploratory sampling techniques used is presented in the Field Procedures section of Appendix A. A discussion of the subsurface conditions encountered is provided in Section 4.2 of this report.

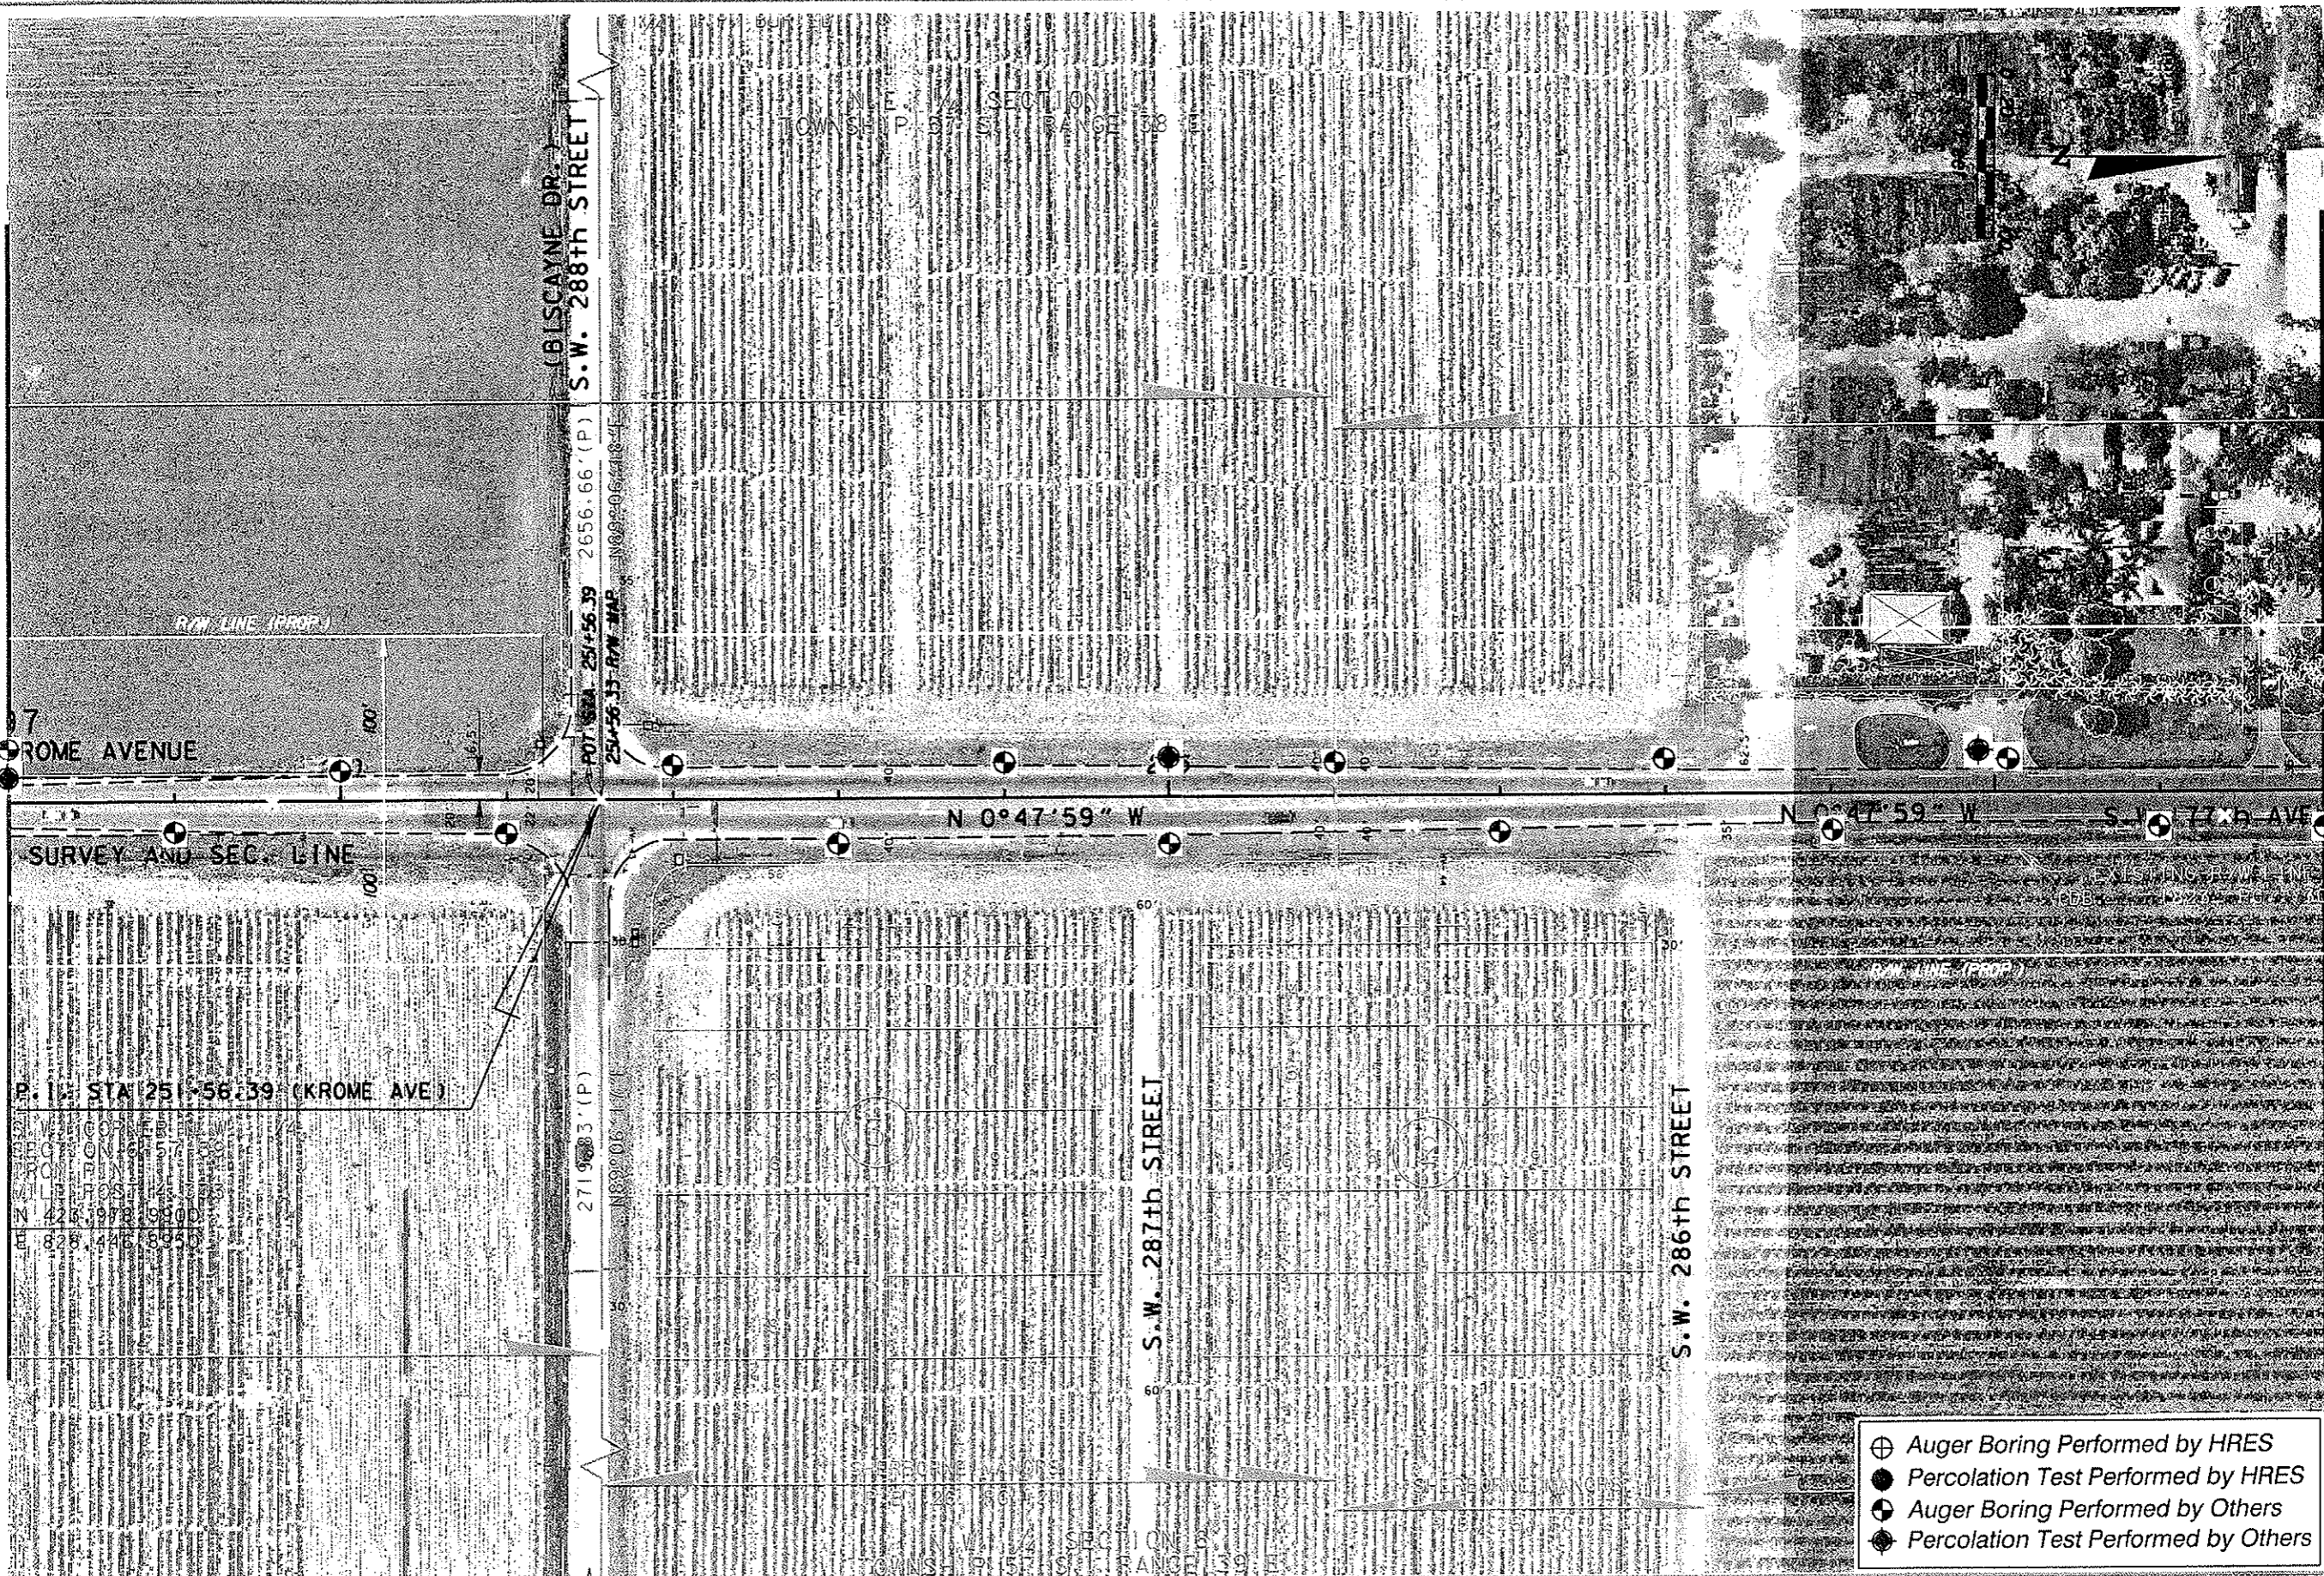
SHEET NO.
A-4

- ⊕ Auger Boring Performed by HRES
- Percolation Test Performed by HRES
- ⊕ Auger Boring Performed by Others
- Percolation Test Performed by Others

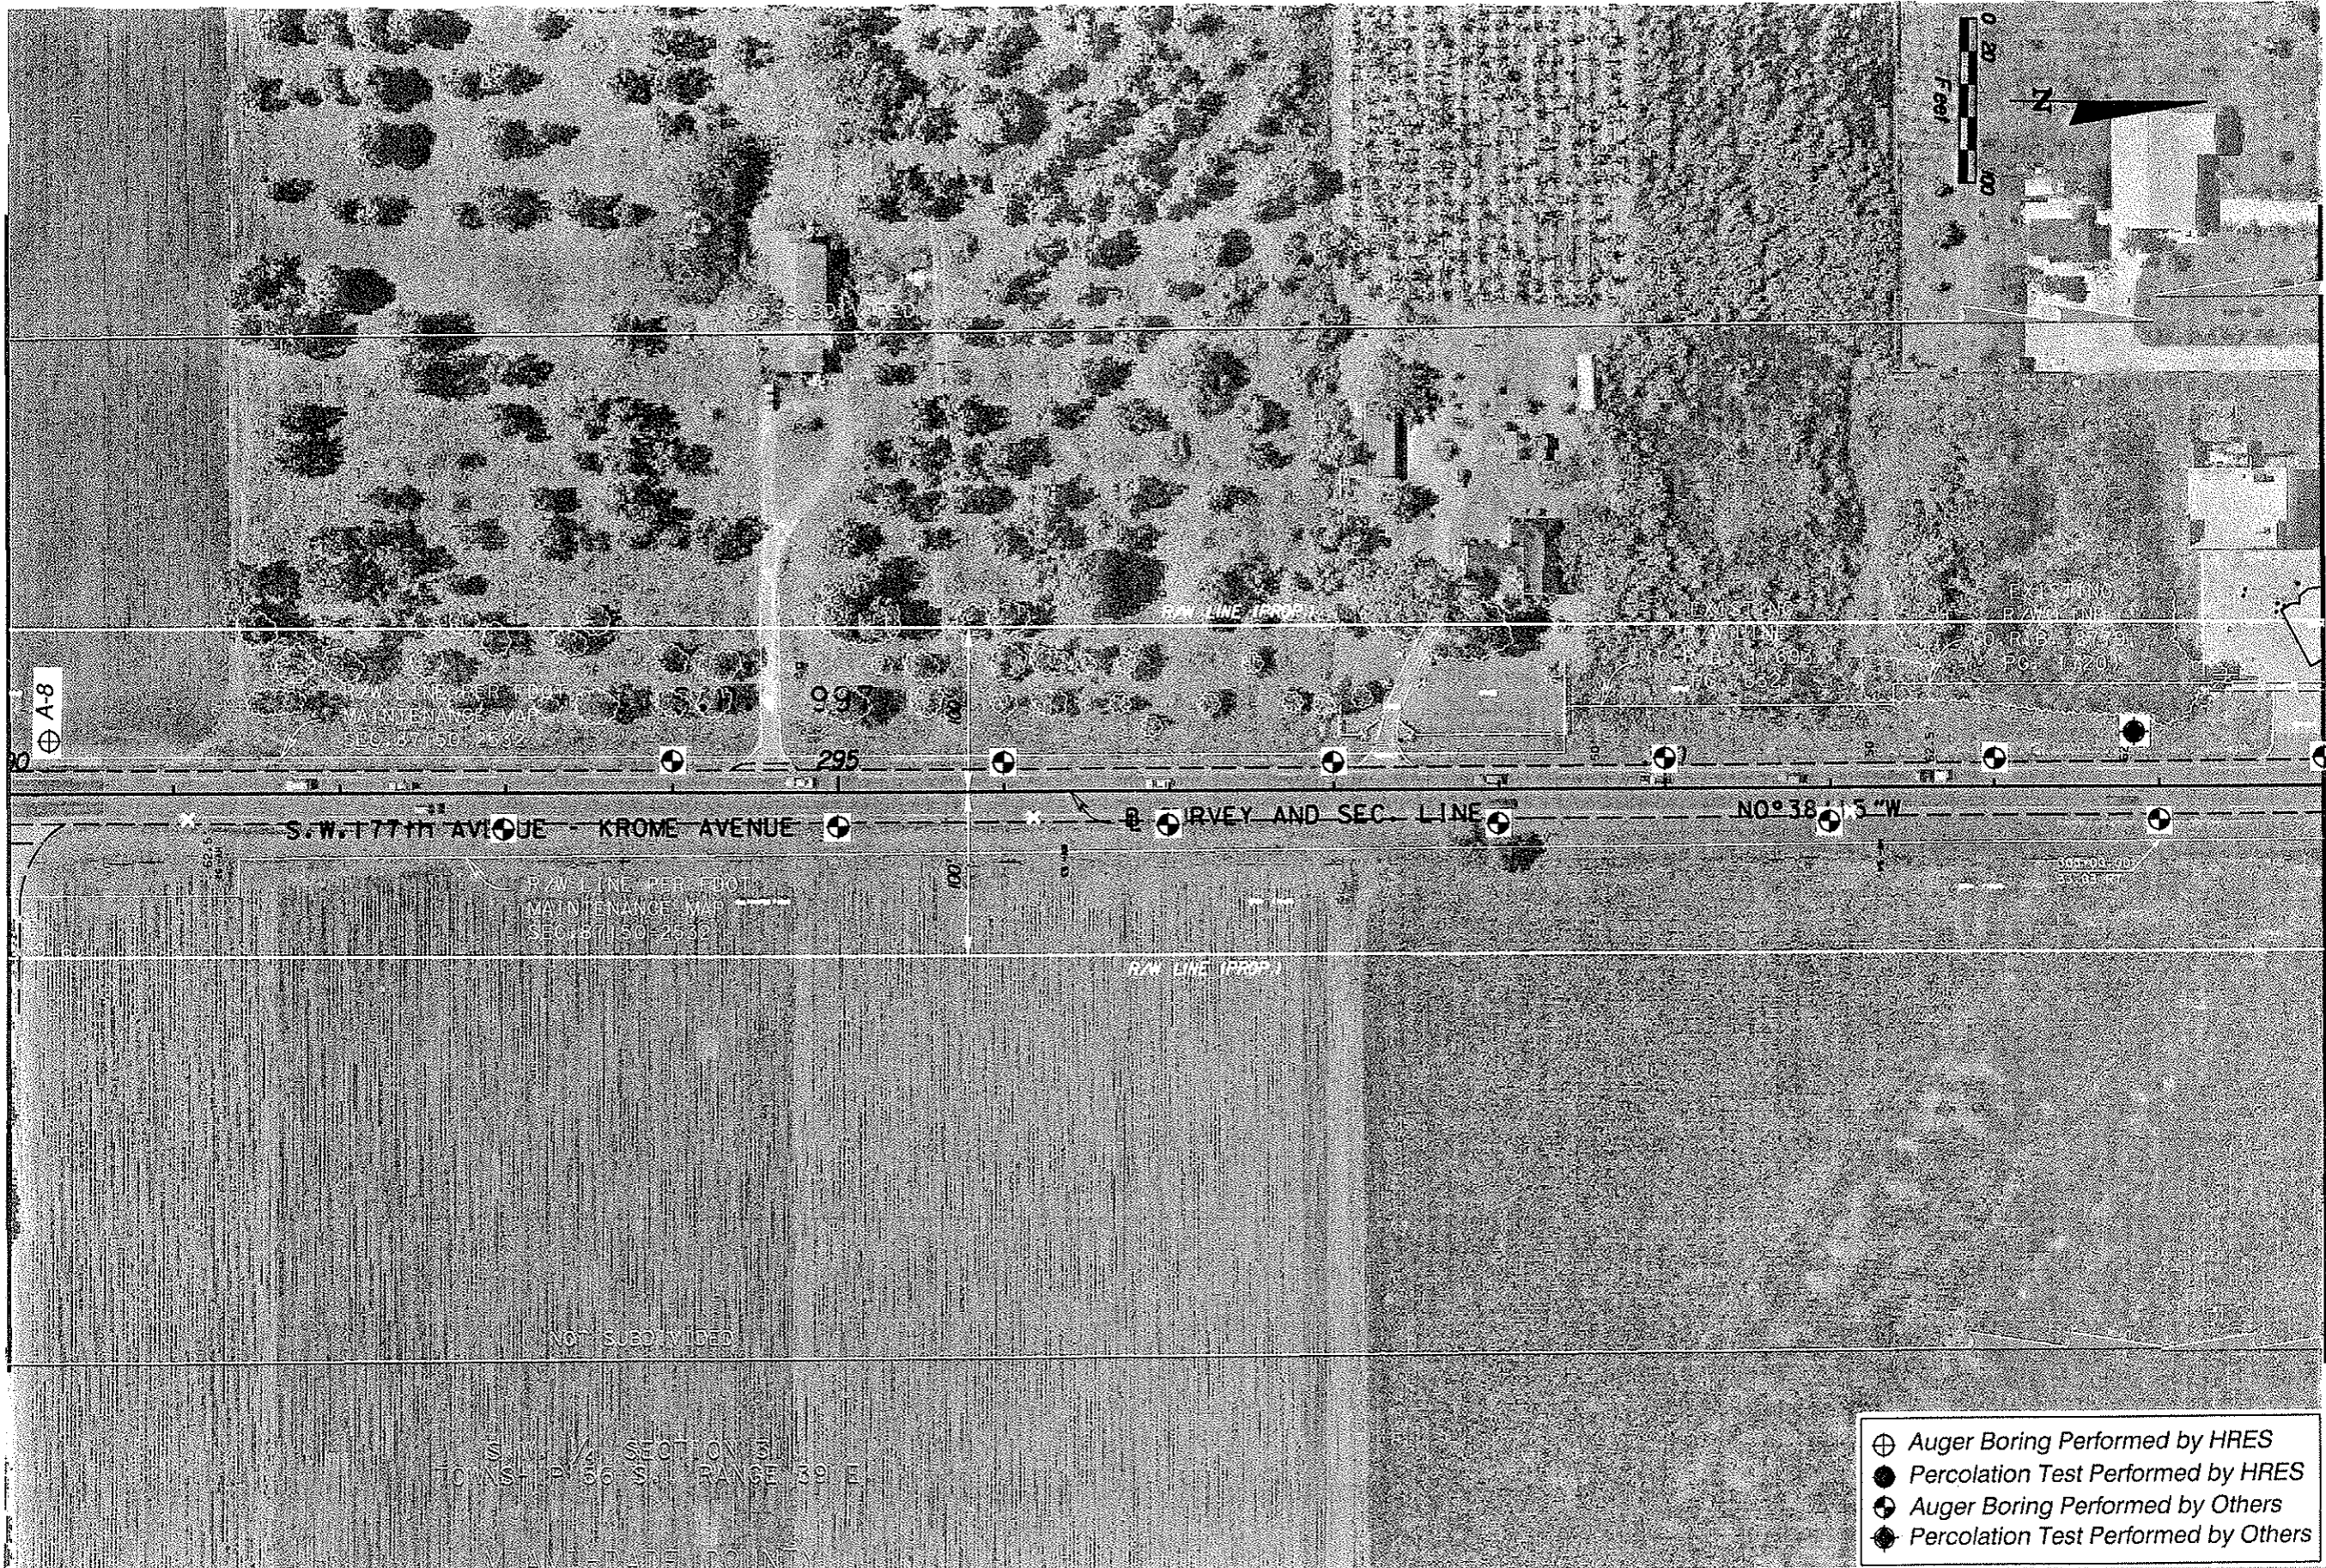
- ⊕ Auger Boring Performed by HRES
- Percolation Test Performed by HRES
- ⊕ Auger Boring Performed by Others
- Percolation Test Performed by Others

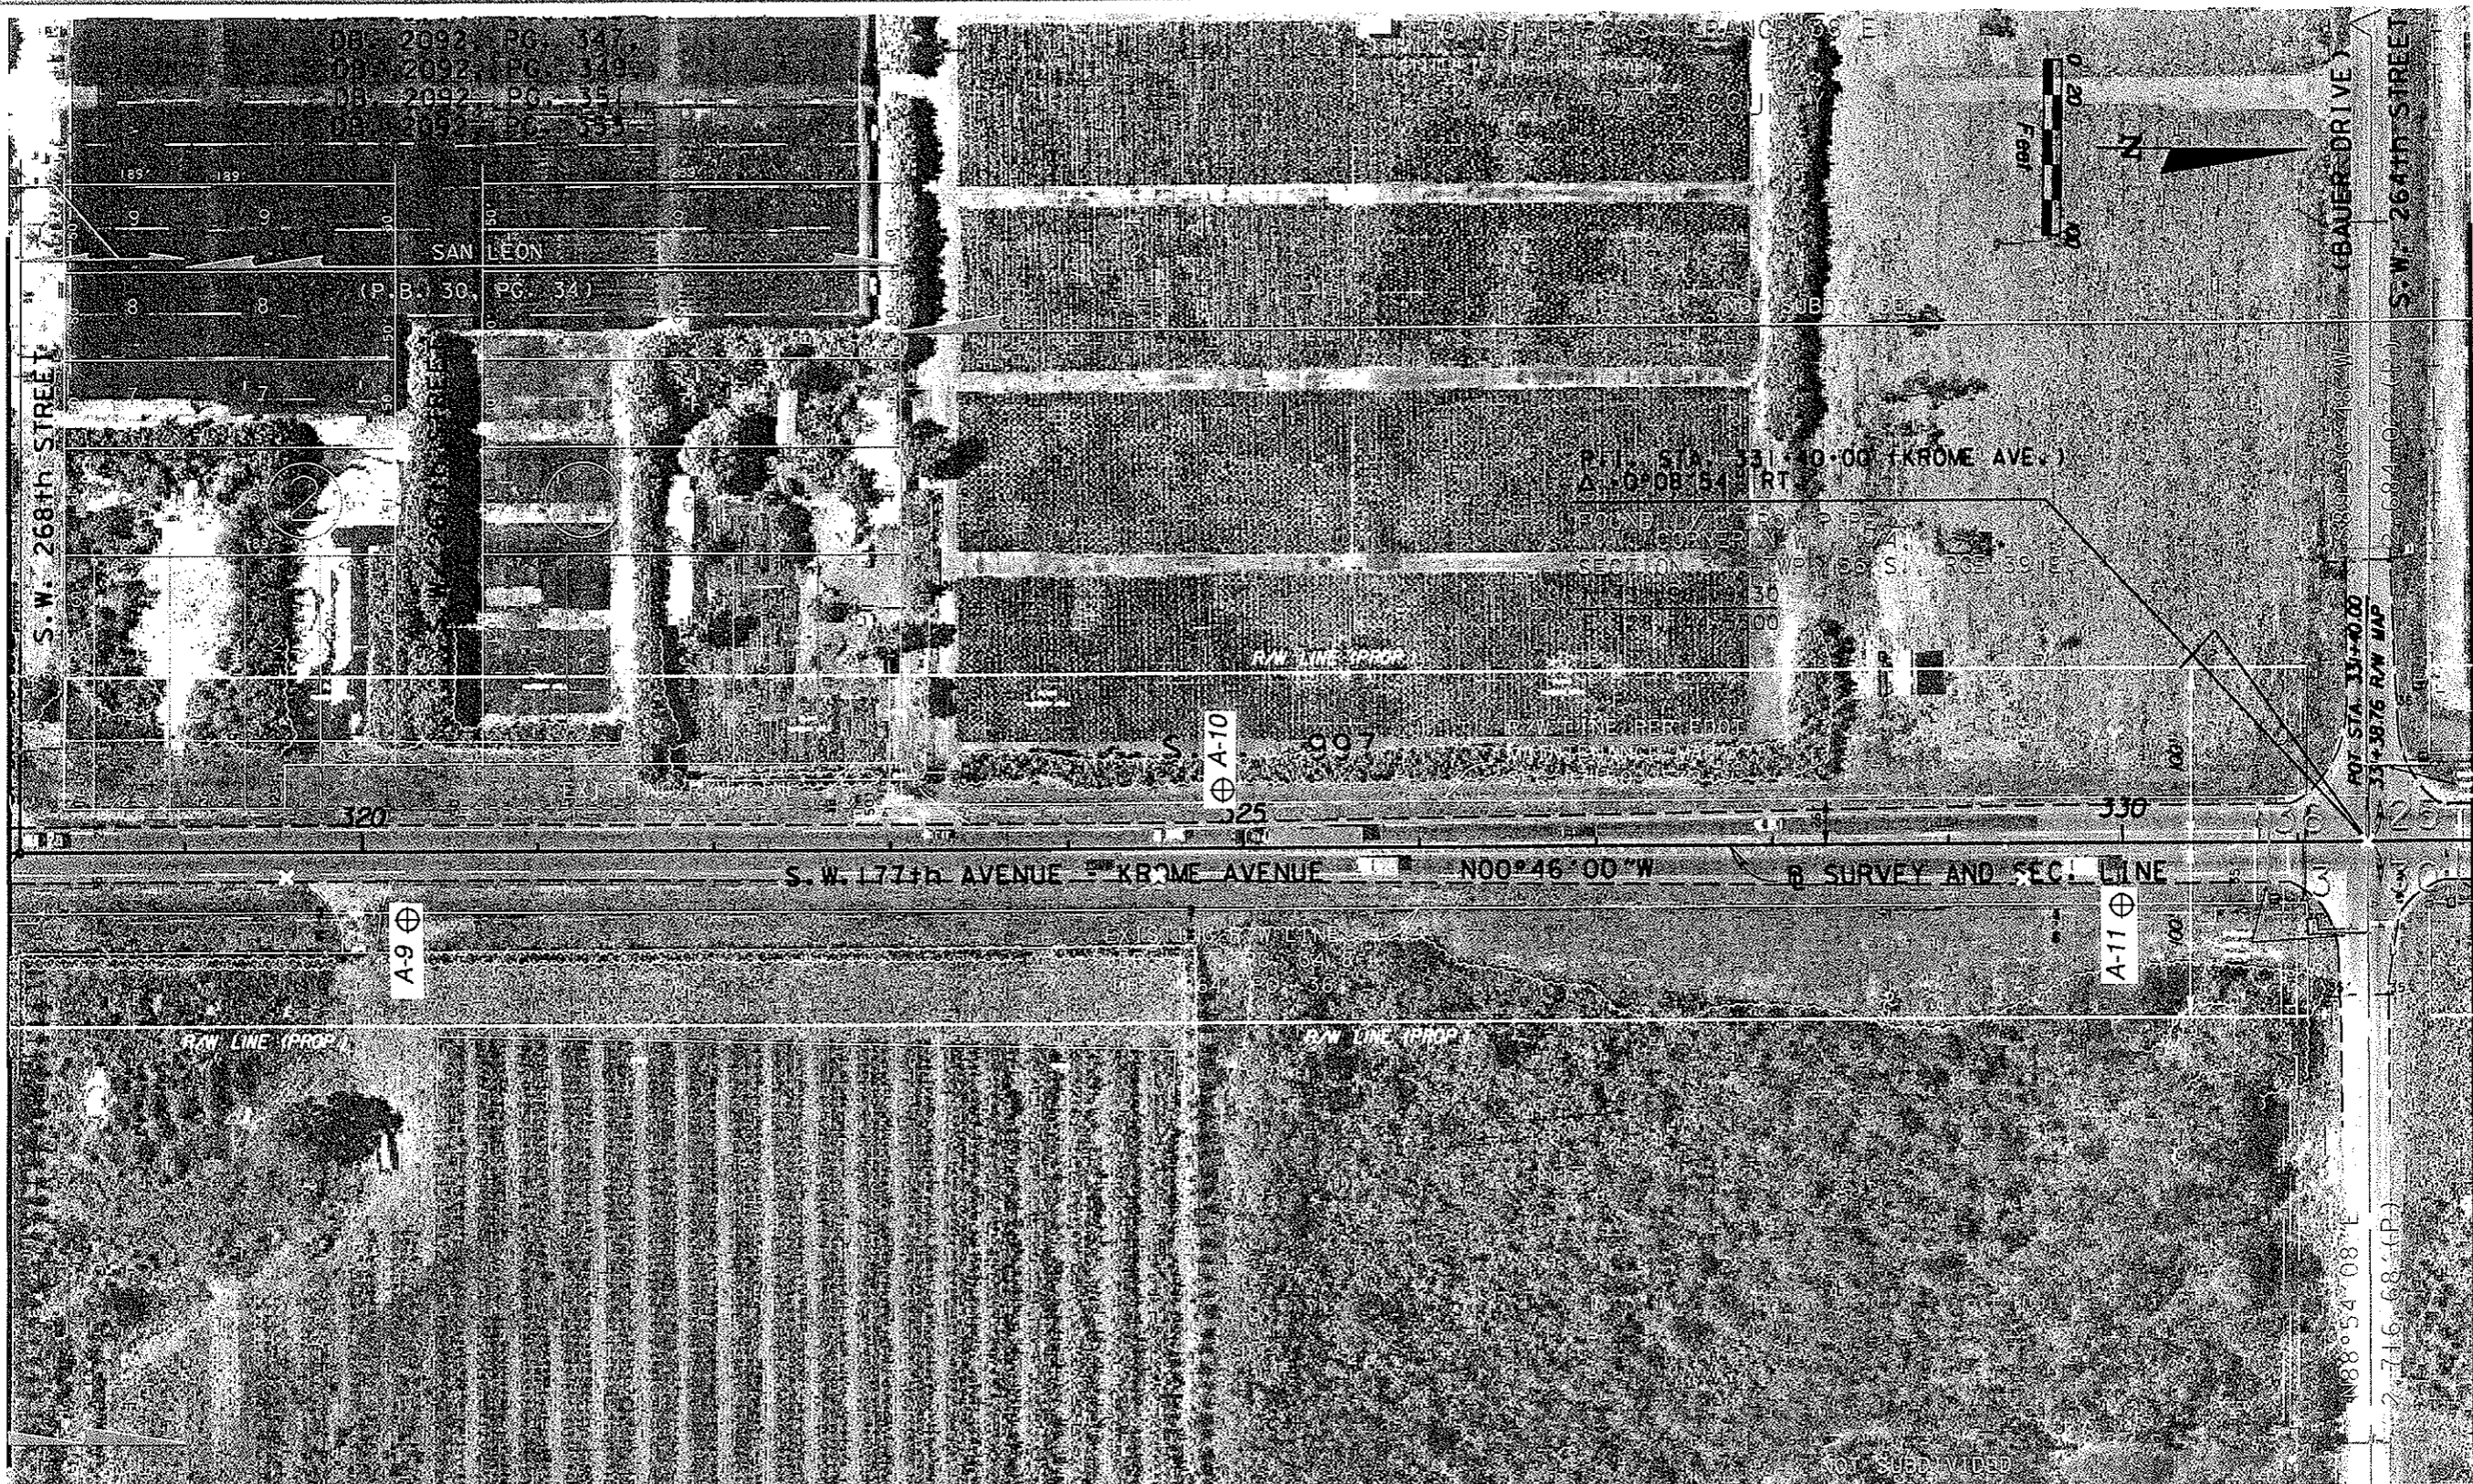
- ⊕ Auger Boring Performed by HRES
- Percolation Test Performed by HRES
- ⊕ Auger Boring Performed by Others
- Percolation Test Performed by Others

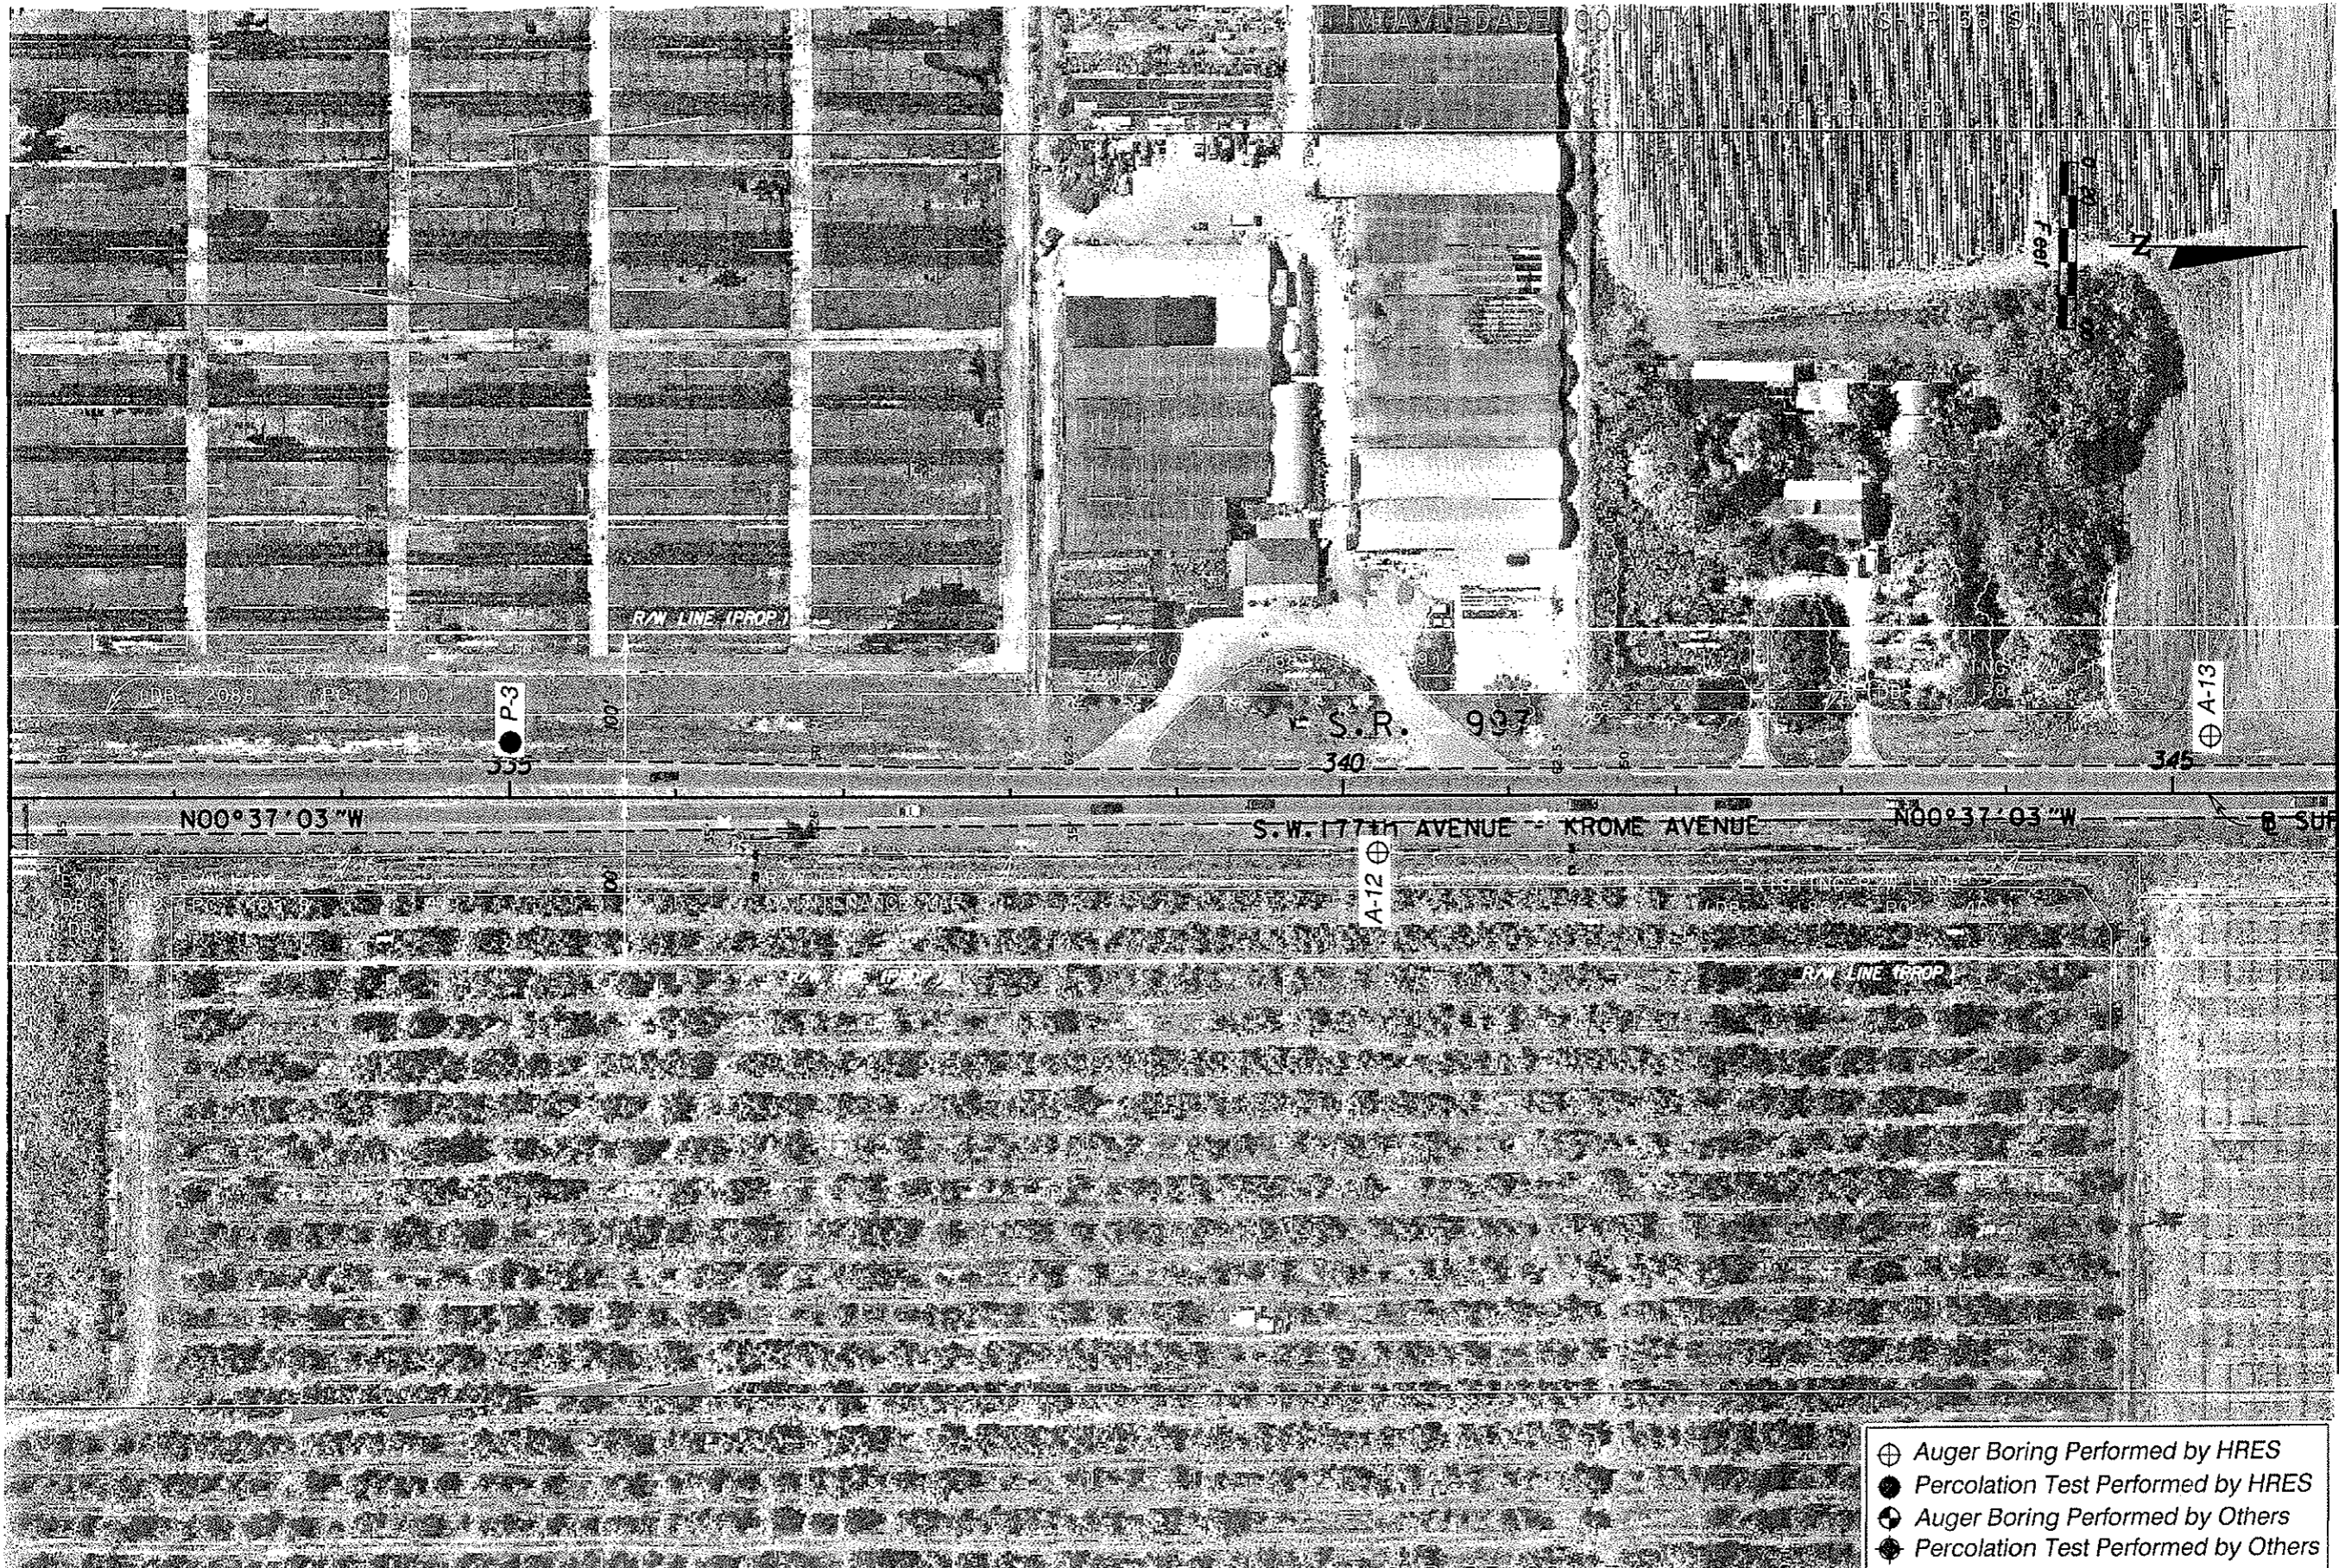
- ⊕ Auger Boring Performed by HRES
- Percolation Test Performed by HRES
- ⊕ Auger Boring Performed by Others
- Percolation Test Performed by Others

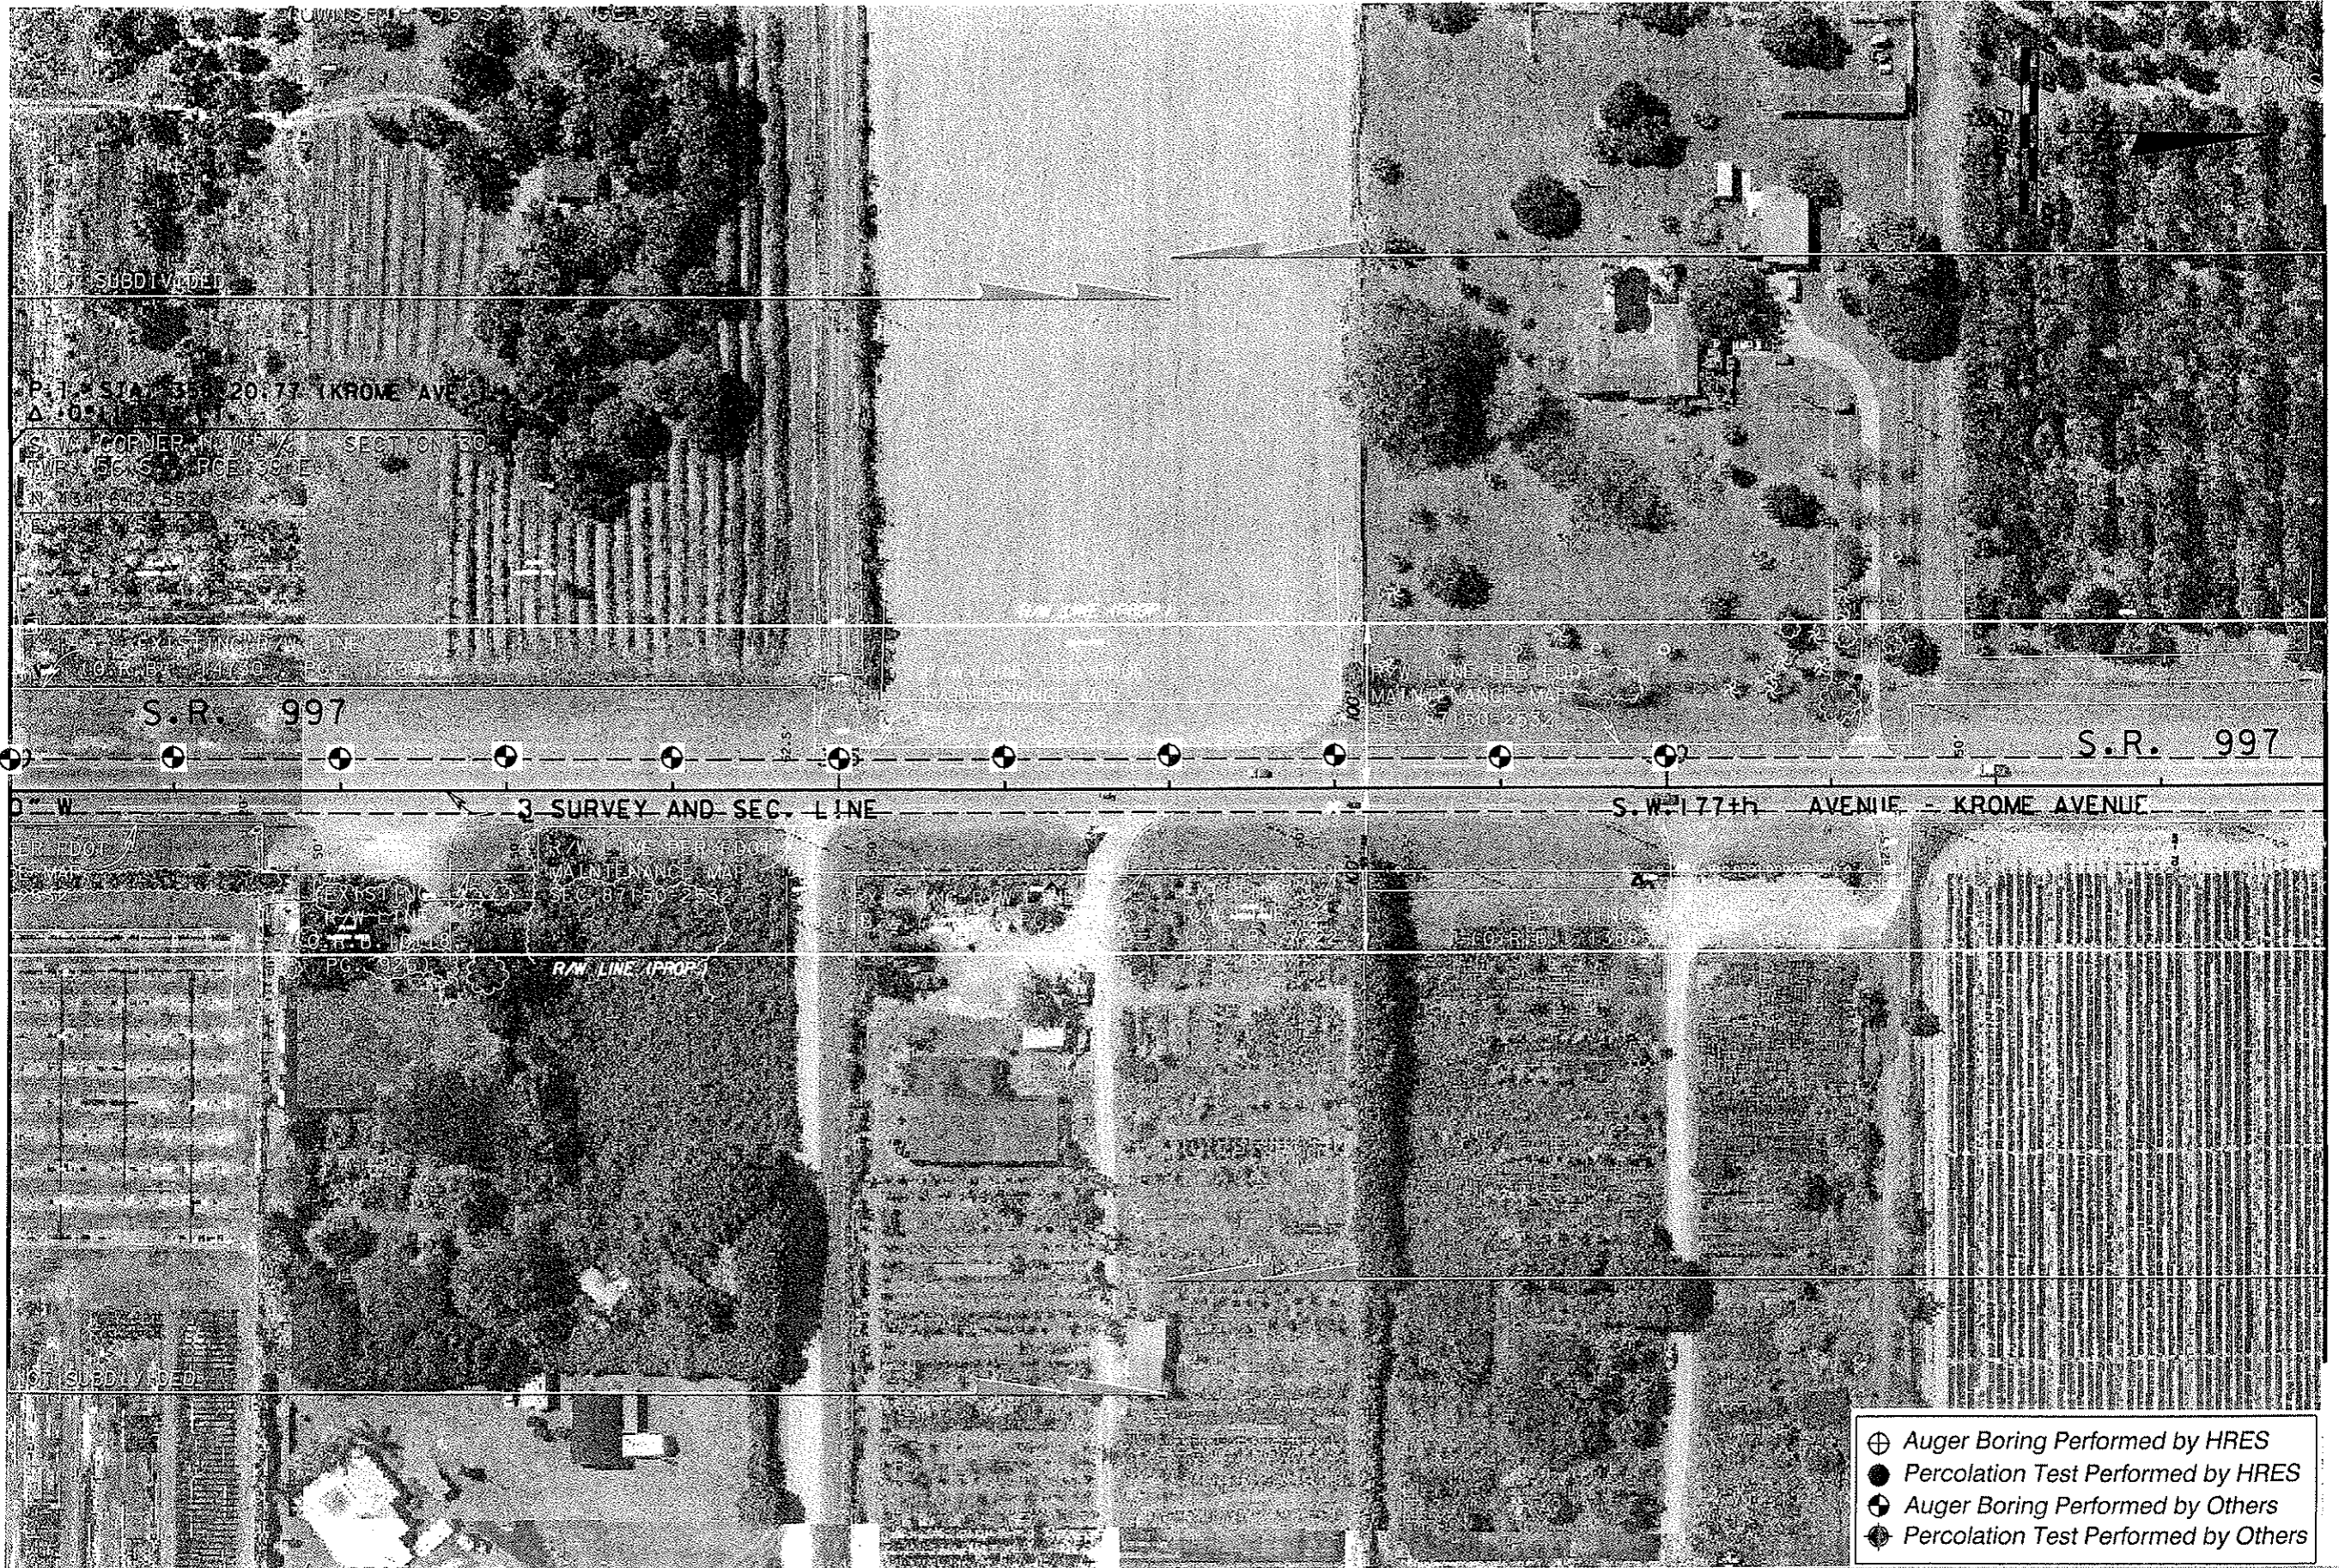
- ⊕ Auger Boring Performed by HRES
- Percolation Test Performed by HRES
- ⊕ Auger Boring Performed by Others
- Percolation Test Performed by Others
