**GEOTECHNICAL REPORT
PROJECT DEVELOPMENT & ENVIRONMENTAL STUDY**

**SR 997 / Krome Avenue / SW 177 Avenue (South)
from SW 296th Street to SW 136th Street**

REPORT OF A SOIL SURVEY - ROADWAY

**SR 997/KROME AVENUE PD&E STUDY
FROM SW 296TH STREET TO SW 136TH STREET
FLORIDA DEPARTMENT OF TRANSPORTATION
DISTRICT 6
MIAMI-DADE COUNTY, FLORIDA
FM No. 249614-4-22-01**

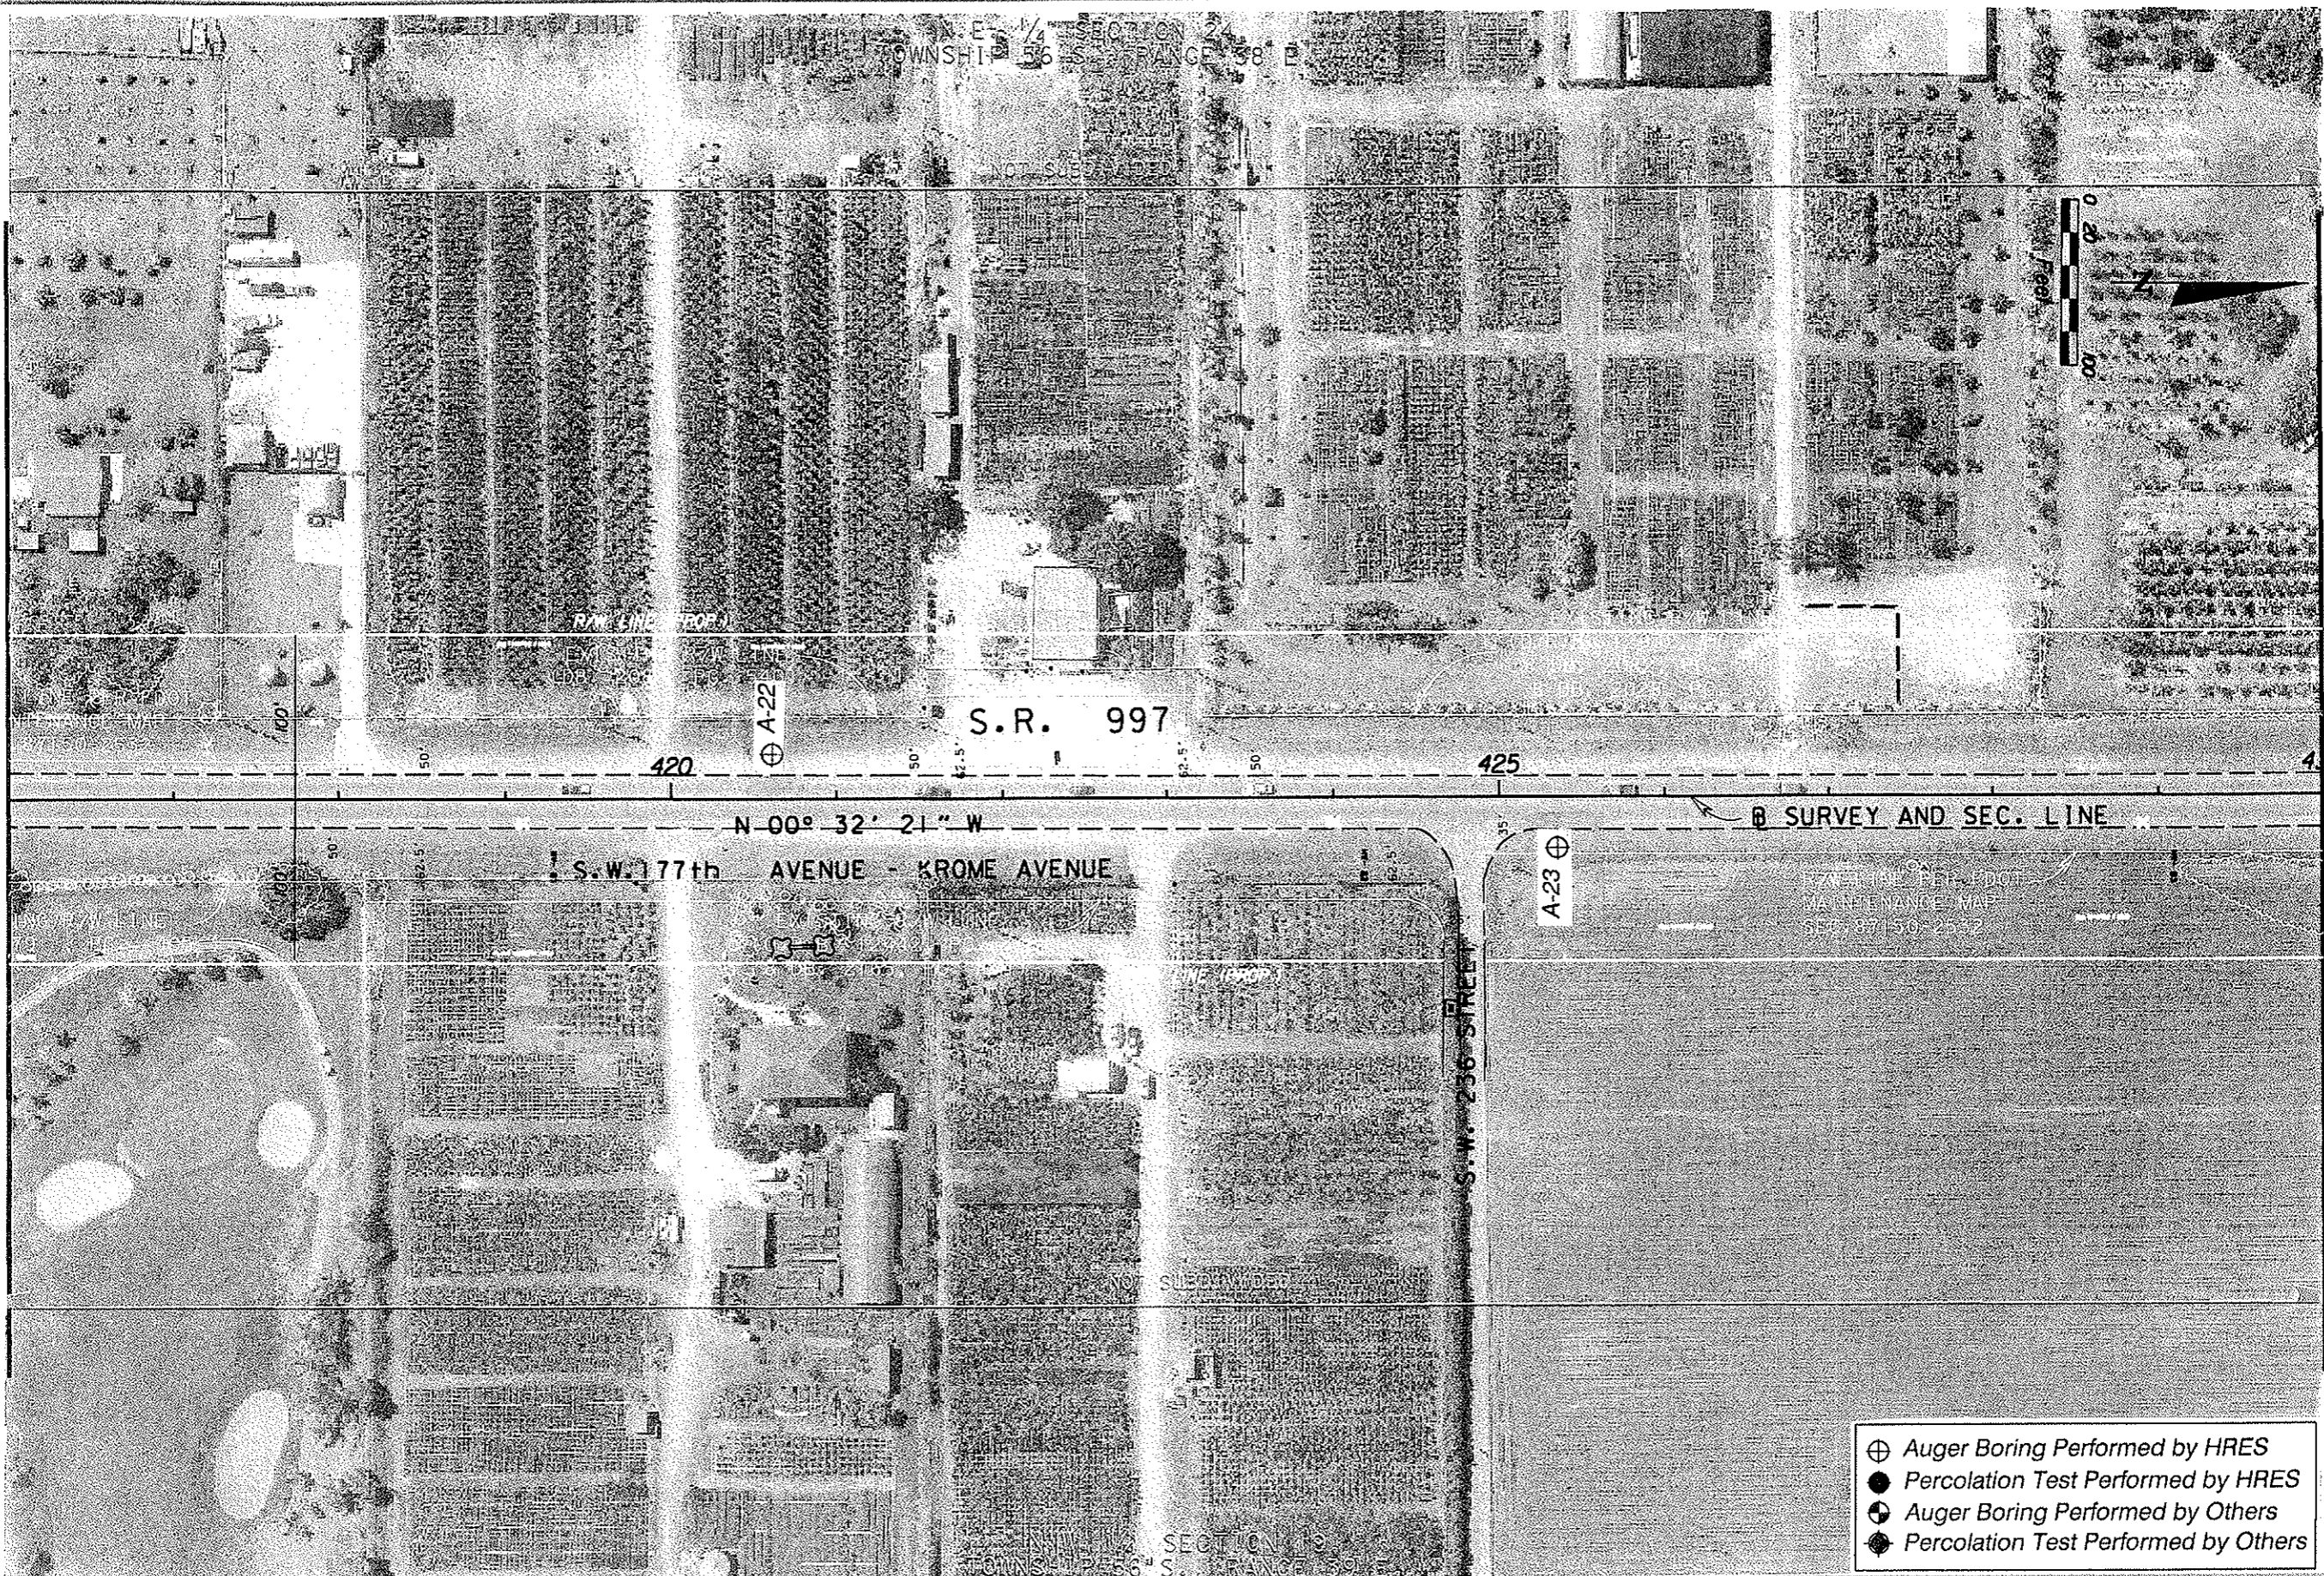
- ⊕ Auger Boring Performed by HRES
- Percolation Test Performed by HRES
- ⊕ Auger Boring Performed by Others
- Percolation Test Performed by Others

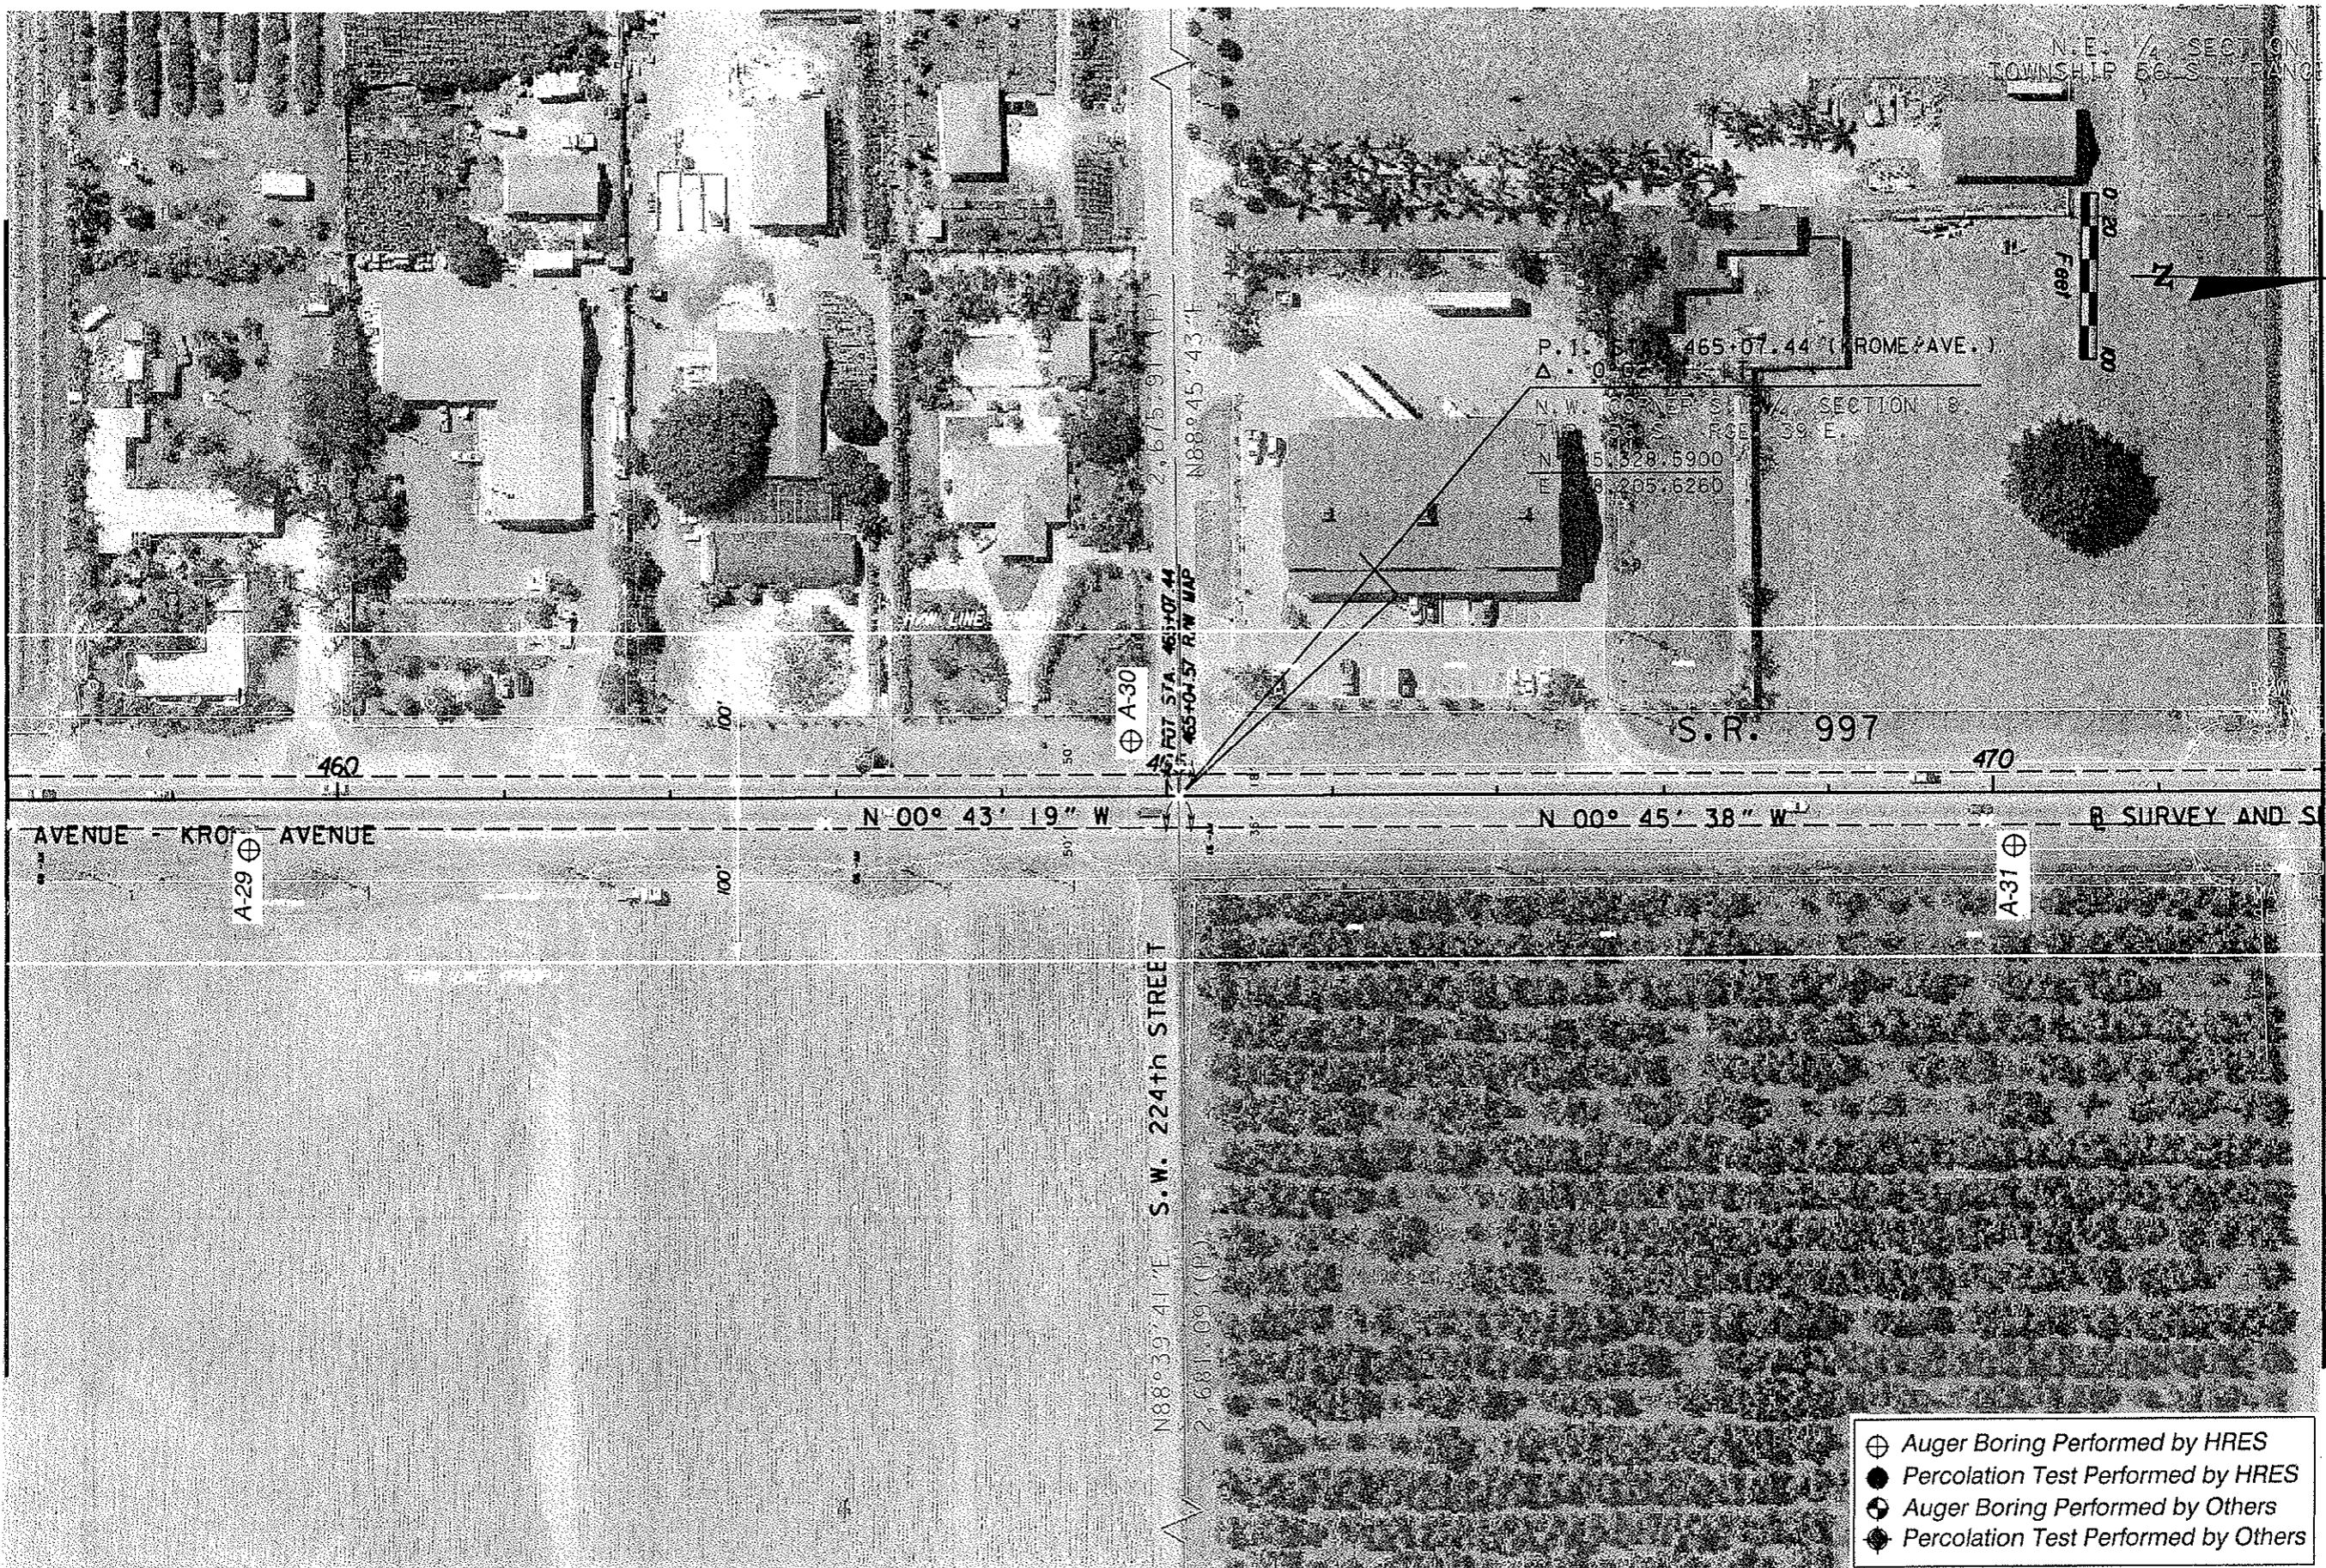
- ⊕ Auger Boring Performed by HRES
- Percolation Test Performed by HRES
- ⊕ Auger Boring Performed by Others
- Percolation Test Performed by Others

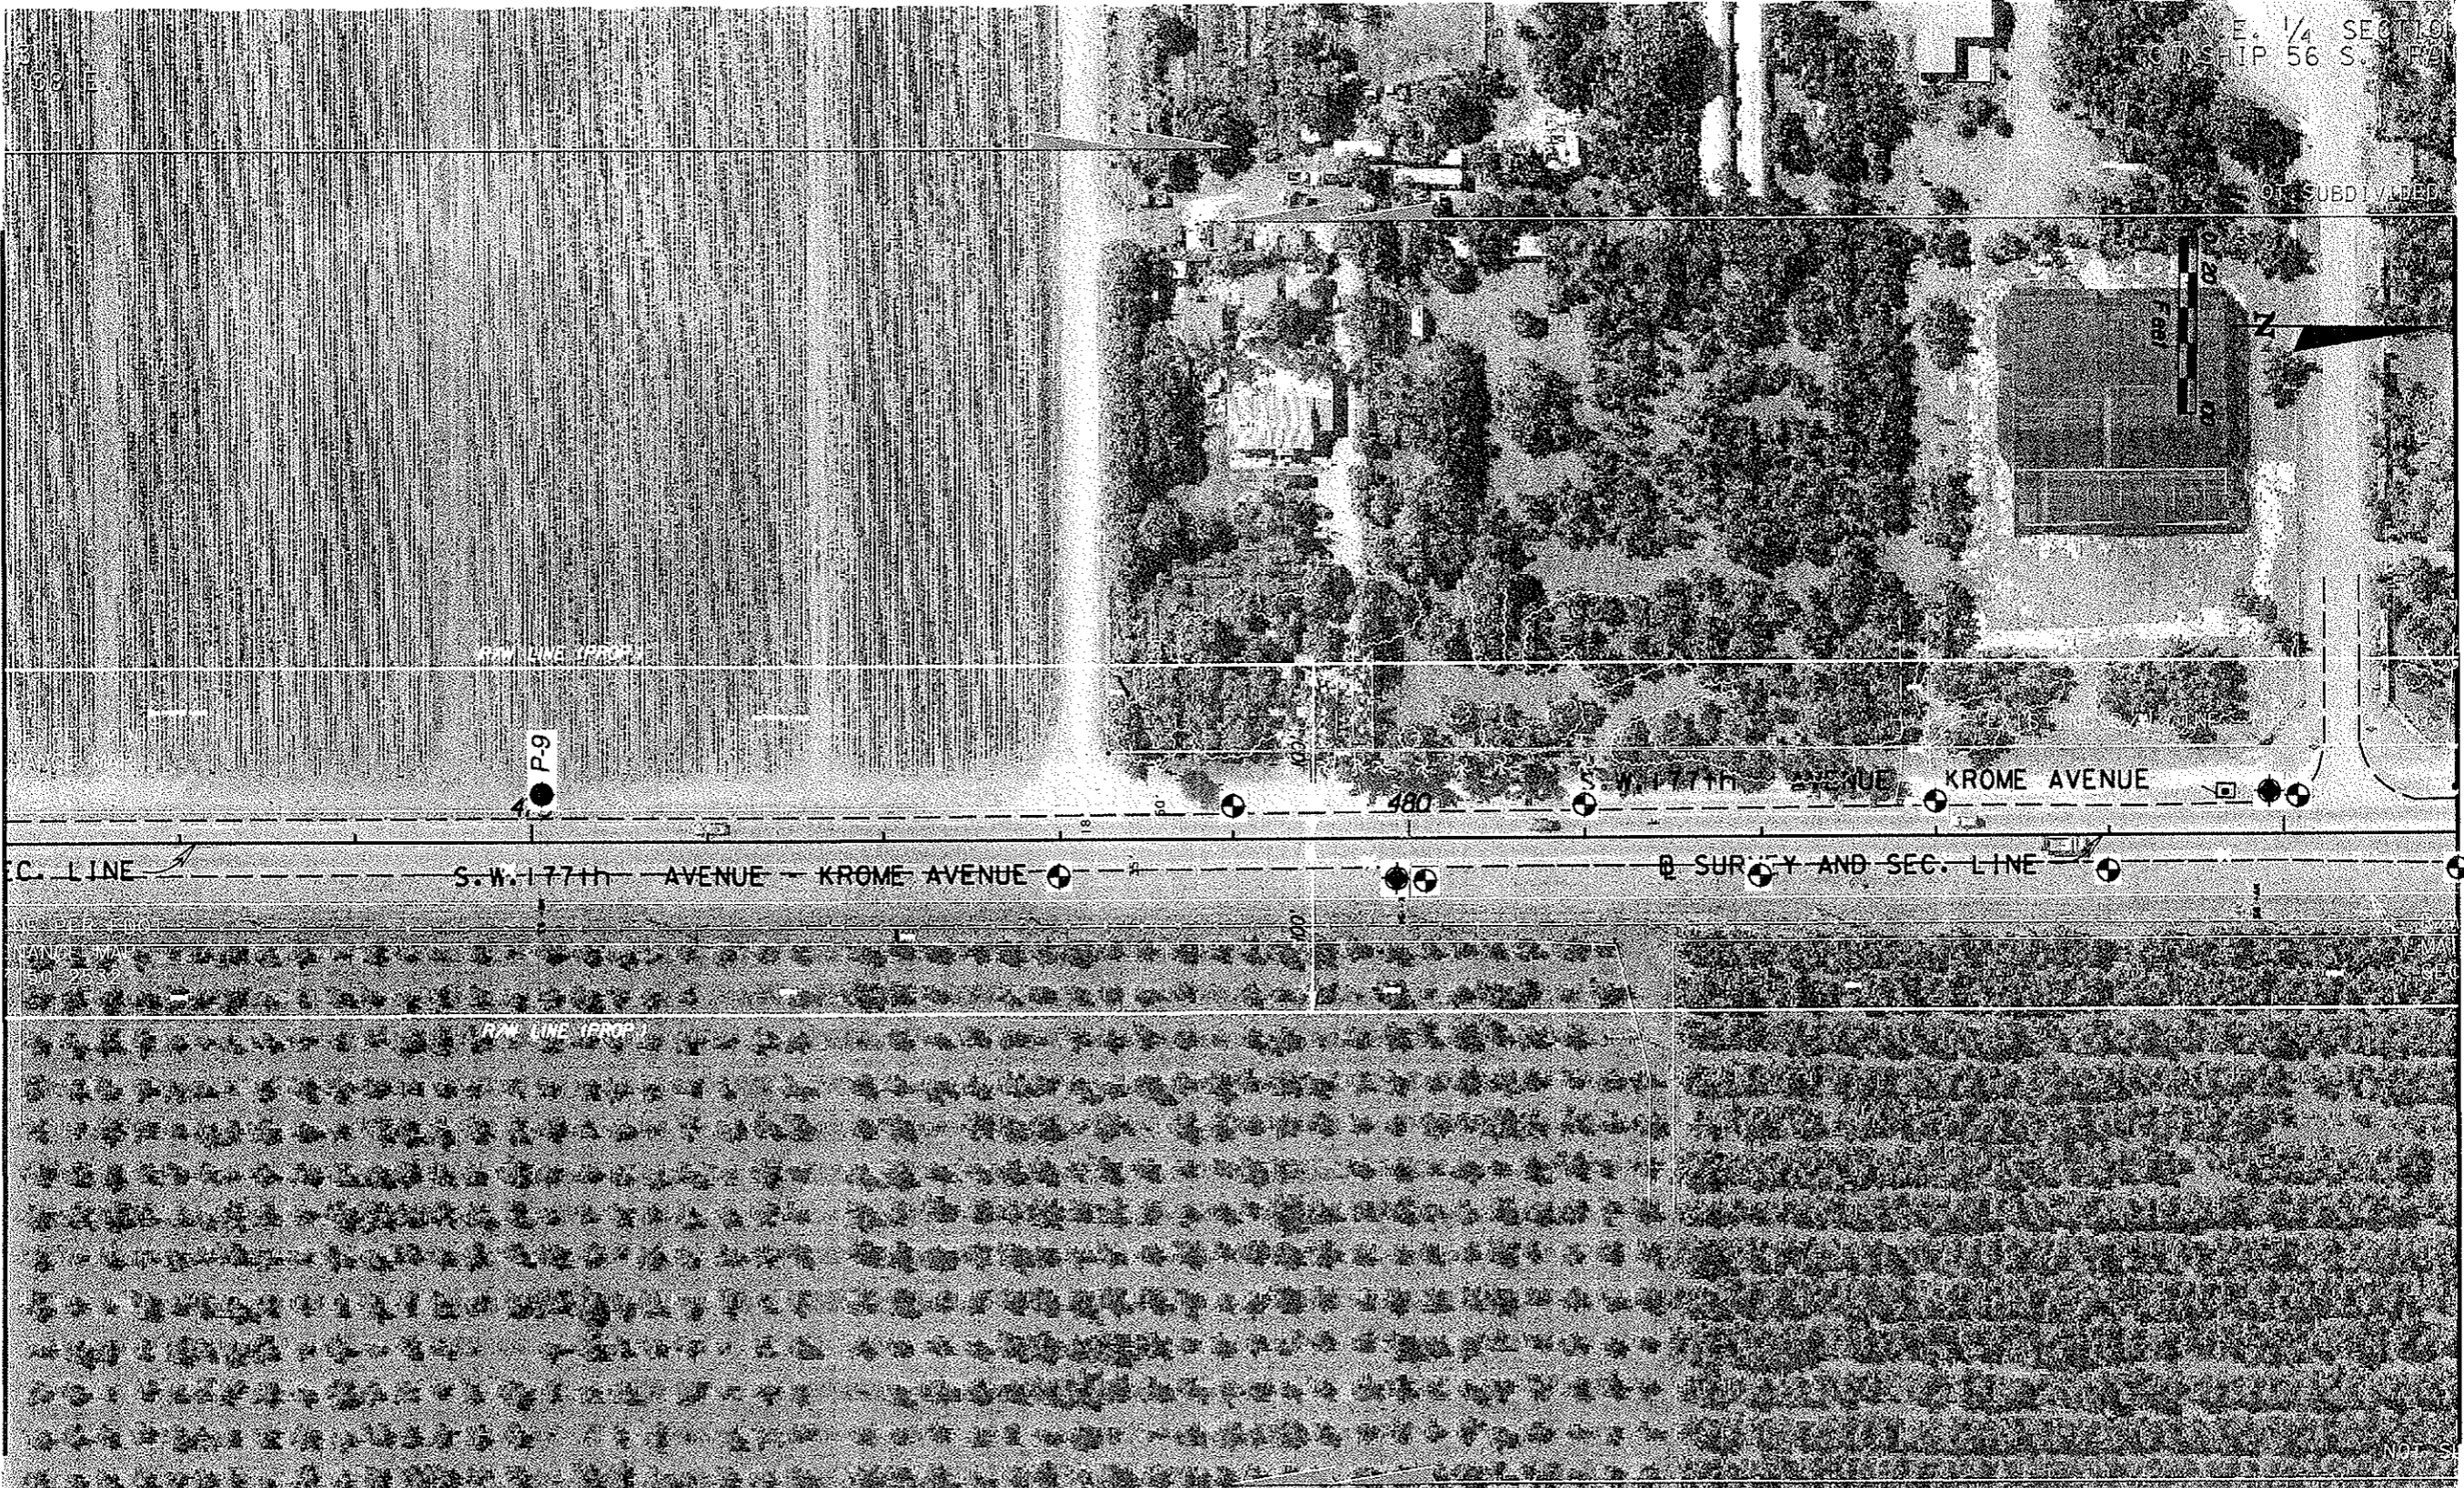
- ⊕ Auger Boring Performed by HRES
- Percolation Test Performed by HRES
- ⊕ Auger Boring Performed by Others
- Percolation Test Performed by Others

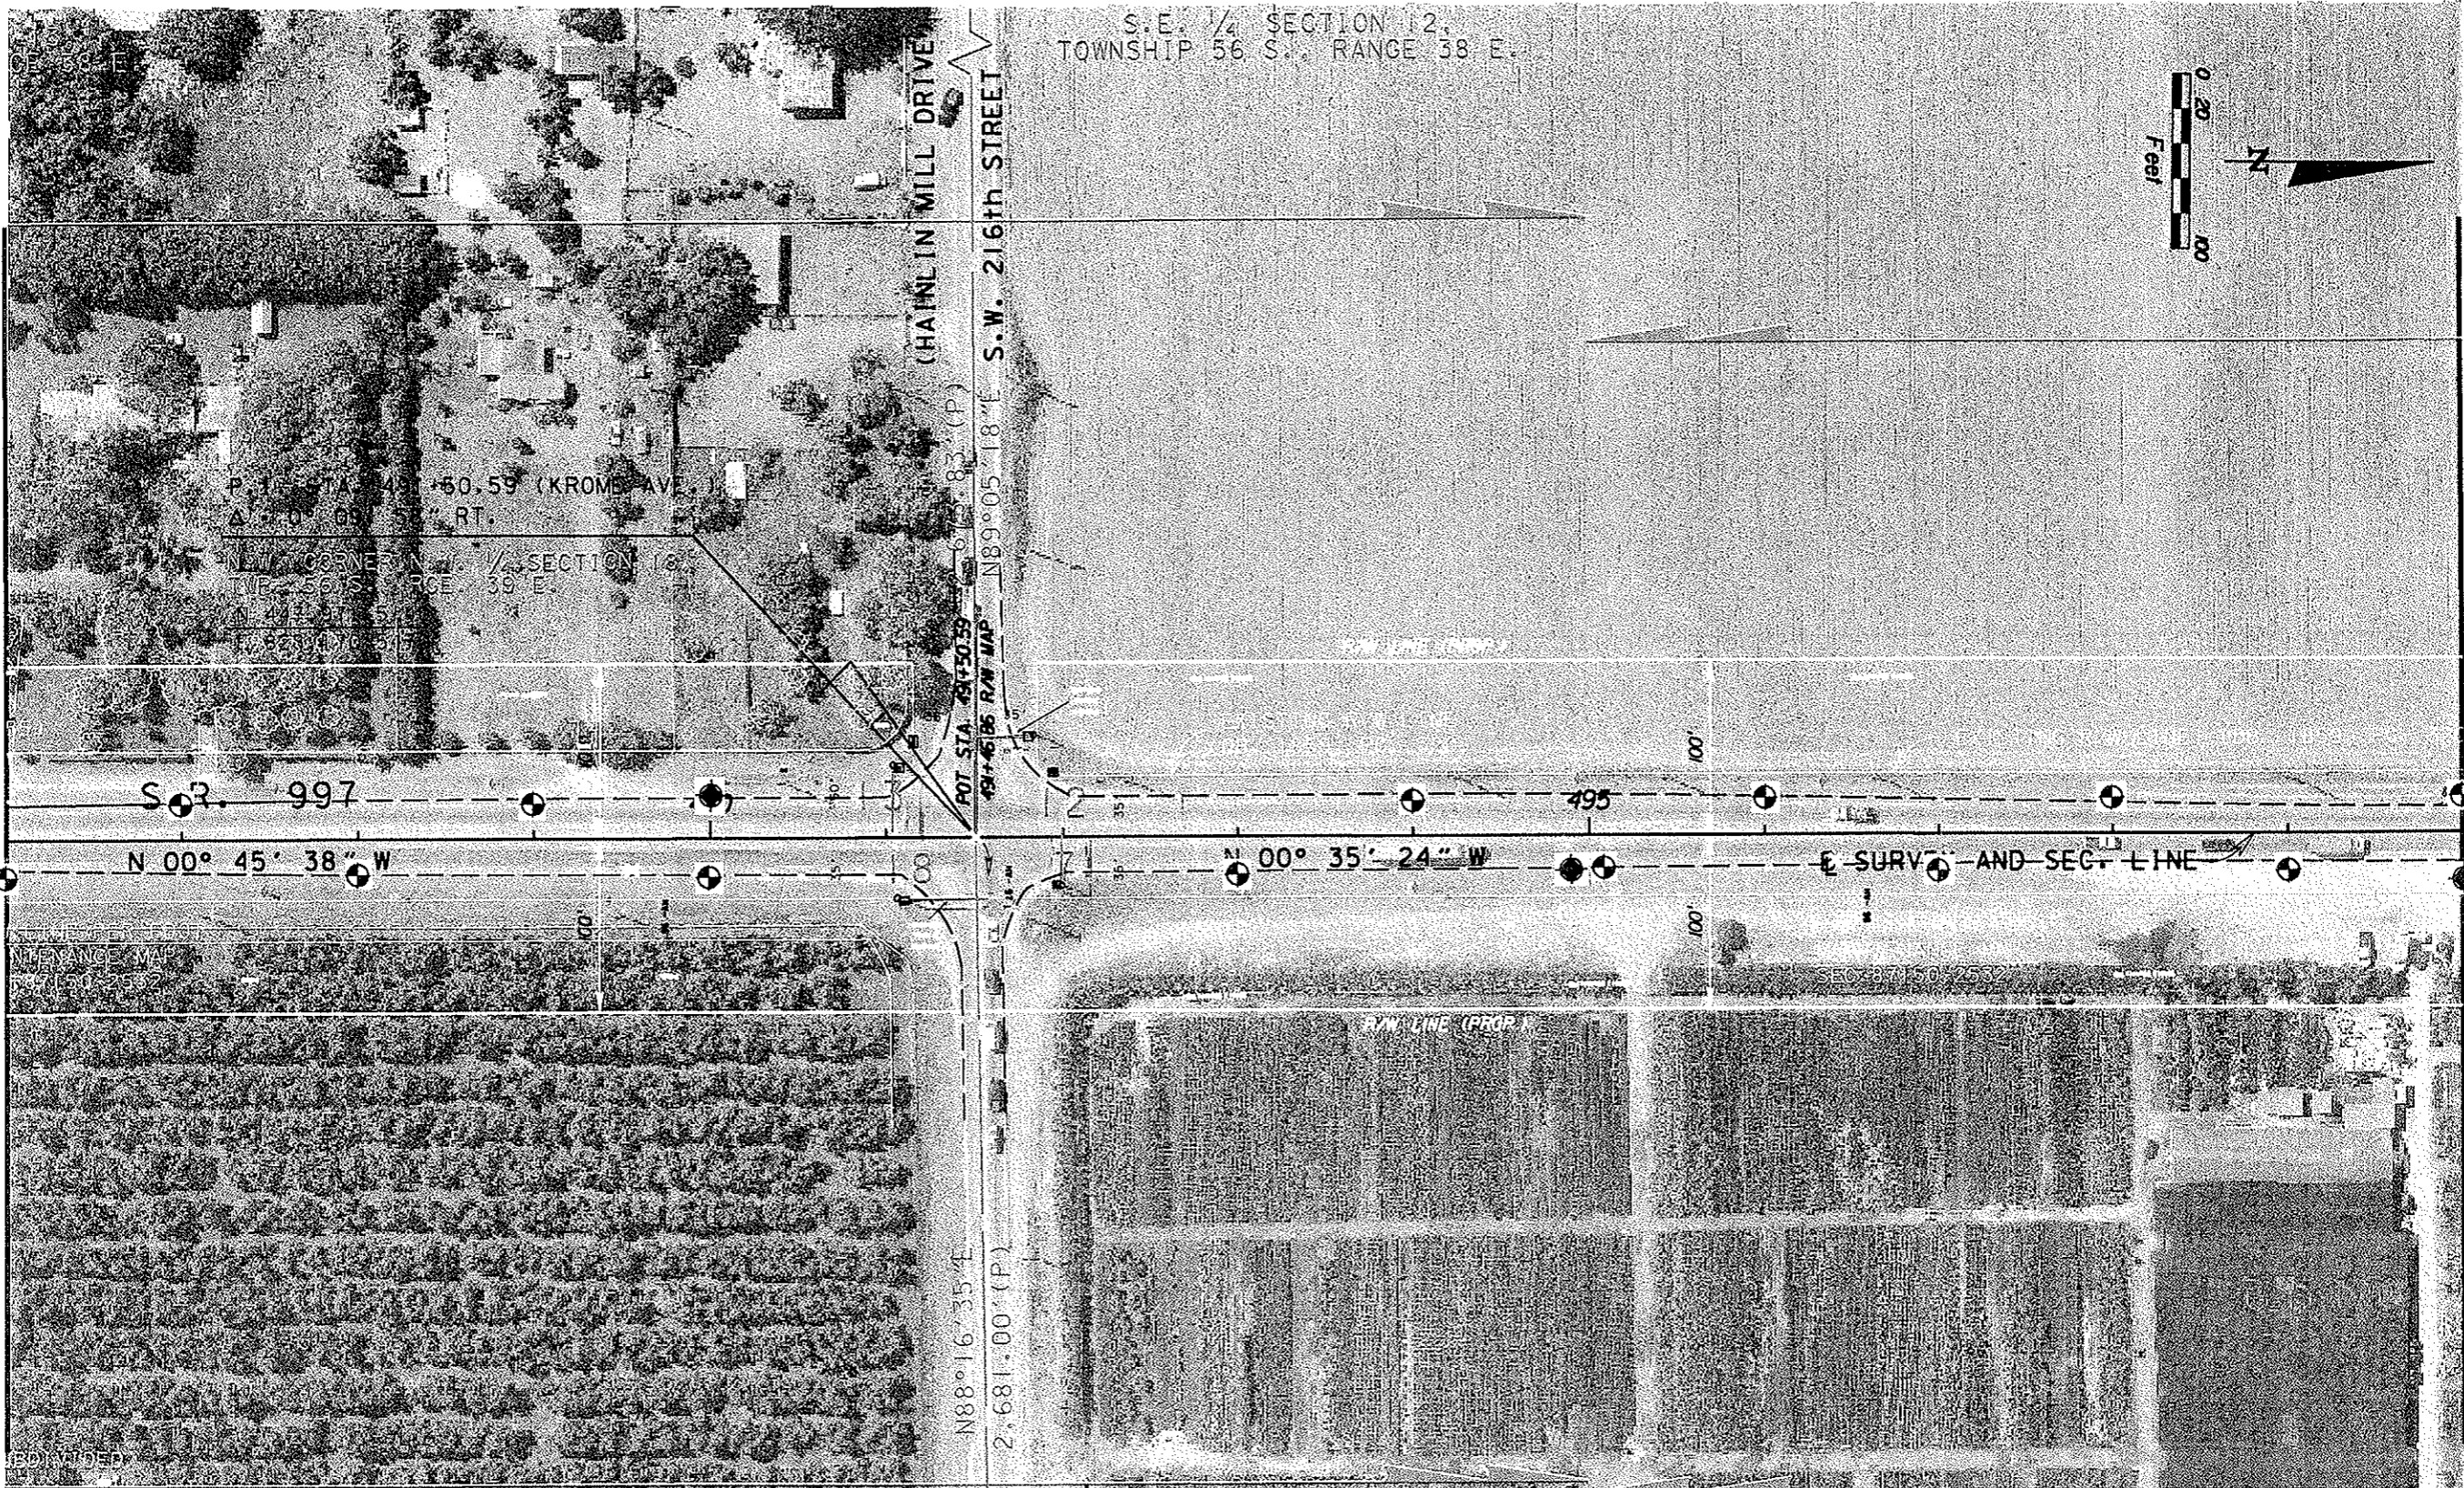
- ⊕ Auger Boring Performed by HRES
- Percolation Test Performed by HRES
- ⊕ Auger Boring Performed by Others
- Percolation Test Performed by Others

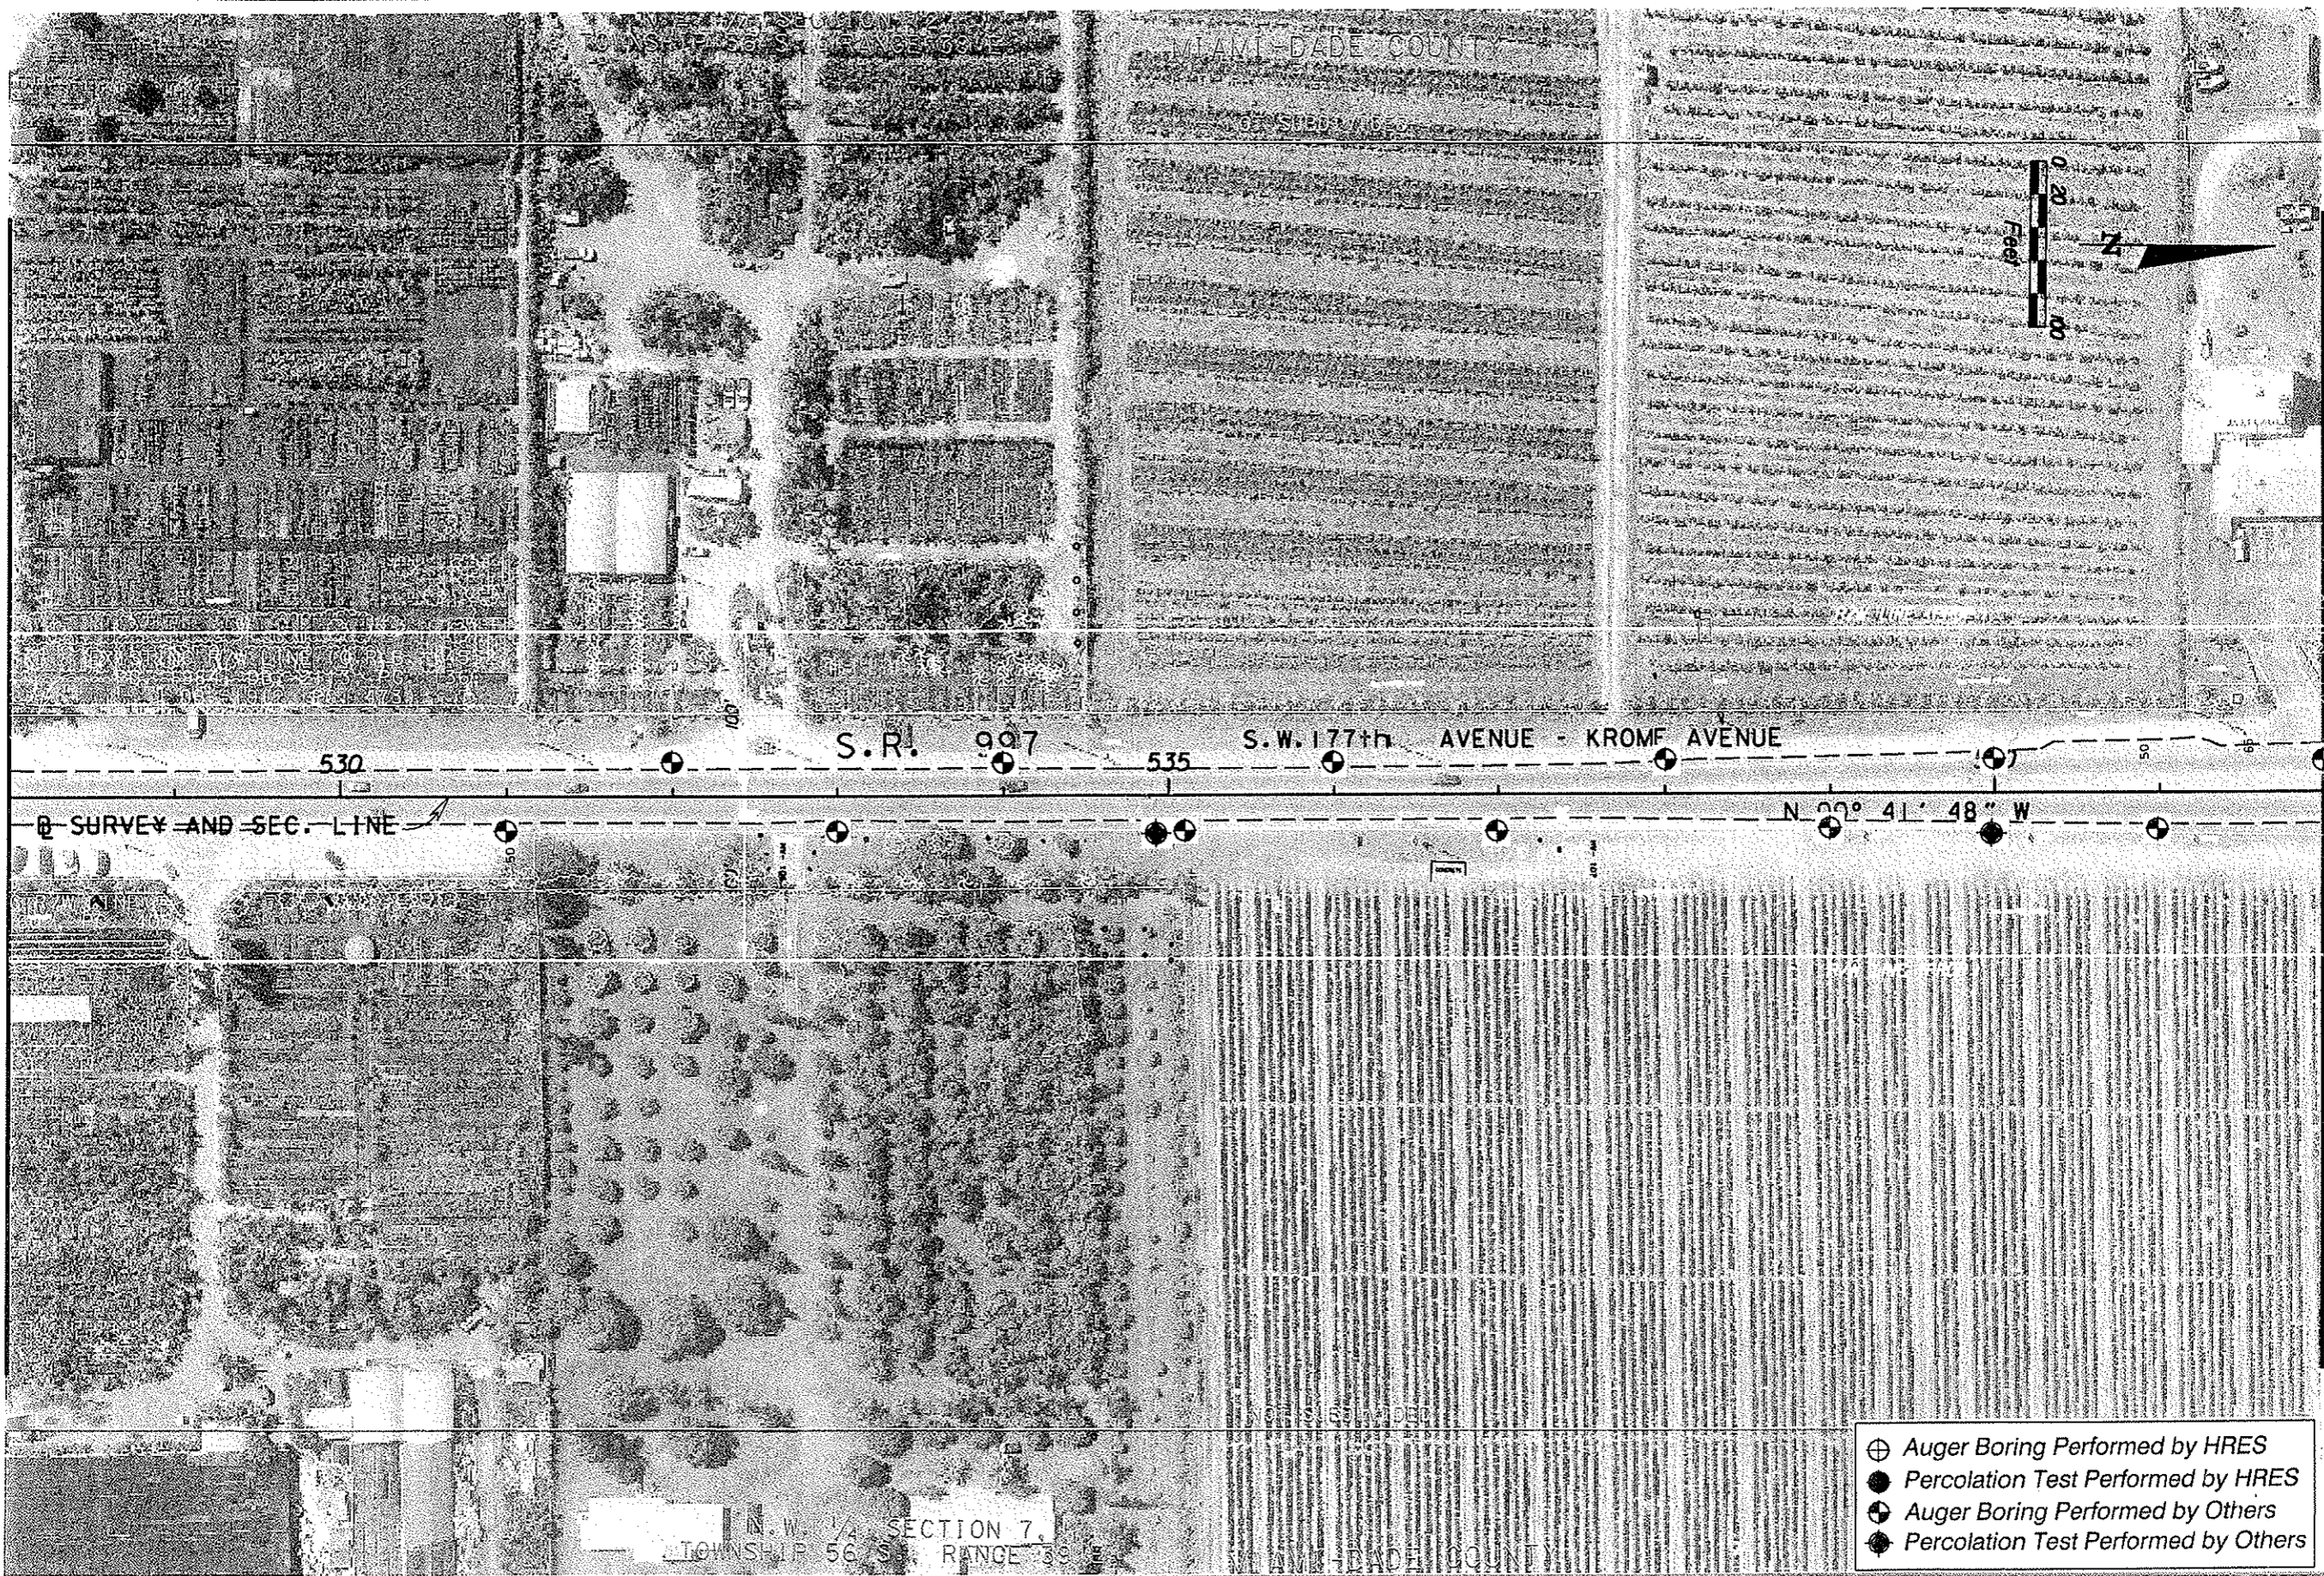
- ⊕ Auger Boring Performed by HRES
- Percolation Test Performed by HRES
- ⊕ Auger Boring Performed by Others
- Percolation Test Performed by Others

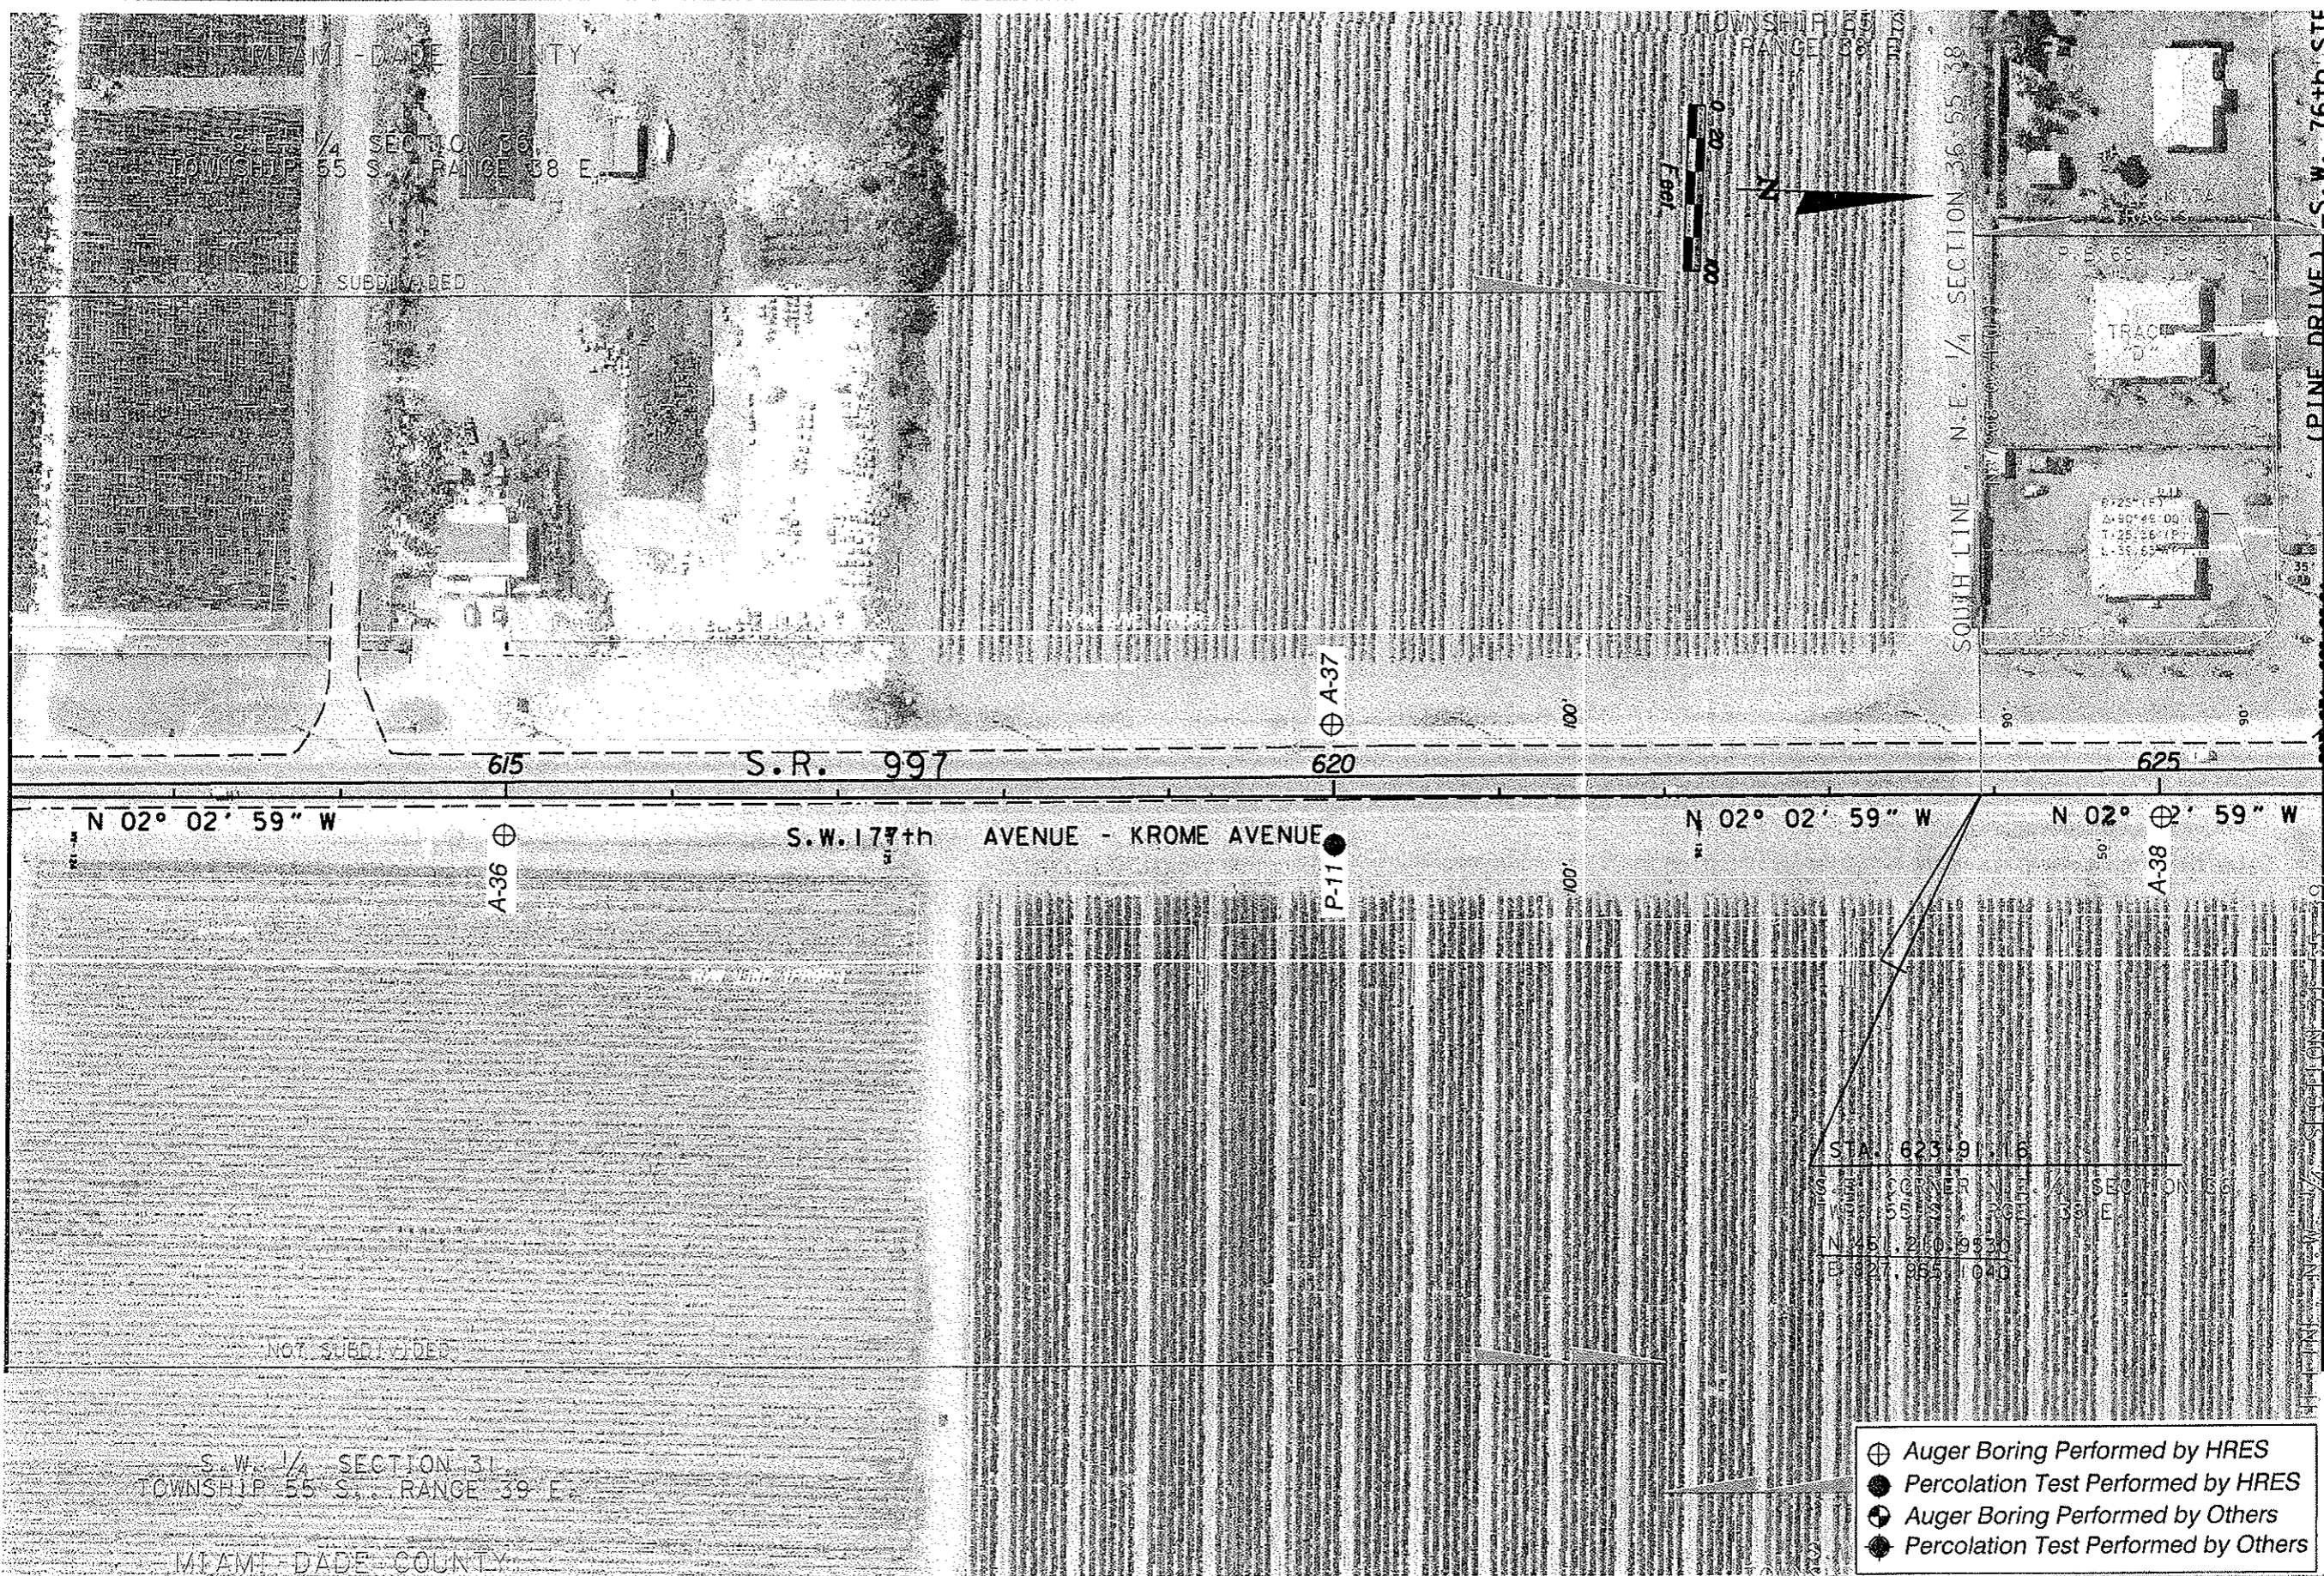
- ⊕ Auger Boring Performed by HRES
- Percolation Test Performed by HRES
- ⊕ Auger Boring Performed by Others
- Percolation Test Performed by Others
