**GEOTECHNICAL REPORT
PROJECT DEVELOPMENT & ENVIRONMENTAL STUDY**

**SR 997 / Krome Avenue / SW 177 Avenue (South)
from SW 296th Street to SW 136th Street**

REPORT OF A SOIL SURVEY - ROADWAY

**SR 997/KROME AVENUE PD&E STUDY
FROM SW 296TH STREET TO SW 136TH STREET
FLORIDA DEPARTMENT OF TRANSPORTATION
DISTRICT 6
MIAMI-DADE COUNTY, FLORIDA
FM No. 249614-4-22-01**

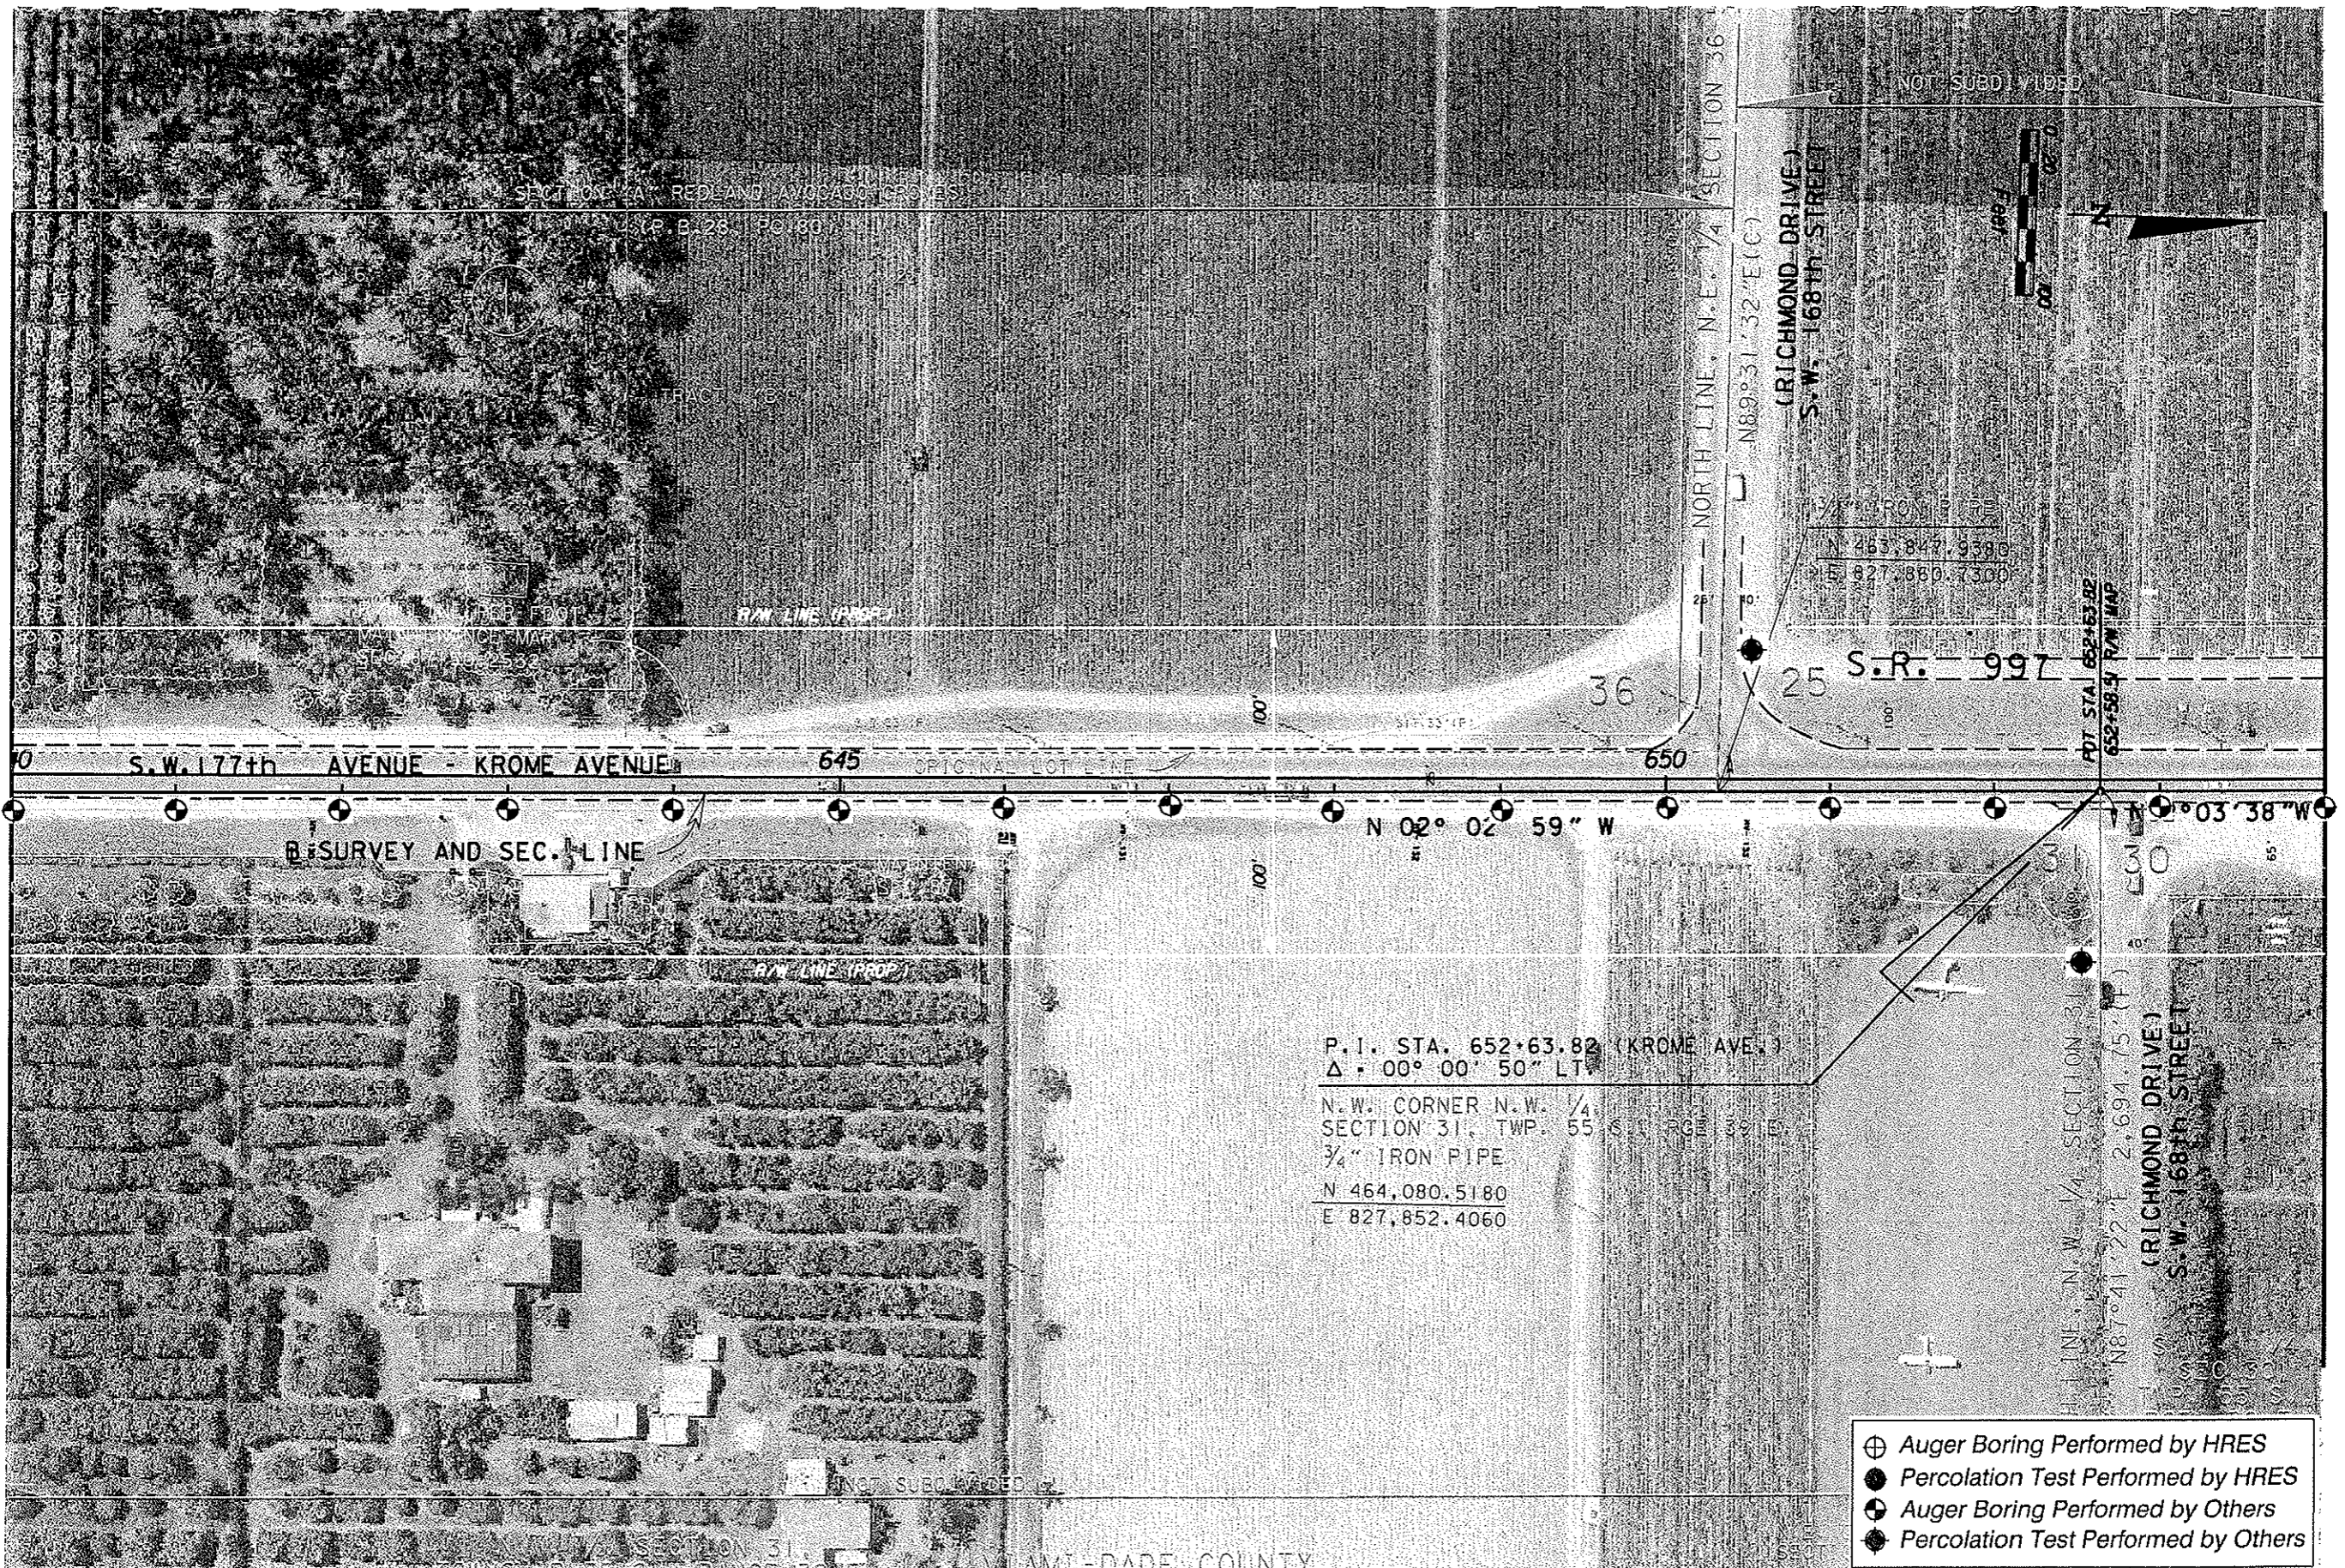
- ⊕ Auger Boring Performed by HRES
- Percolation Test Performed by HRES
- ⊕ Auger Boring Performed by Others
- Percolation Test Performed by Others
