**Atlantic Isle at West of SR A1A
Bridge No. 874218
Project Development and Environment Study**

Contamination Screening Evaluation Report

Atlantic Isle Bridge (Bridge No. 874218)
Atlantic Avenue, Sunny Isles Beach, FL
Miami-Dade County, FL

February 2023

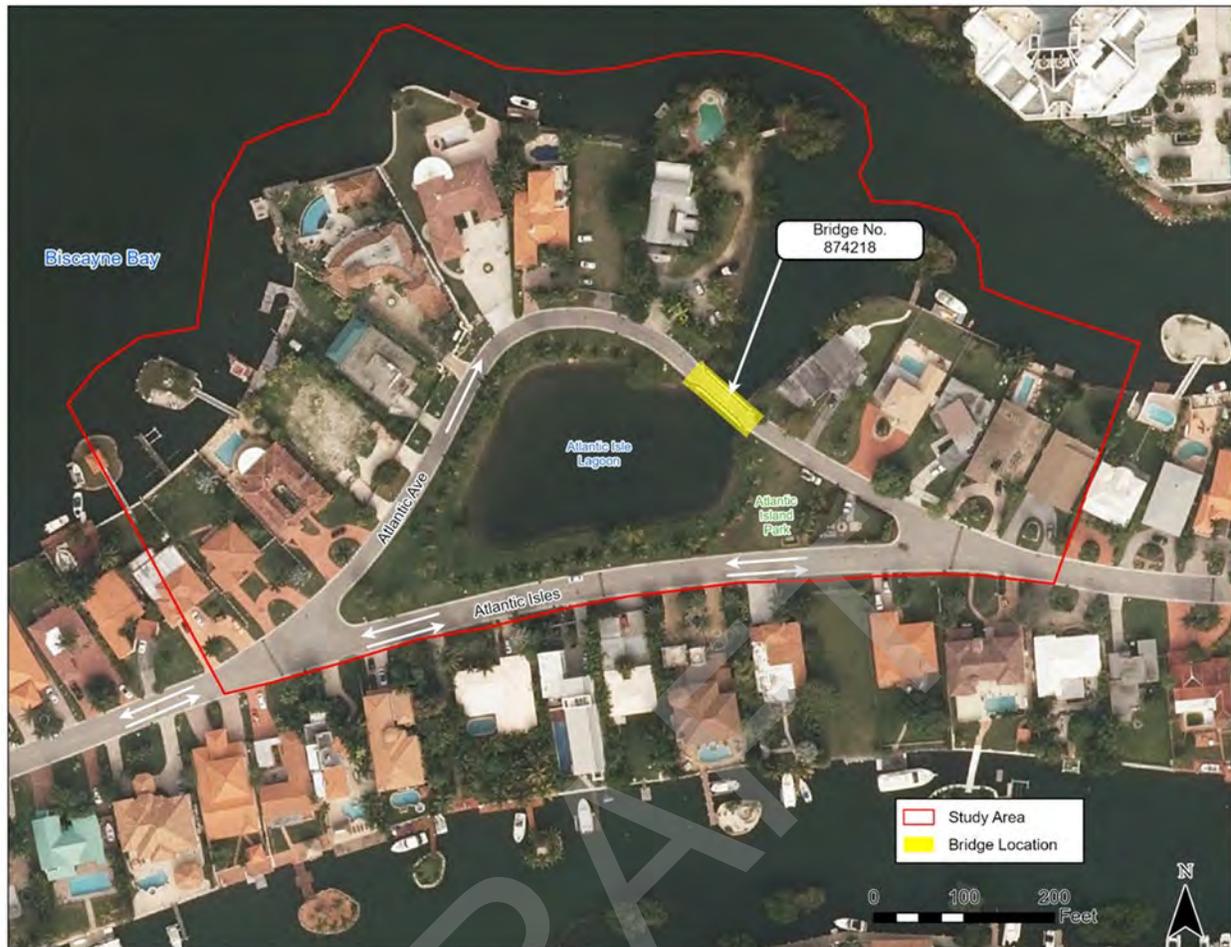
Figure 1-2 Project Study Area

The Atlantic Isle Bridge is a one-way, low-level fixed bridge located along Atlantic Avenue on the north side of the Atlantic Isle Lagoon, approximately 0.25 miles west of SR A1A. The project study area (**Figure 1-2**) includes Atlantic Avenue and Atlantic Isles between the western and eastern intersections of the two roadways. The project study area is within the historic triangular landscape of the Atlantic Island Park [Florida Master Site File (FMSF) No. 8DA6433], which is both privately and publicly owned, and further includes an artificial lake, Lake of the Isles (8DA15824), which is historically known as Atlantic Isle Lagoon. Built circa 1925, Atlantic Isle Lagoon and Atlantic Island Park are also NRHP eligible.

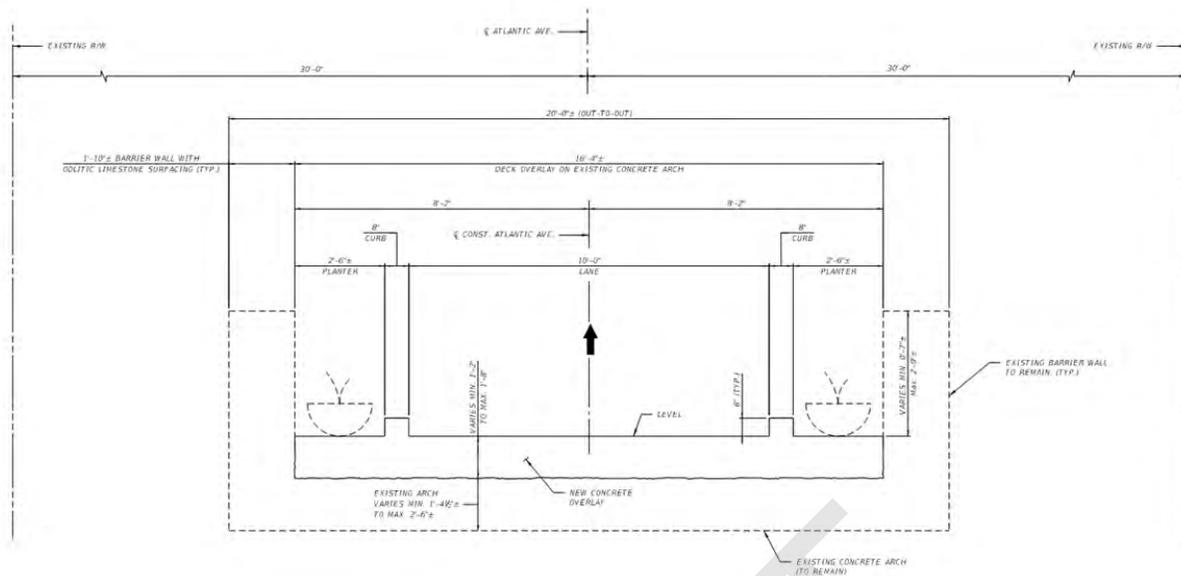
Figure 2-1 Bridge Rehabilitation Proposed Typical Section

The rehabilitation alternative does not address the bridge's functional deficiencies (substandard traffic barriers) because that would require removal and replacement of the arch spandrel walls, which could compromise the integrity of the already deteriorating bridge. The existing roadway limerock base and pavement would be removed and replaced with a concrete riding surface provided by the new arch structure. With the bridge rehabilitation, one-way travel on the bridge would be maintained. The rehabilitated bridge typical section would remain as is, consisting of a single 10-foot-wide travel lane, 8-inch-wide curbs, 2.5-foot-wide planter easements, and 1-foot 10-inch-wide barriers on each side of the bridge. **Figure 2-1** presents the proposed typical section.

This alternative involves rehabilitation of the existing bridge superstructure, providing a new CIP reinforced concrete arch structure, and maintaining one-way travel on the bridge. The existing bridge typical section, roadway width, and vertical roadway geometry would be maintained. The proposed concrete arch would provide a new load-carrying structure within the limits of the existing bridge. The proposed arch would extend beyond the ends of the existing concrete arch by approximately 5 feet at each end of the bridge.

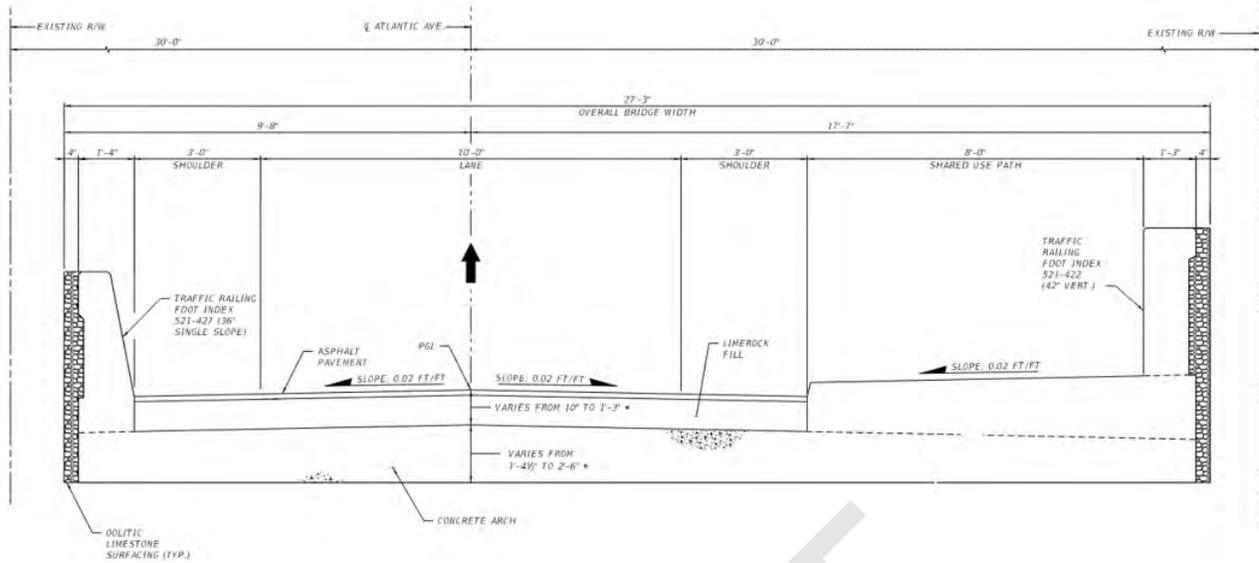
Figure 2-2 Bridge Replacement Typical Section

Limestone rock fill with roadway pavement will be placed on top of the new arch structure. New approach retaining walls will replace the existing retaining walls. A new rubble oolitic limestone façade would be placed along the exterior faces of the vertical shape barriers and retaining walls to mimic the existing structure. The limestone could be obtained from the original source used to construct the original bridge, or the limestone from the existing bridge could be reused and incorporated into the new bridge. New bridge approach slabs are anticipated and would be the standard length of 30 feet (FDOT Standard Plan 400-090) at both ends.

The replacement bridge substructure alternatives to support the new reinforced concrete arch include spread footings, steel pile, prestressed concrete piles, auger cast piles, and drilled shafts. Based on the available information to date, site conditions, and coordination with the project geotechnical engineer, drilled shafts are anticipated to be the foundation type for the proposed bridge. Because of the site constraints and subsurface soil conditions, permanent casing and rock socketing is anticipated for drilled shaft construction. Based on the Preferred Alternative for this PD&E Study, the bridge foundation type would be determined during the design phase and documented in a Bridge Development Report.

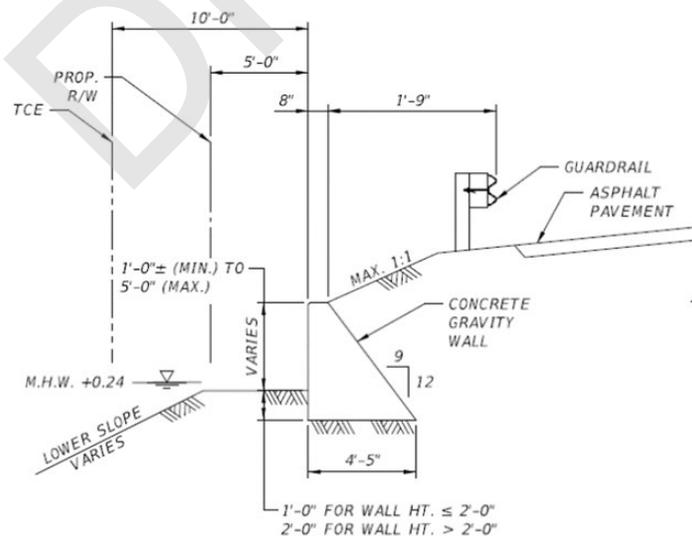
Figure 2-3 Roadway Section through Gravity Wall Limits

Both Build Alternatives involve consideration of maintenance of traffic during construction. Temporary roadway widening for both Build Alternatives is required to maintain two-way access along Atlantic Avenue west of the bridge during construction. For these alternatives, a temporary roadway turnout is proposed west of the bridge to accommodate turn around traffic. The temporary turnout would require temporary walls for both Build Alternatives. Either gravity or sheet pile wall-types would be required. All wall options would require excavation of the soil or installation via driving or vibratory methods near the waterline of the Atlantic Isle Lagoon. For both alternatives, the wall is considered temporary and could be removed following completion of the bridge construction work and elimination of the temporary turnouts. **Figure 2-3** illustrates the potential roadway section through the gravity wall limits.

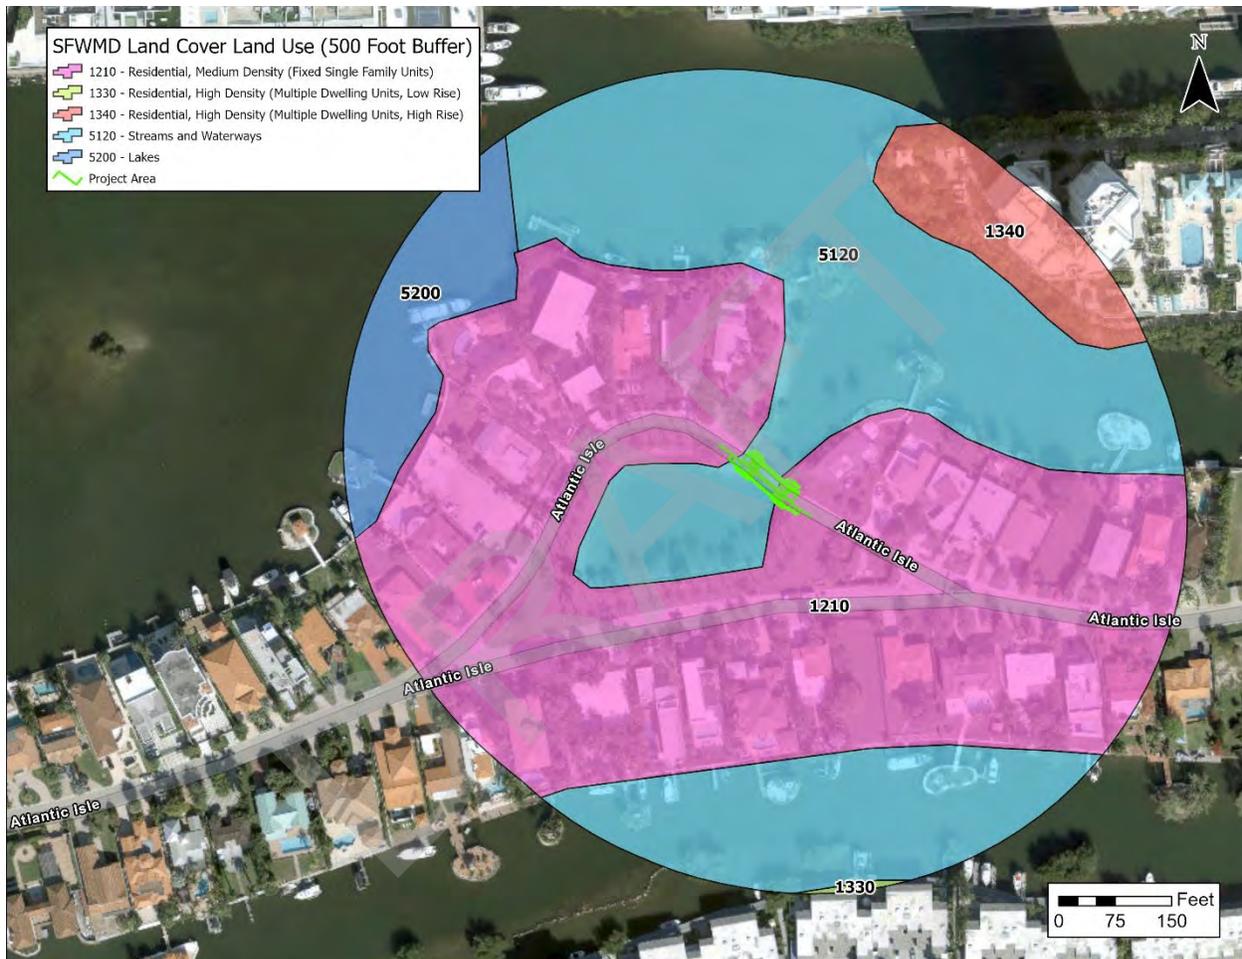
Figure 4-1 Land Use

The existing land uses within 500 feet of the project area were identified through review and interpretation of the latest South Florida Water Management District (SFWMD) Land Cover Land Use (LCLU) 2017-2019 GIS layer, updated September 14, 2022. (see **Figure 4-1**).

The majority of the land use surrounding the project area consists of medium and high-density residential land uses (1210, 1330, 1340). of roads and highways (8140) and transportation (8100). Surrounding the island of Atlantic Isle are water bodies categorized as streams and waterways (5120) and lakes (5200).

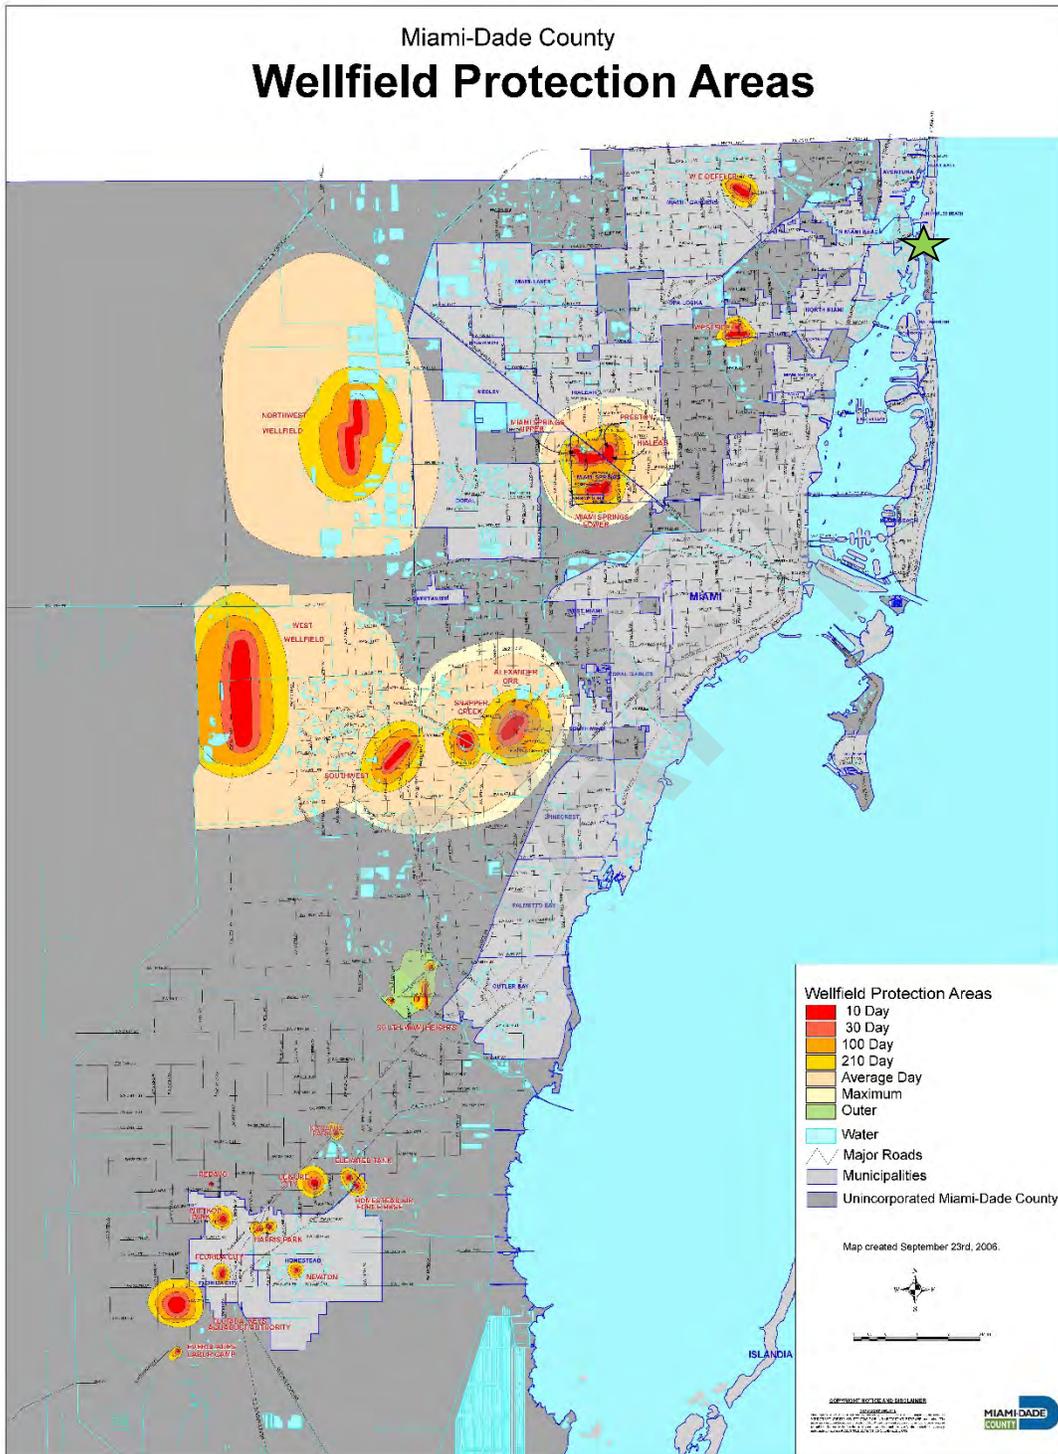
Figure 5-1 Wellfield Protection Areas

The Biscayne Aquifer is classified by the State of Florida as a Sole Source Aquifer (SSA) and is therefore designated as the principal source of drinking water for MDC. Due to its shallow depth and high permeability, the aquifer is susceptible to contamination, and Miami-Dade has designated Wellfield Protection Areas based on characteristics of the aquifer. According to the MDC Wellfield Protection Areas Map, the project area is not located within the cone of influence of any current designated protection areas. The nearest wellfields are located approximately 6 miles northwest (W.E. Oeffler Wellfield) and approximately 6.25 miles southwest (Westside Wellfield) (see **Figure 5-1**). Stormwater runoff in the project area runs directly to Biscayne Bay/Intracoastal Waterway or the lagoon or is collected in curbside inlets before being discharged to Biscayne Bay. To prevent contaminated water from entering local waterways, wastewater generated by local properties is discharged to on-site septic systems.

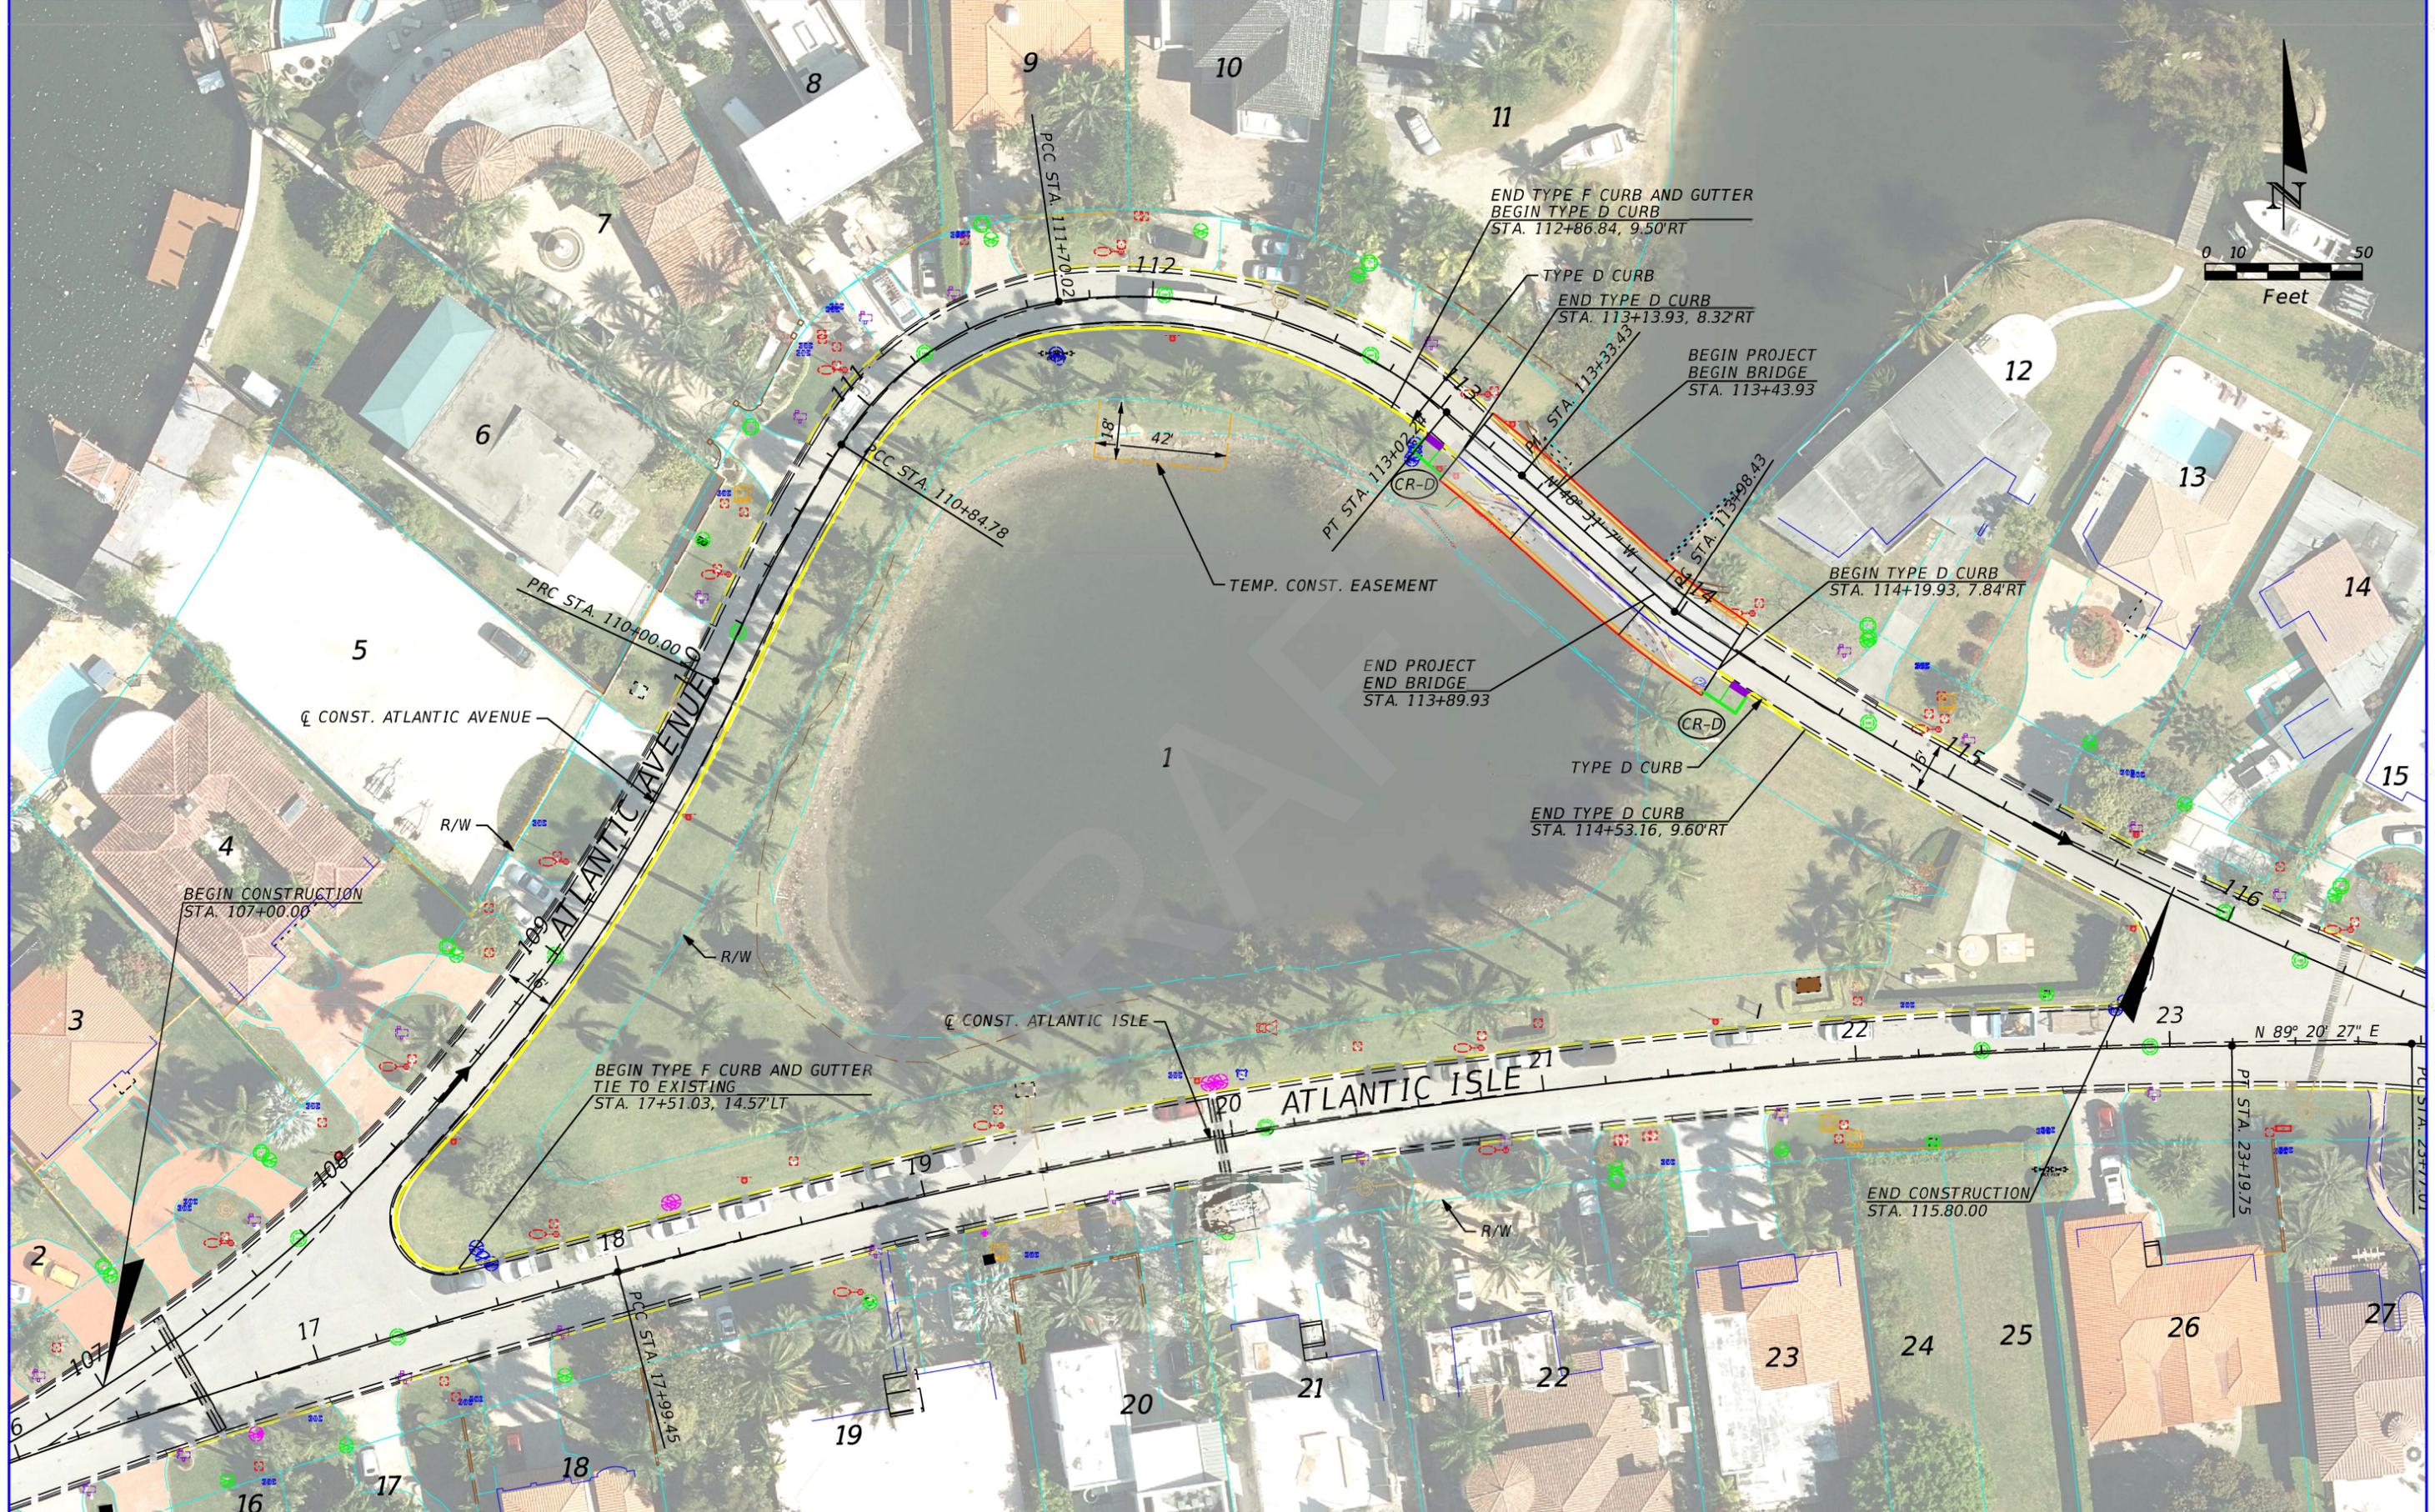
PLAN SHEET
BRIDGE REPLACEMENT (ALT 2)

BEGIN/END BRIDGE STATIONS SUBJECT TO CHANGE
 BRIDGE SHOWN IS ONLY TO DETERMINE VERTICAL CLEARANCE AND DOES NOT REPRESENT THE ACTUAL BRIDGE APPEARANCE

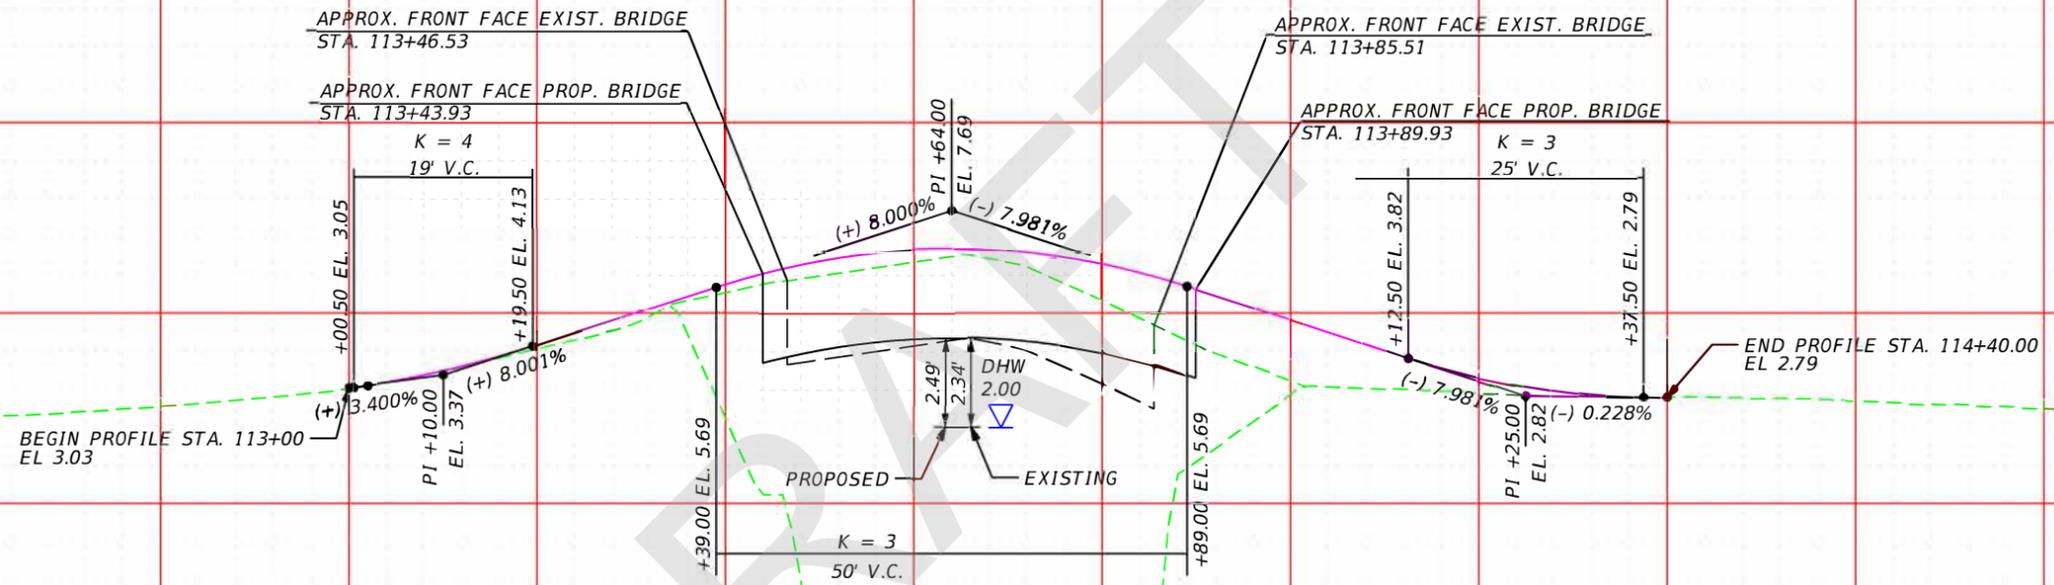
PROFILE SHEET
BRIDGE REPLACEMENT (ALT 2)

SCALE:
 1" = 20' HORIZONTAL
 1" = 5' VERTICAL

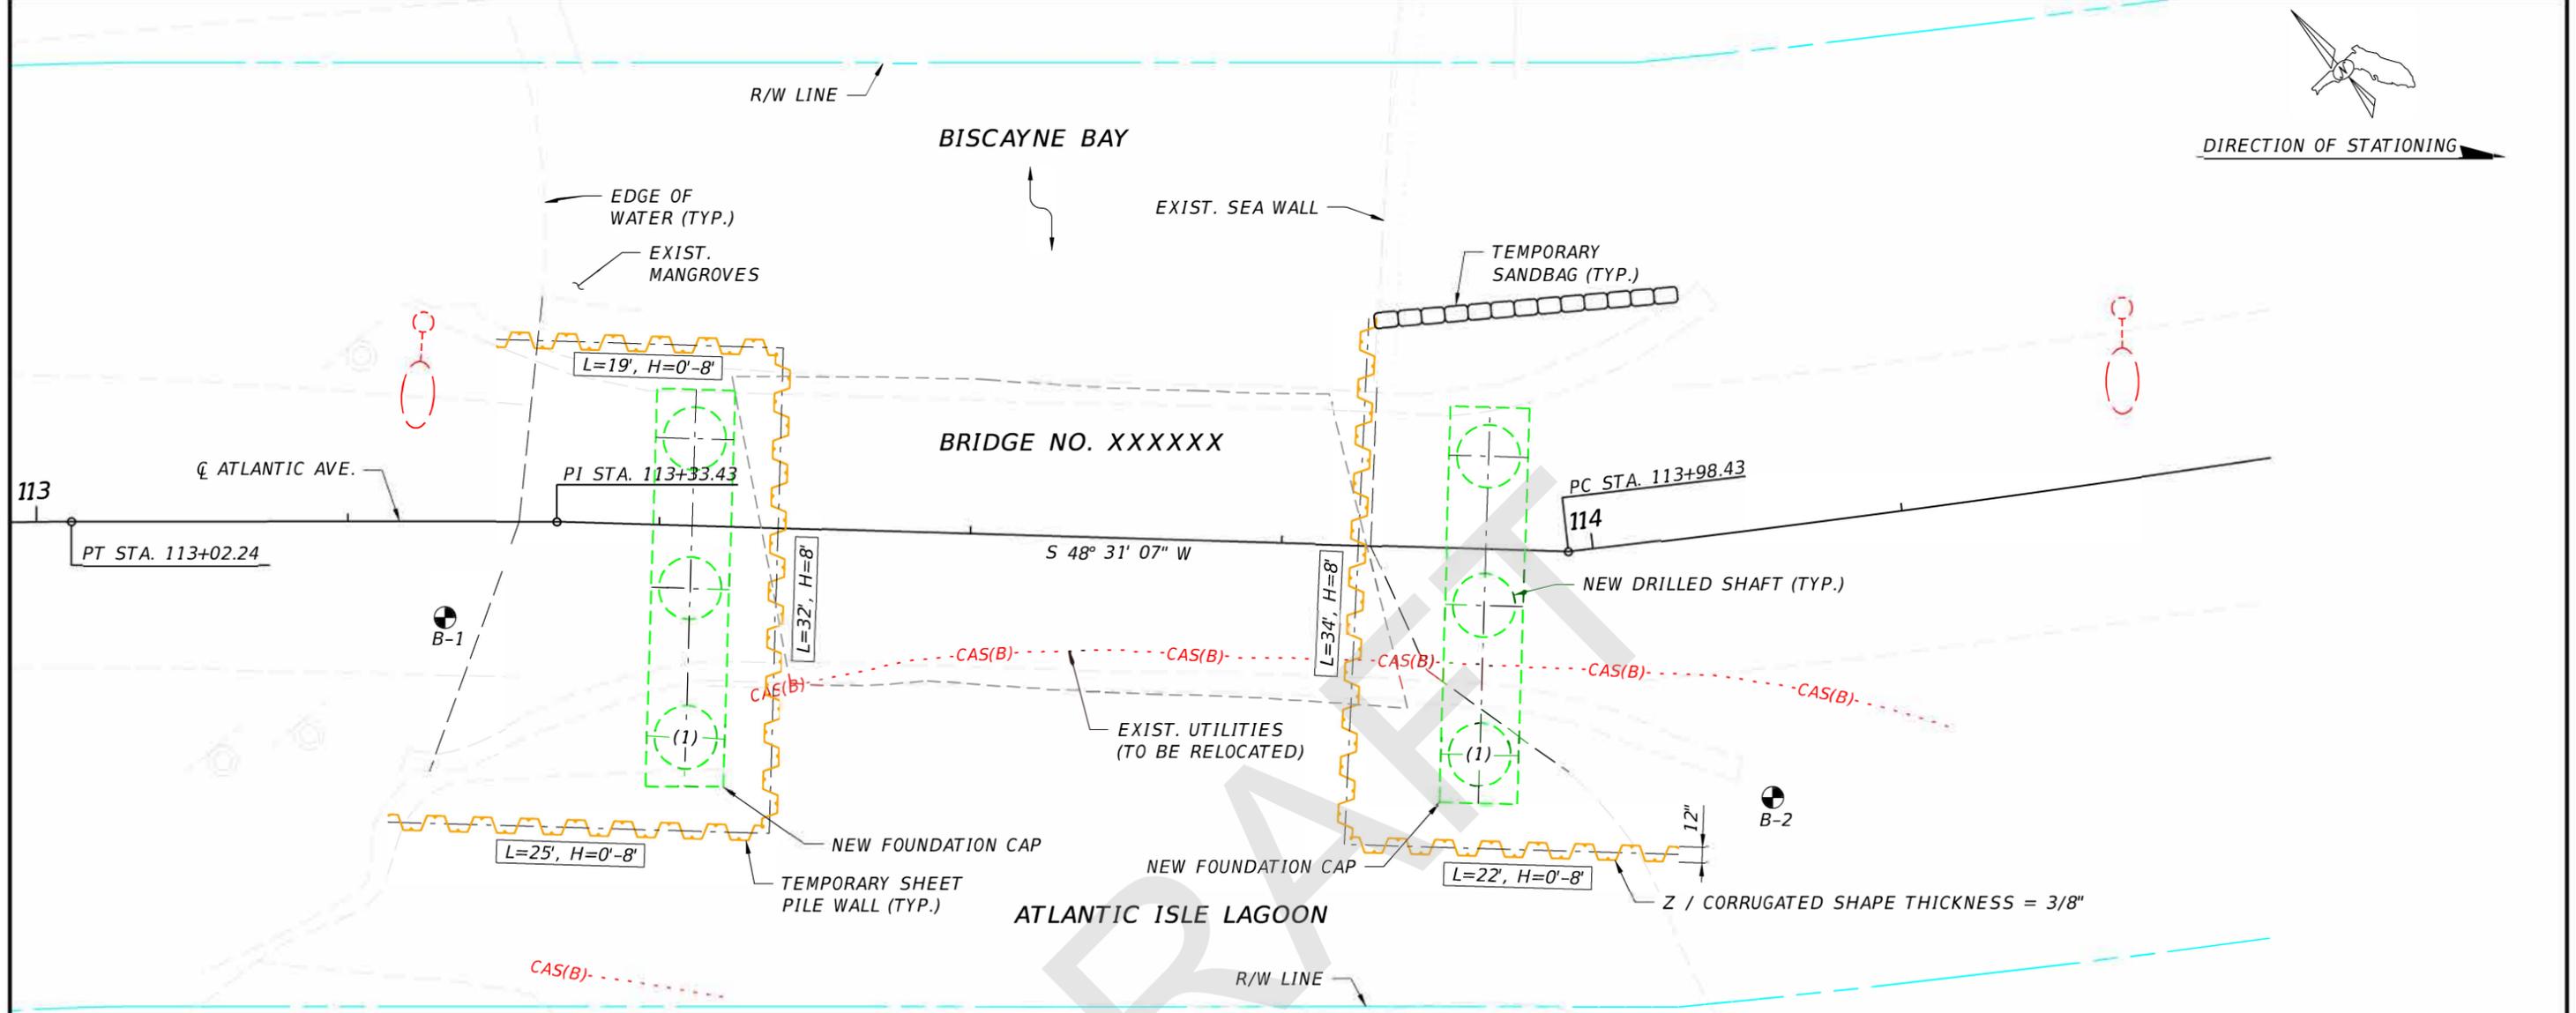
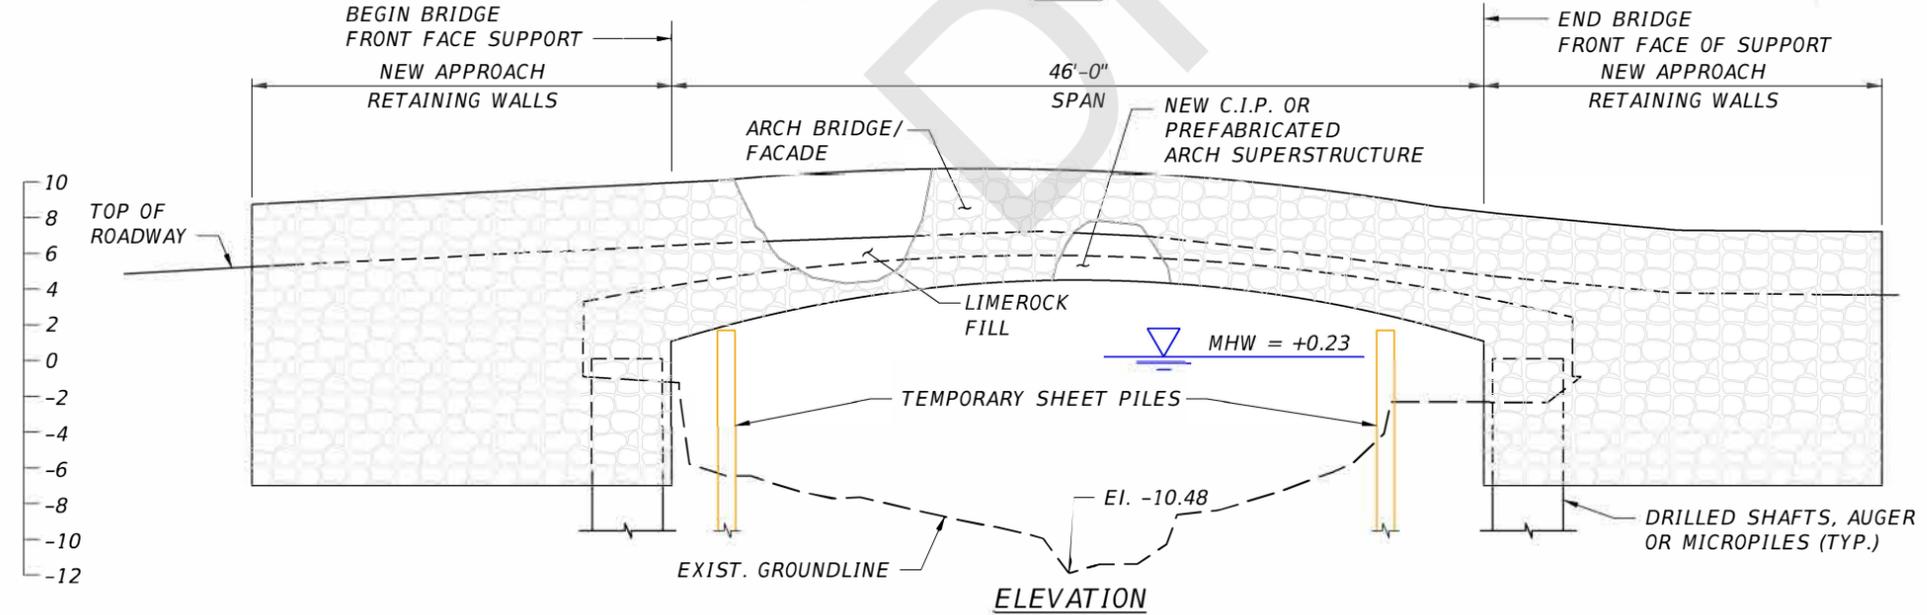
SHEET TITLE: ALTERNATIVE 2 - BRIDGE REPLACEMENT CONSTRUCTABILITY CONCEPT	REF. DWG. NO.
PROJECT NAME: ATLANTIC AVE. OVER OCEAN CANAL	SHEET NO. B1-3

- NOTE:
- EXISTING BRIDGE 874218 TO BE COMPLETELY REMOVED INCLUDING FOUNDATIONS.
 - TEMPORARY SHEET PILING SHOWN WILL BE REMOVED PRIOR TO CONSTRUCTION OF THE ARCH AND SUPERSTRUCTURE.

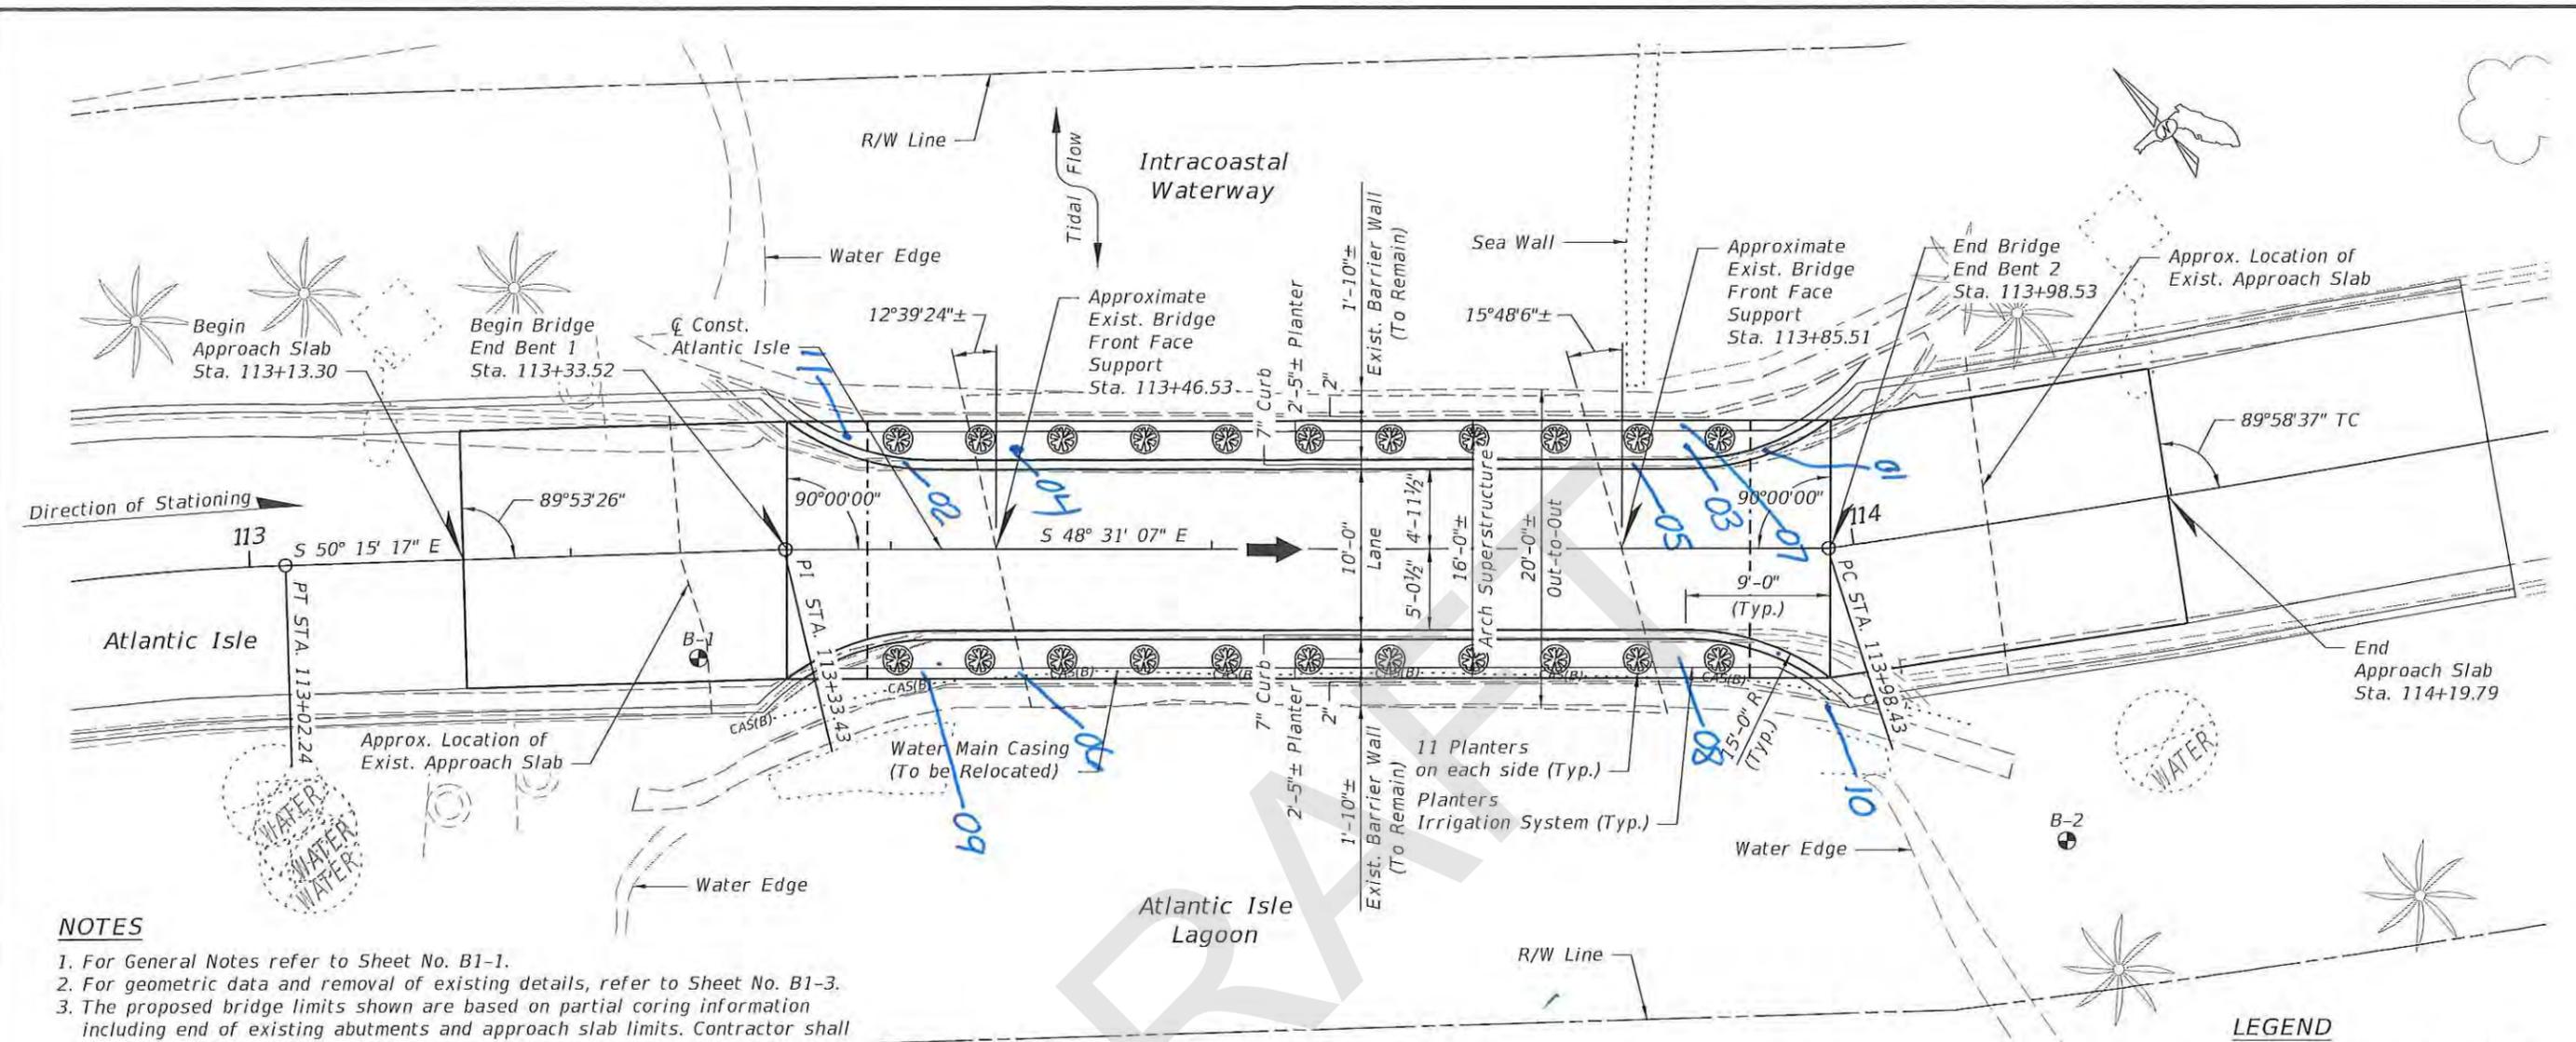
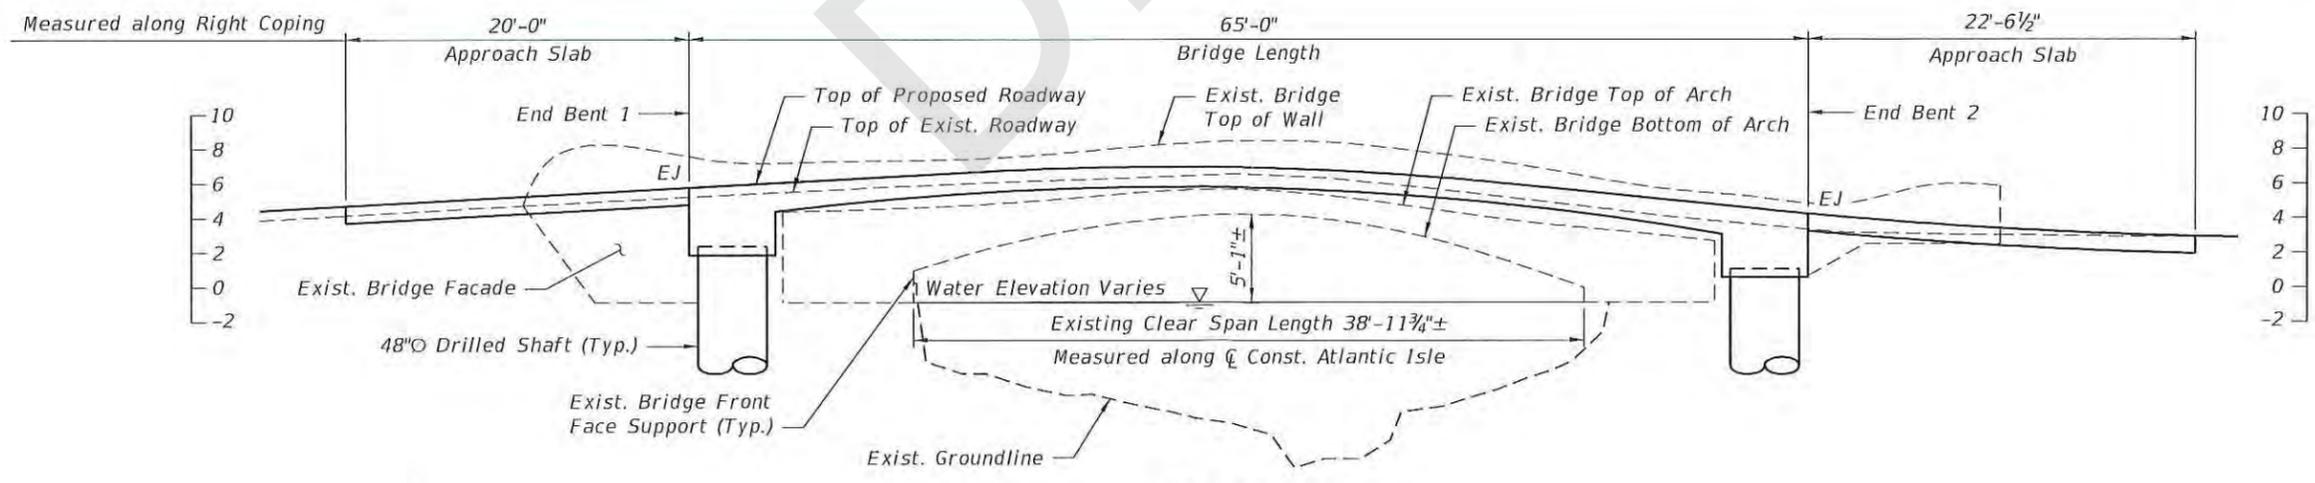
PLAN WITH ACM SAMPLE LOCATIONS

1. For General Notes refer to Sheet No. B1-1.
2. For geometric data and removal of existing details, refer to Sheet No. B1-3.
3. The proposed bridge limits shown are based on partial coring information including end of existing abutments and approach slab limits. Contractor shall determine the existing abutment location (begin and end) and approach slab limits and submit the information to the Engineer for verification, 45 days prior to commencing foundation installation activities.
