CULTURAL RESOURCE ASSESSMENT SURVEY REPORT

SR 994/SW 200th Street/Quail Roost Drive PD&E Study

From SW 137th Avenue to SW 127th Avenue

December 8, 2022

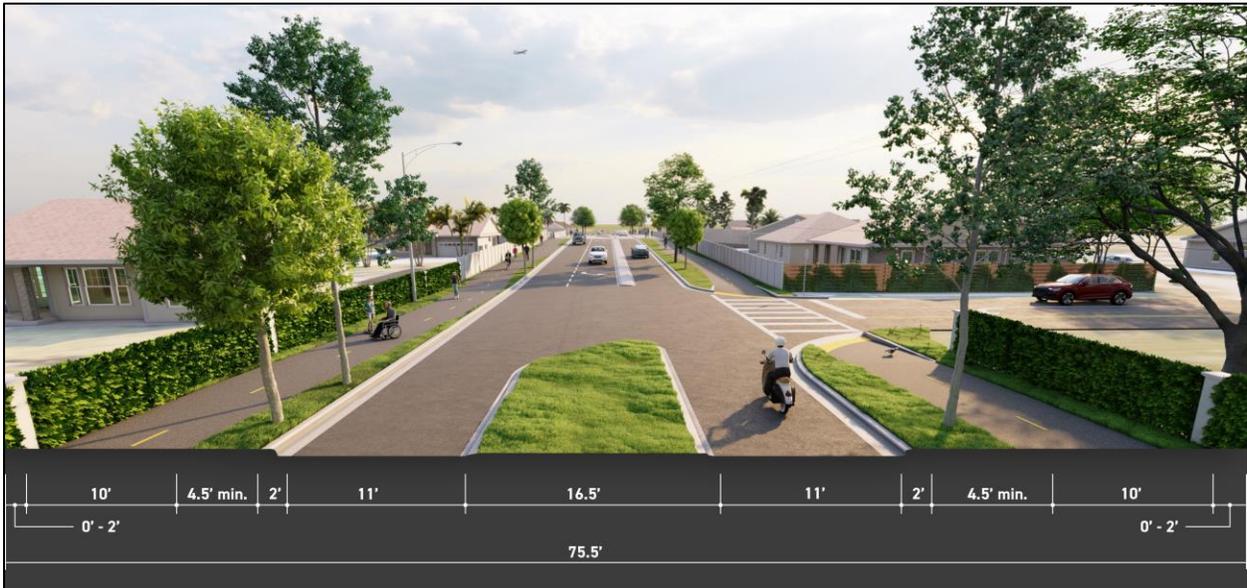
Figure 2-3: Build Alternative 1 Typical Section

Build Alternative 1: This alternative maintains one lane of traffic in each direction, while adding a 16.5-ft median with exclusive left turn lanes along SR 994. Curb and Gutter Type F is being proposed on the outside of the travel lanes while Type B curb is the typical condition on the inside to maximize the available landscaping area within the raised islands. This alternative proposes a 10-ft SUP along both sides of the corridor, which are intended to be utilized by pedestrians as well as bicyclists. A minimum 4.5-ft buffer is proposed from the back of curb to the front of the SUPs. A 2-ft buffer is proposed behind each of the SUPs to accommodate signing and lighting features. A traffic signal is proposed at the intersection of SR 994/Quail Roost Drive and SW 134th Avenue. See **Figure 2-3** for details.

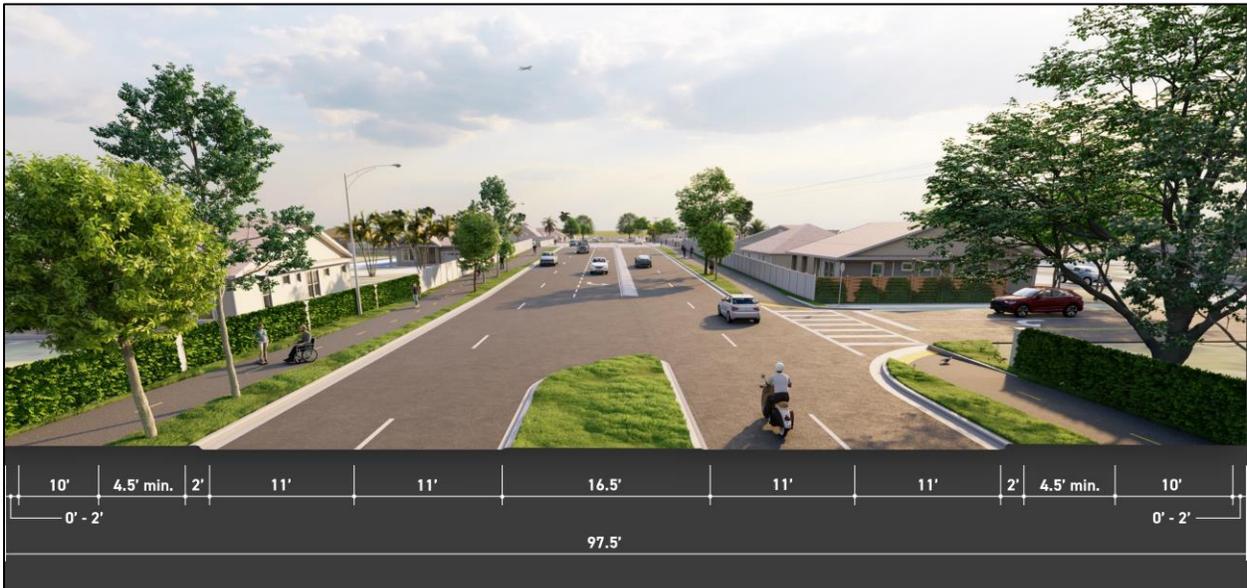
Figure 2-4: Build Alternative 2 Typical Section

Build Alternative 2: This alternative proposes one additional travel lane in each direction, for a total of two 11-ft lanes on each bound, and a 16.5-ft median with exclusive left turn lanes along SR 994. Curb and Gutter Type F is proposed on the outside of the travel lanes while Type B curb is the typical condition on the inside to maximize the available landscaping area within the raised islands. This alternative also proposes a 10-ft SUP along both sides of the corridor, which are intended to be utilized by pedestrians as well as bicyclists. A minimum 4.5-ft buffer is proposed from the back of curb to the front of the SUP. A 2-ft buffer is proposed behind each of the SUPs to accommodate signing and lighting features. A traffic signal is proposed at the intersection of SR 994/Quail Roost Drive and SW 134th Avenue. See **Figure 2-4** for details.

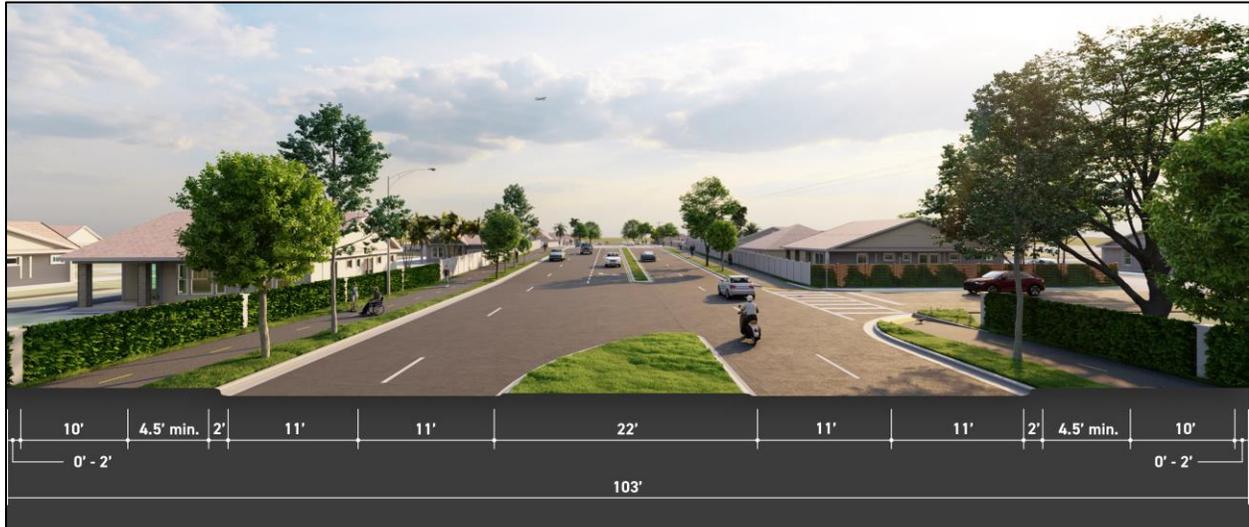
Figure 2-5: Build Alternative 3 Typical Section

Build Alternative 3: Similar to Build Alternative 2, this alternative proposes adding one travel lane in each direction along SR 994 for a total of two 11-ft lanes on each bound. A 22-ft-wide raised median with exclusive left turn lanes is provided along the corridor, restricting access to the minor roads and driveways connecting to SR 994. At the intersections, a striped buffer is proposed between the left turn lanes and the through traffic lanes. Curb and Gutter Type F is being proposed on the outside of the roadway, while Type B curb is the typical condition on the inside to maximize the available landscaping area within the raised median when present. This alternative also proposes a 10-ft SUP along both sides of the corridor, which are intended to be utilized by pedestrians as well as bicyclists. A minimum 4.5-ft buffer is proposed from the back of

curb to the front of the SUP. A 2-ft buffer is proposed behind each of the SUPs to accommodate signing and lighting features. A traffic signal is proposed at the intersection of SR 994/Quail Roost Drive and SW 134th Avenue. This alternative has the greatest impact to the existing ROW and also the most access management restrictions. See **Figure 2-4** for details.

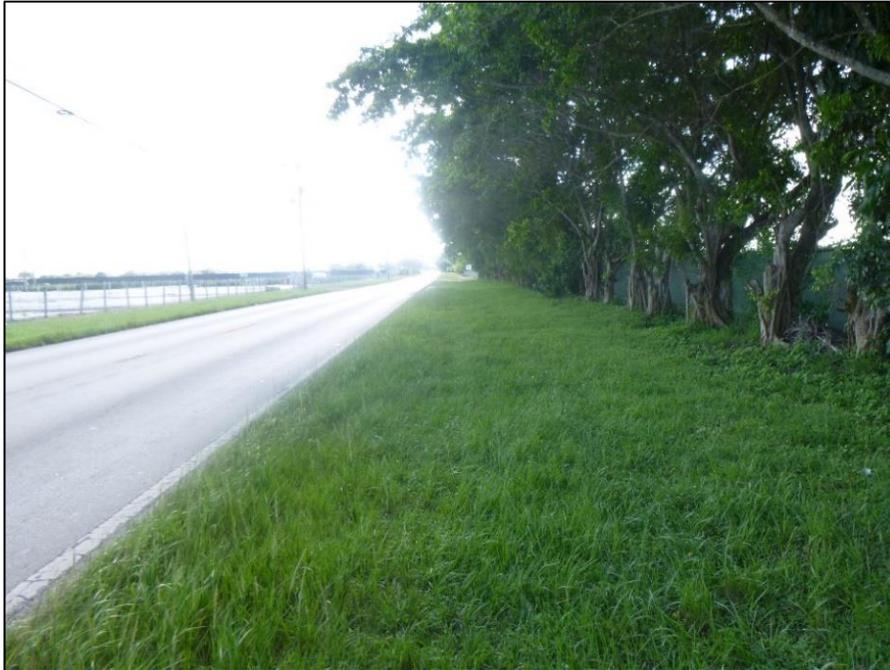
Figure 10-1: Location of shovel tests 1 and 2 on the south ROW of Quail Roost Drive, facing east

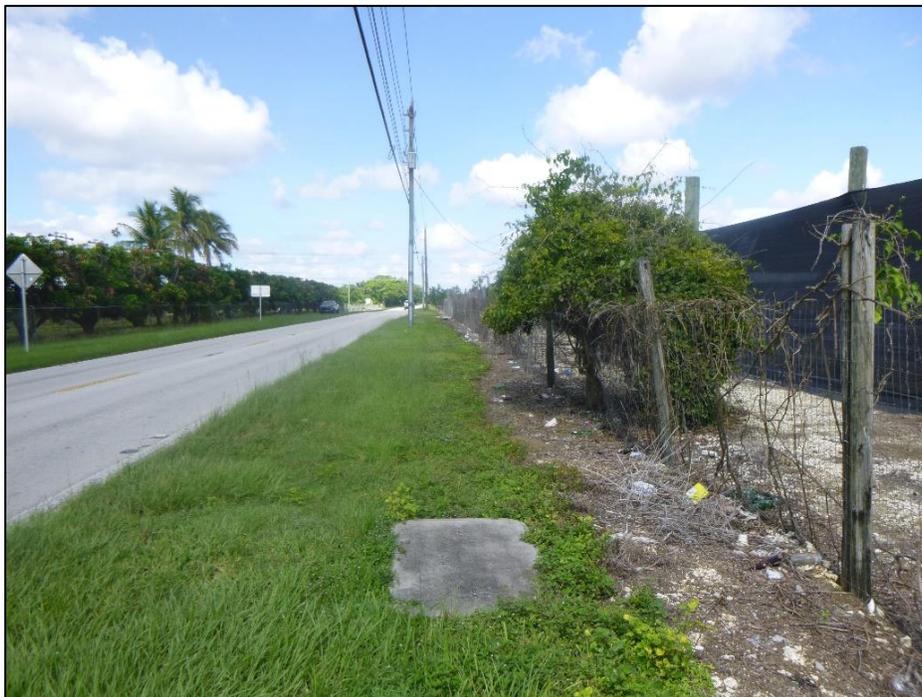
Figure 10-2: North ROW of Quail Roost Drive with buried and aerial utilities; shovel tests 3,4, and 5 were excavated on South ROW across the street, facing west

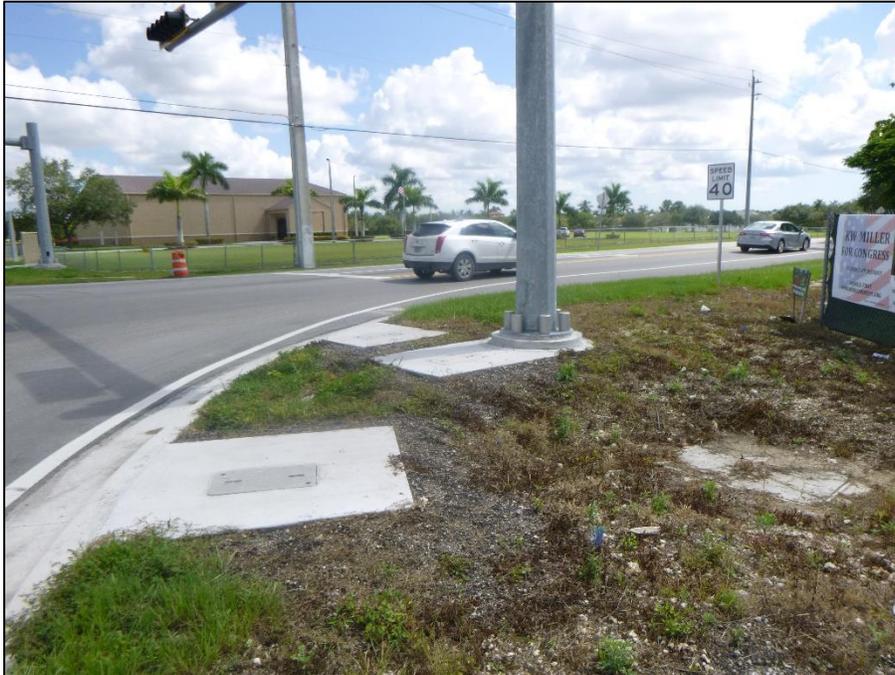
Figure 10-3: Disturbed fill soils, buried utilities, and fencing along the edge of ROW at the southeast corner of Quail Roost Drive and SW 137th Avenue, facing northeast

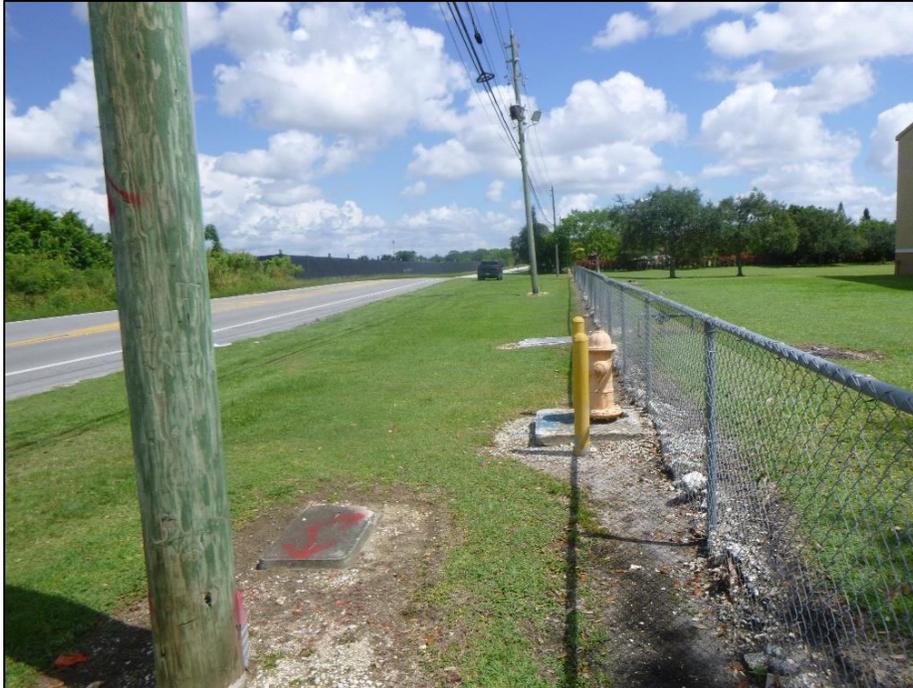
Figure 10-4: Fence and buried utilities on west ROW of SW 137th Avenue, north of Quail Roost Drive, facing north

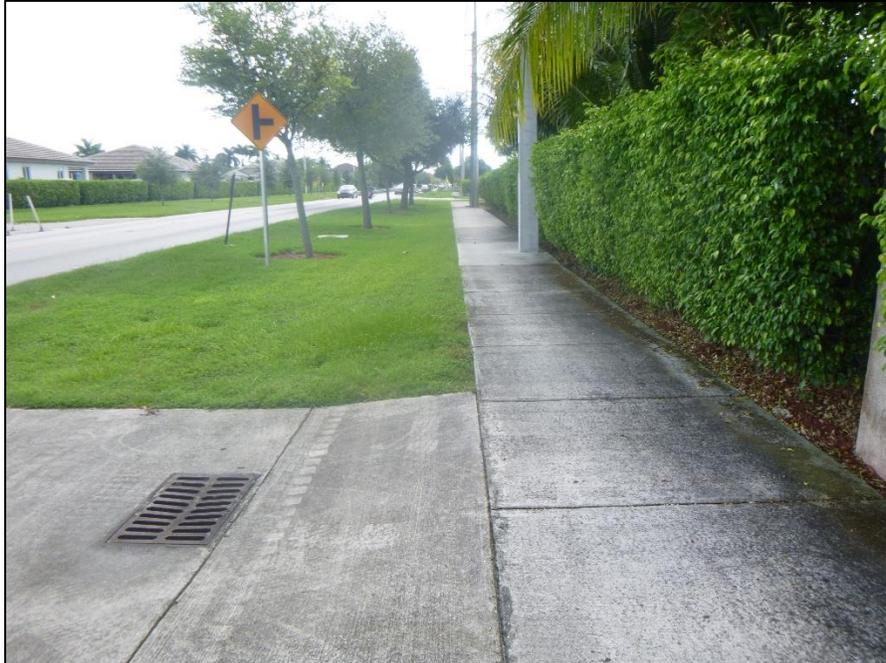
Figure 10-6: Drainage, hardscape, and landscaping on Quail Roost Drive east of 133rd Court, facing east

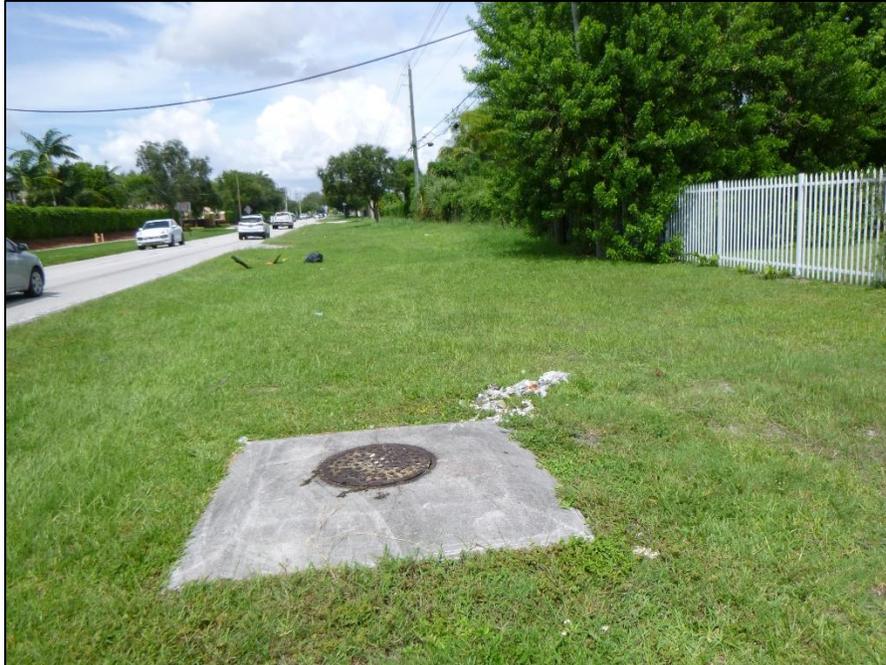
Figure 10-8: Buried sewer on North ROW of Quail Roost Drive east of SW 129th Avenue, facing west

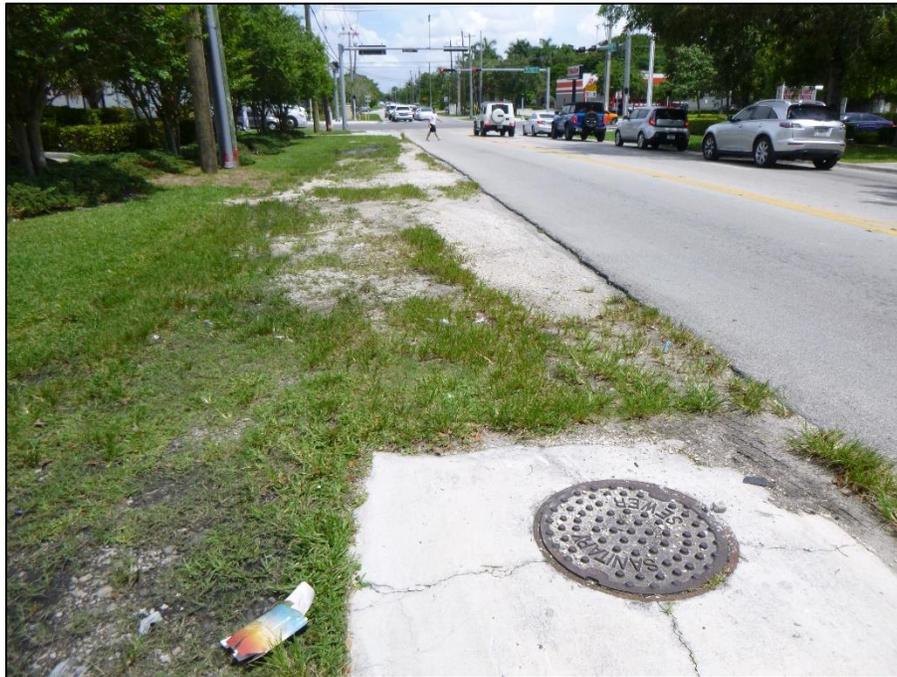
Figure 10-9: West ROW of SW 127th Avenue south of Quail Roost Drive with buried utilities, facing north

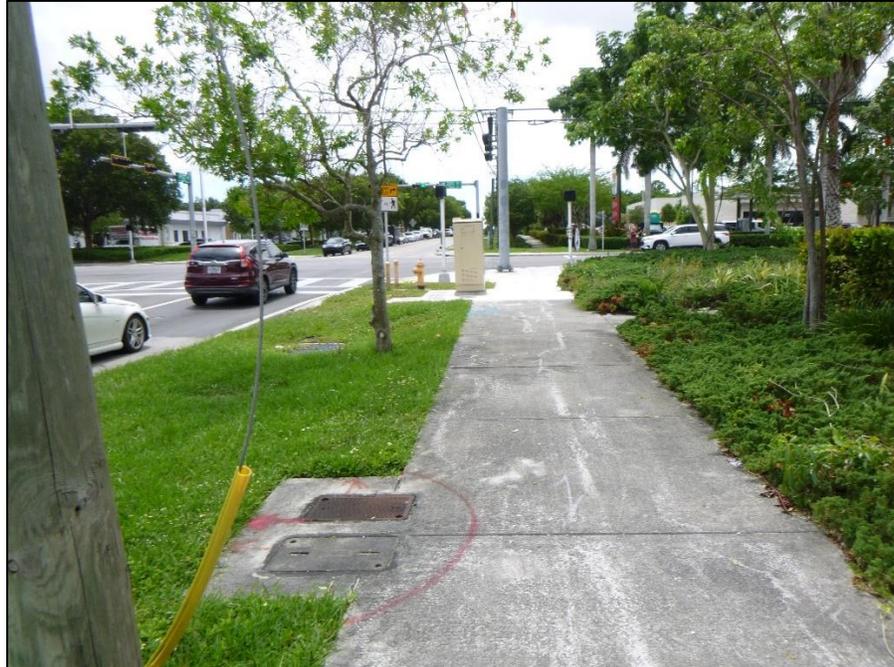
Figure 10-10: Buried utilities, hardscape, and landscaping along SW 127th Avenue north of Quail Roost Drive, facing south

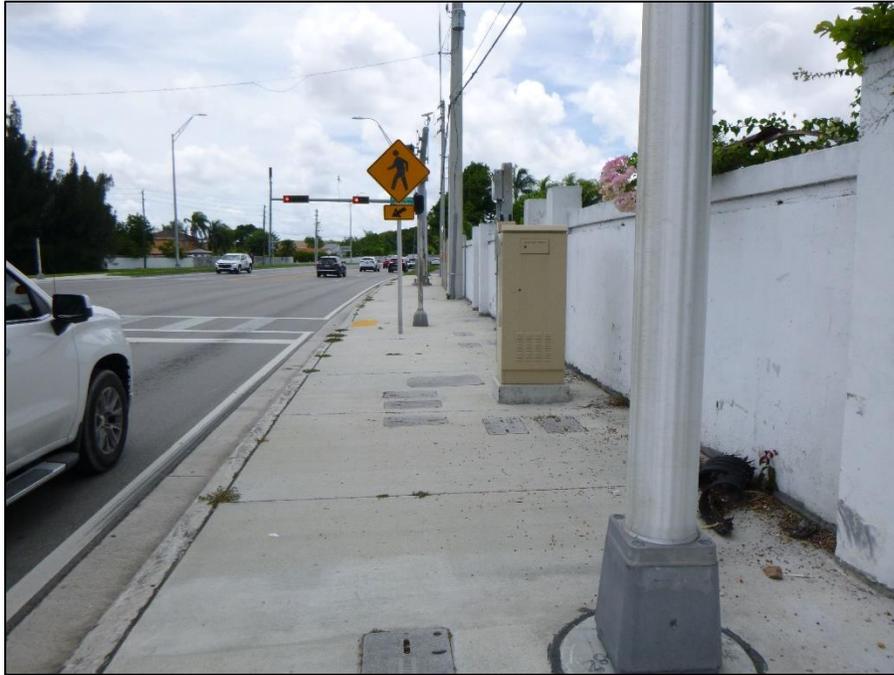
Figure 10-11: Hardscape and buried utilities along the north Quail Roost Drive ROW near the east end of the project corridor, facing west

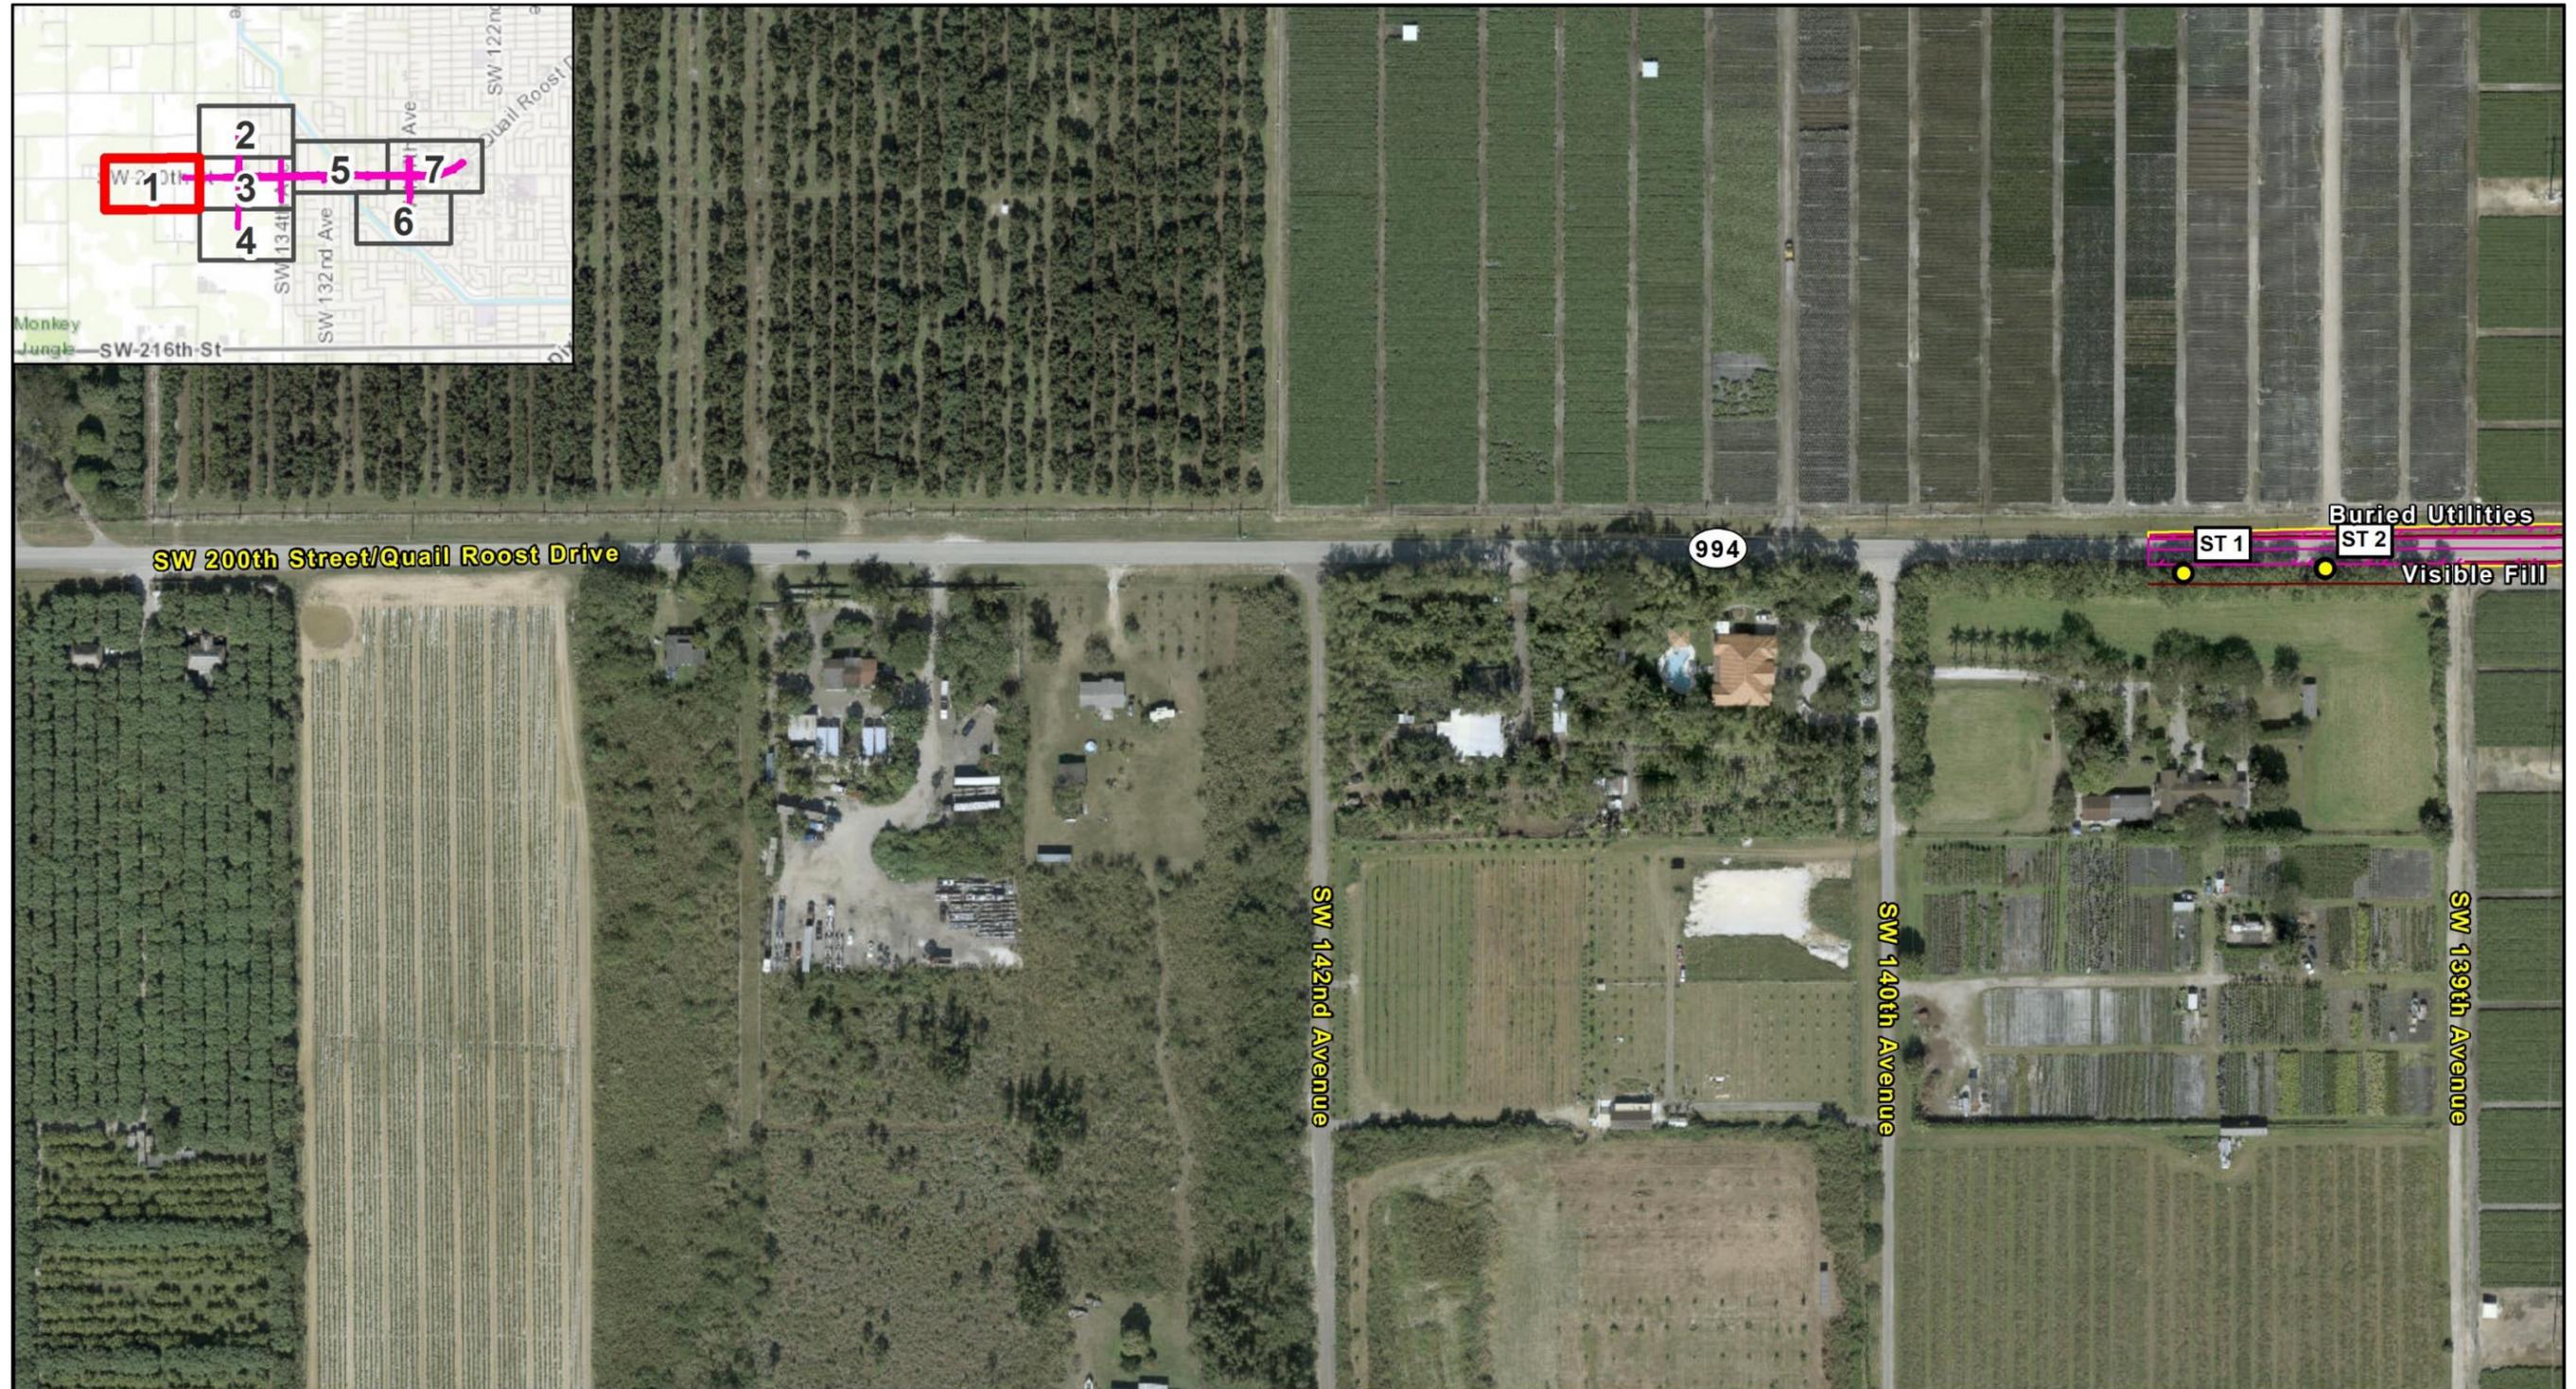
Figure 10-12a: Shovel Tests and Field Conditions (Map 1 of 7)

The six (6) shovel tests excavated within the archaeological APE contained gray or brown fill and rock with no natural soils present. Impenetrable compacted fill, which occurred as shallow as 11 cm deep in one test and as deep as 22 cm in another test, prevented excavation any deeper. The average depth of excavation measured approximately 18 cm deep. Crews excavated five tests within two areas on the south (eastbound) ROW of SR 994/Quail Roost Drive/SW 200th Street, which were initially considered to have low archaeological site potential. Only one test could be excavated in an area initially considered to have moderate archaeological site potential on the south (eastbound) ROW. All tests were in the less urbanized western half of the project corridor. Tests were excavated at 50-m intervals where possible, but the testable areas free of utilities were limited. No cultural materials were identified in any shovel test. The locations of the shovel tests are shown on aerial images in **Figures 10-12a** through **10-12g**.

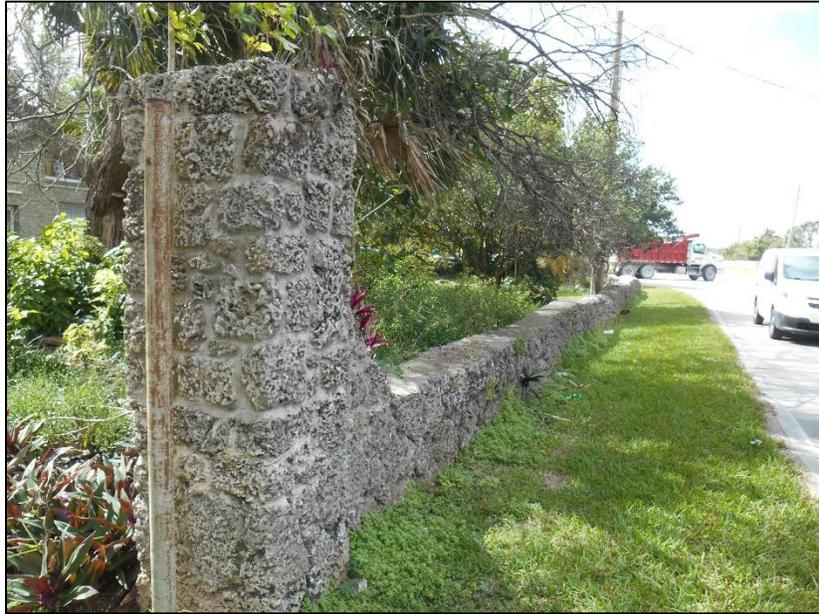
Figure 10-14: Oolitic limestone exterior wall, located at the northeastern corner of the National Register–eligible and locally designated Talbott Estate (8DA2789), facing west

The Talbott Estate retains overall very high historic integrity. The alterations that have occurred to the main house and cottage outbuilding have not significantly detracted from their integrity. The oolitic rock perimeter wall, while having been damaged in portions, retains its distinctive materials and spatial relationship to the buildings and street. The shed outbuilding has not retained historic integrity due to its enclosure and conversion into a habitable building.

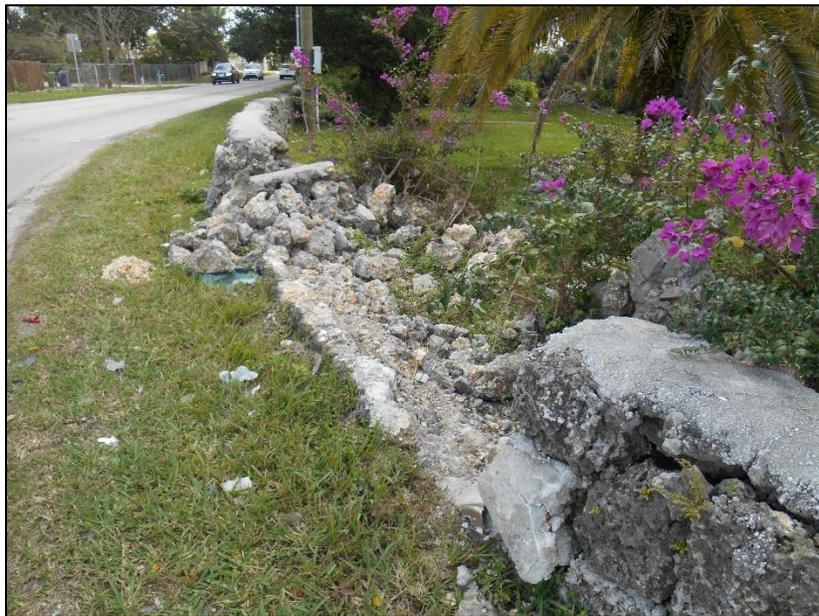
Figure 10-15: Damaged segment of oolitic limestone exterior wall, located at the northwestern corner of the National Register–eligible and locally designated Talbott Estate (8DA2789), at the intersection of SW 134th Avenue/Talbot Road and SW 200th Street/Quail Roost Drive, facing east

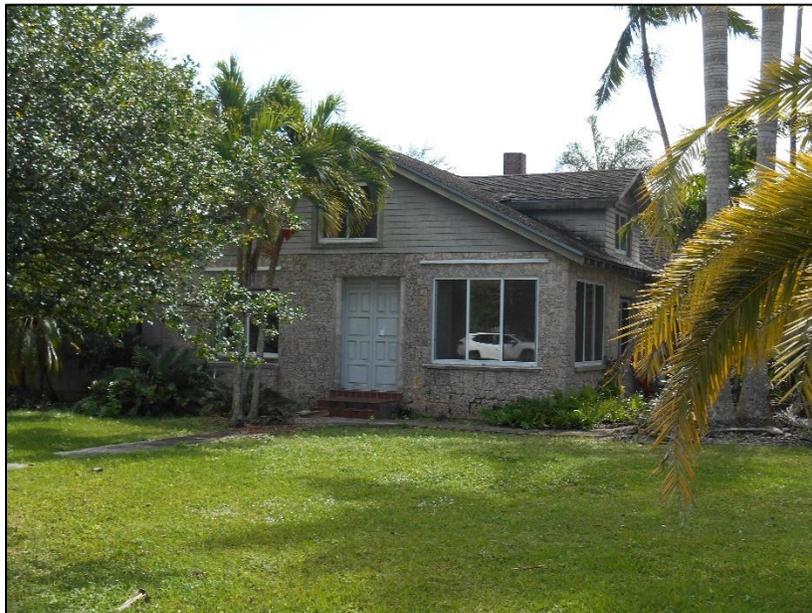
Figure 10-17: Northern elevation of the main house of the National Register–eligible and locally designated Talbott Estate (8DA2789). The doorway features thin oolitic limestone columns flanking the entrance, facing south

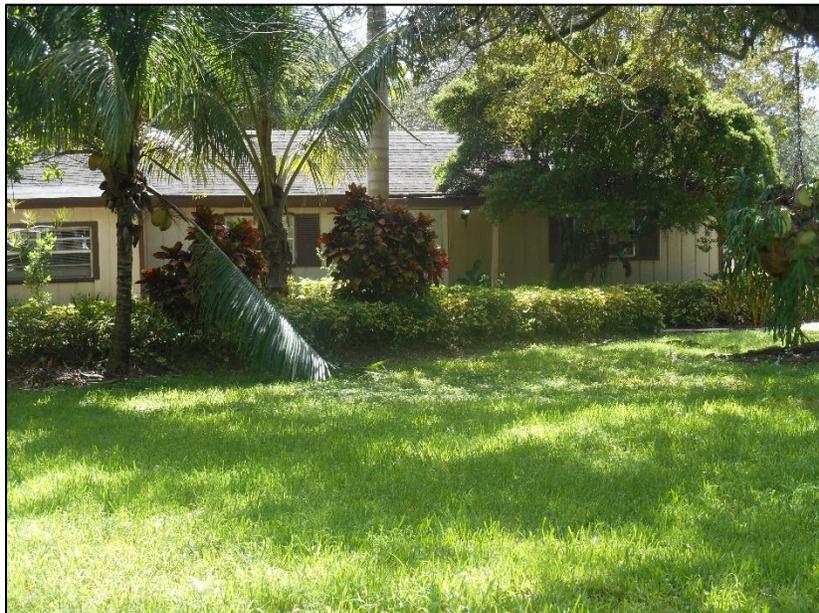
Figure 10-19: Enclosed shed building south of the main house on the National Register-eligible and locally designated Talbott Estate (8DA2789), facing east

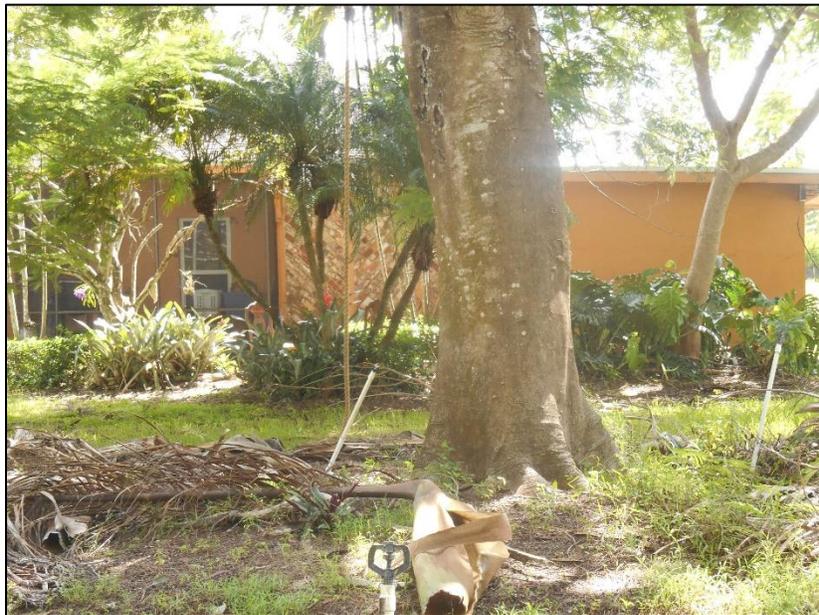
Figure 10-21: Western elevation of the cottage outbuilding south of the converted shed on the National Register–eligible and locally designated Talbott Estate (8DA2789). The decorative brickwork on the western wall of this building is visible in this photograph, facing east

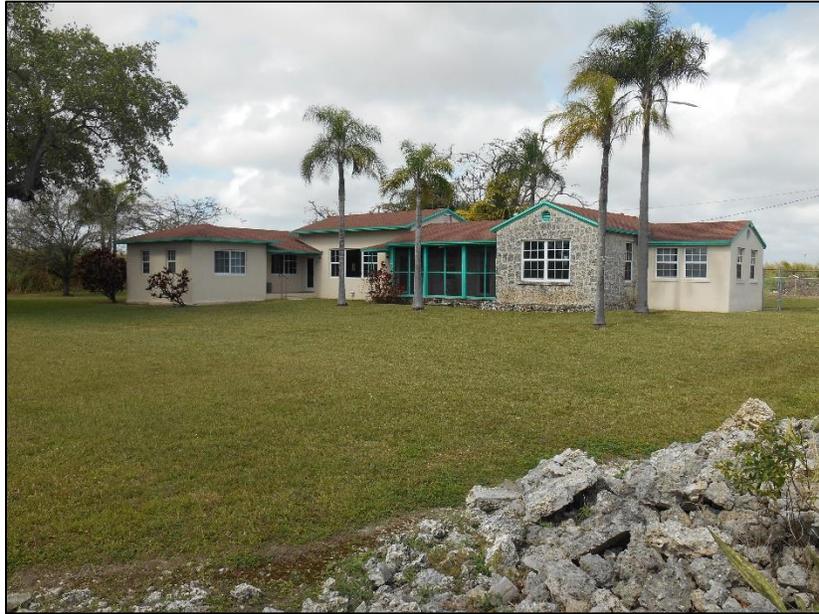
Figure 10-22: Southern elevation of the National Register–eligible MacDonell Residence (8DA20712), with a damaged segment of the parcel’s oolitic limestone wall in the foreground, facing northwest

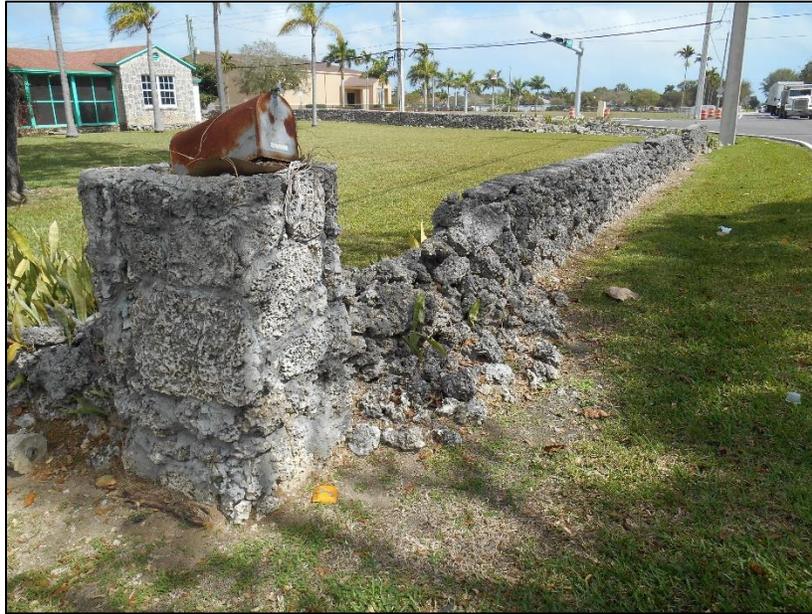
Figure 10-24: Damaged segment of oolitic limestone exterior wall, located at the southwestern corner of the National Register–eligible MacDonell Residence (8DA20712), facing northeast

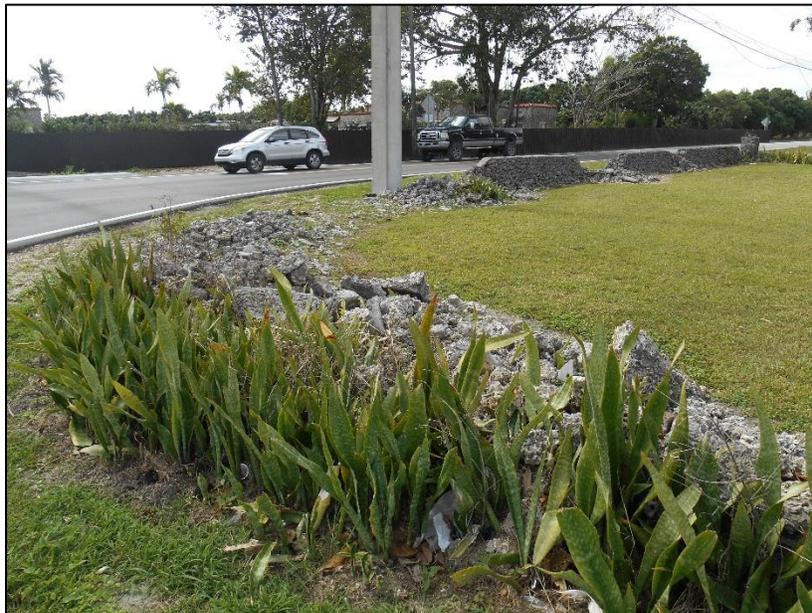
Figure 10-25: Damaged segment of oolitic limestone exterior wall, located at the southwestern corner of the National Register–eligible MacDonell Residence (8DA20712), facing northeast

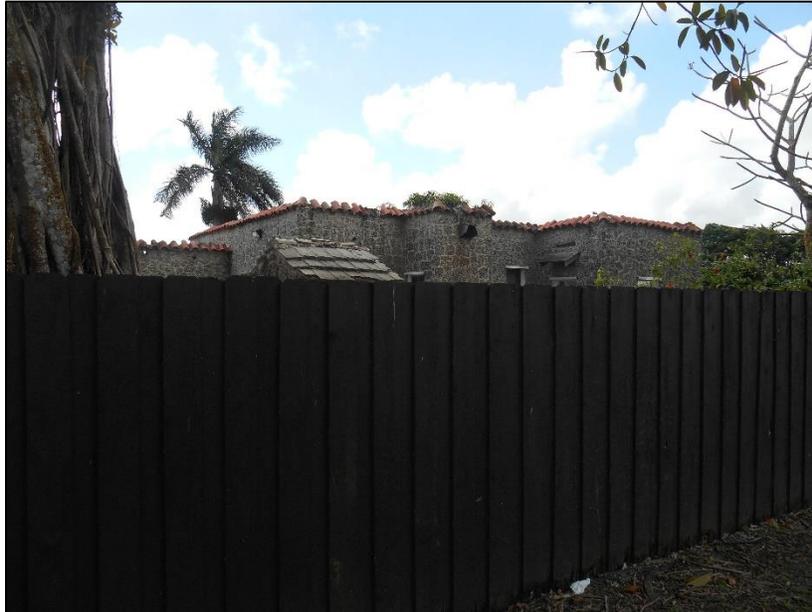
The main building on the parcel (**Figures 10-27** and **10-28**), located at the northern end, has its main entrance on the eastern elevation, at the end of a driveway. The single entrance door on this elevation is covered by a small projecting canopy. Along all of the other elevations of the building, are regularly placed one-over-one single-hung windows. The entrance room of the house is of a smaller scale than the rooms to its west. The entire building is built of oolitic limestone, with small scuppers along several of the walls to relieve water build-up on the building’s flat roofs. The edge of the roofline is consistently clad in single Spanish tiles. A small inclined covered area extends from the southern elevation of the building.

Figure 10-27: Northern elevation of the National Register–eligible building at 20000 SW 137th Avenue (8DA20713). The gabled topper of the parcel’s oolitic limestone wall is visible in the foreground, behind the privacy fence, facing south

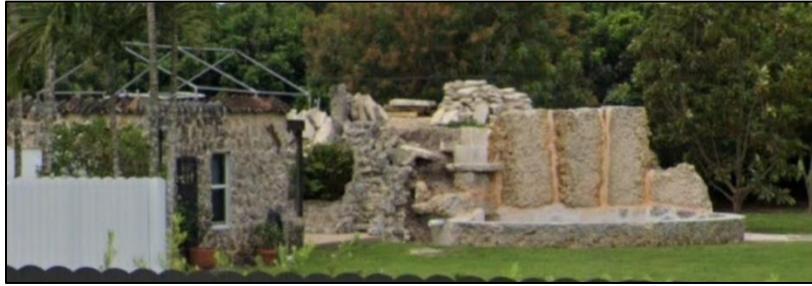
The outbuilding at the southwest corner of the property was not visible from the public ROW due to the privacy fence, but a March 2021 Google Streetview photograph (*Figure 10-31*) shows the outbuilding to be in a ruinous state, though clearly made of the same oolitic limestone as the other elements of the parcel.

Figure 10-31: Southwestern outbuilding on the property containing the National Register–eligible building at 20000 SW 137th Avenue (8DA20713). This outbuilding is in a ruinous state. March 2021 Google Streetview photograph, facing southwest

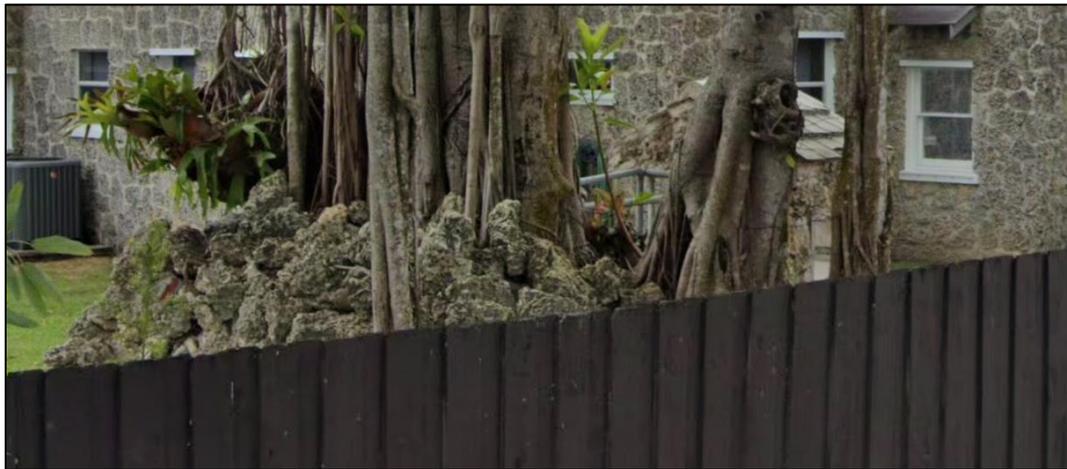
At the northern end of the parcel, north of the main house, remains two small segments of oolitic rock wall (*Figure 10-32*), which would have marked the boundaries of the property during the historic period. These wall segments were not visible from the public ROW during fieldwork, but Google StreetView shows the location of these elements, right behind the privacy fence. The small segment to the west is topped by a gabled shingle element, and the segment to the east is slightly collapsed.

Figure 10-32: Surviving material from historic oolitic rock perimeter walls on the property containing the National Register–eligible building at 20000 SW 137th Avenue (8DA20713). The walls are located north of the main house on the property, near the parcel boundary. April 2022 Google Streetview photograph, facing south

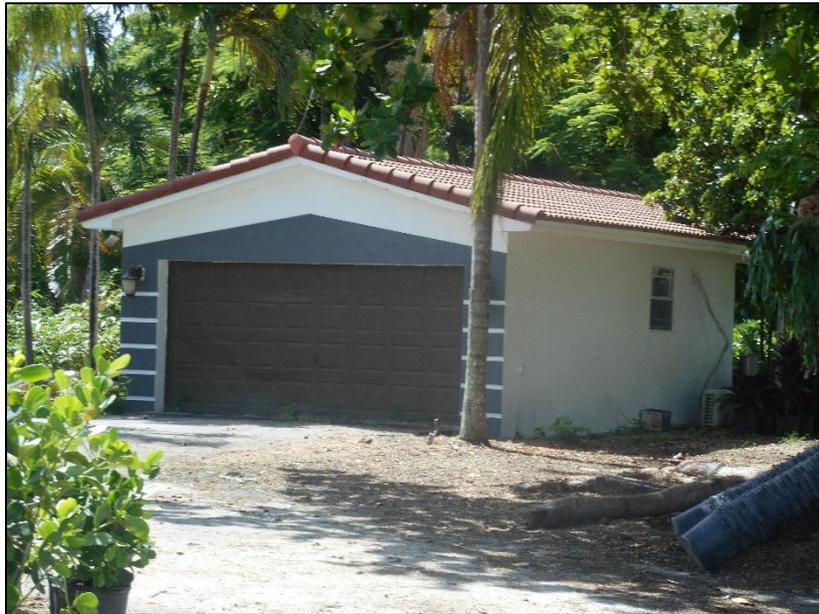
Figure 10-36: Outbuilding garage at 13650 SW 200th Street (8DA20715), considered National Register–ineligible, facing south

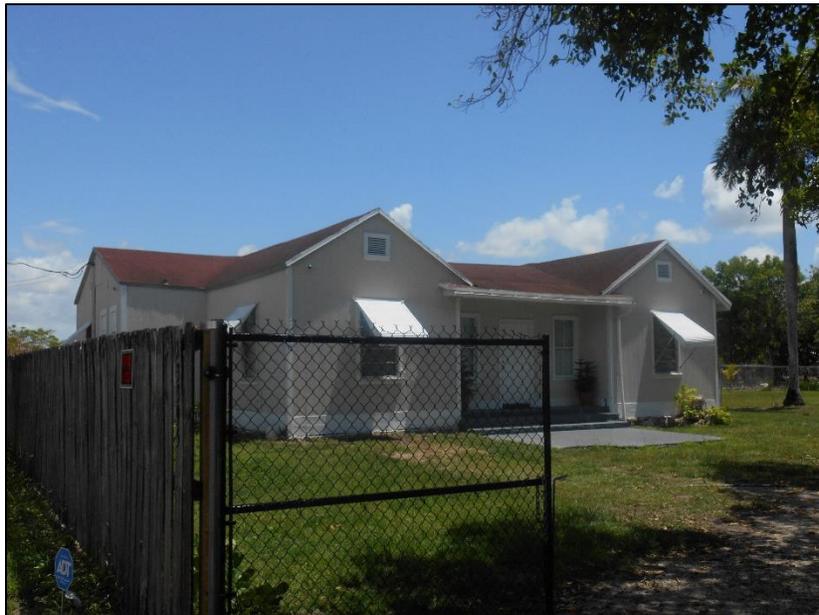
This circa 1910 building is located at the northeast corner of SR 994/Quail Roost Drive and SW 134th Avenue/Talbot Road, in Section 2 of Township 56 South, Range 39 East on the Goulds (1988) USGS quadrangle map (Figure 10-37). The Frame Vernacular building has a square exterior plan with a gabled tile roof. The recessed main entrance, located on the street-facing southern side of the building, is covered by a slanted roof segment, and flanked by a gable on each side. The windows on the house are vinyl single-hung, and are primarily two-over-two, with the majority covered by Bahama shutters. The building had a small, enclosed addition built to the on its northern side (Miami-Dade County Property Appraiser 2022). A small shed was constructed in the house’s backyard. While the house is older those in its surroundings, it exhibits common design types found throughout Florida from its period, and itself has no architectural significance. Limited research has also revealed no historical associations with significant persons or events. Therefore, the property is considered individually ineligible for inclusion in the National Register under Criteria A, B, C, or D, or as part of a potential historic district.

Figure 10-37: 13395 SW 200th Street (8DA20716), c. 1910, considered National Register–ineligible, facing north

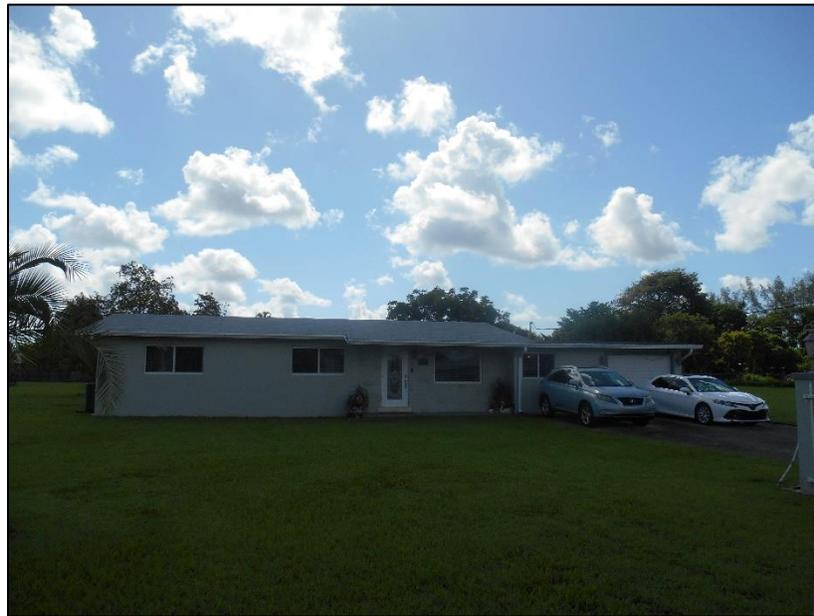
This circa 1966 building is located east of SW 134th Avenue/Talbot Road, north of the roadway’s intersection with SR 994/Quail Roost Drive, in Section 2 of Township 56 South, Range 39 East on the Goulds (1988) USGS quadrangle map (Figure 10-38). The Masonry Vernacular residence has a rectangular exterior plan with a gabled slate shingle roof and is clad in stucco. The roof projects slightly outward over the front entrance, which is surrounded by faux-masonry veneer. The building features very little ornamentation or detailing otherwise. While the roof of the majority of the building is gabled, the roof over the garage is flat. The windows of the building are primarily single-slide. The building had a small, enclosed addition built on to the southeast (Miami-Dade County Property Appraiser 2022). The house exhibits a common design type found throughout Florida. Limited research has revealed no historical associations with significant persons or events. Therefore, the property is considered individually ineligible for inclusion in the National Register under Criteria A, B, C, or D, or as part of a potential historic district.

Figure 10-38: 19805 SW 134th Avenue (8DA20717), c. 1966, considered National Register–ineligible, facing east

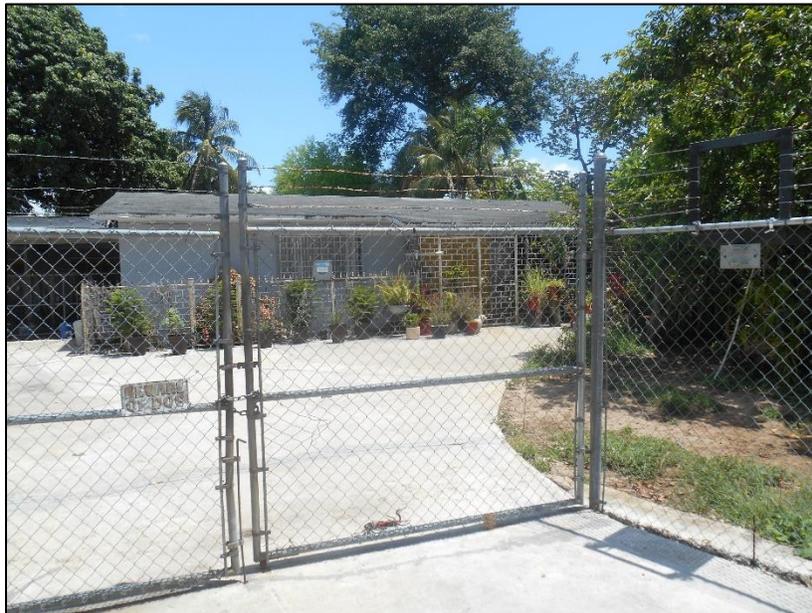
This circa 1966 building is located north of SR 994/Quail Roost Drive, East, east of the roadway’s intersection with SW 134th Avenue/Talbot Road, in Section 2 of Township 56 South, Range 39, on the Goulds (1988) USGS quadrangle map (Figure 10-39). The one-story Masonry Vernacular residence is clad in stucco and has a gabled tile roof. Along the southern elevation of the building, the roofline extends outward, and the entrance area is enclosed by a metallic patio structure. The building features very little ornamentation or detailing otherwise. The building has had minimal alterations (Miami-Dade County Property Appraiser 2022). The house exhibits a common design type found throughout Florida. Limited research has revealed no historical associations with significant persons or events. Therefore, the property is considered individually ineligible for inclusion in the National Register under Criteria A, B, C, or D, or as part of a potential historic district.

Figure 10-39: 13355 SW 200th Street (8DA20718), c. 1966, considered National Register–ineligible, facing north
