CULTURAL RESOURCE ASSESSMENT SURVEY REPORT

SR 994/SW 200th Street/Quail Roost Drive PD&E Study

From SW 137th Avenue to SW 127th Avenue

December 8, 2022

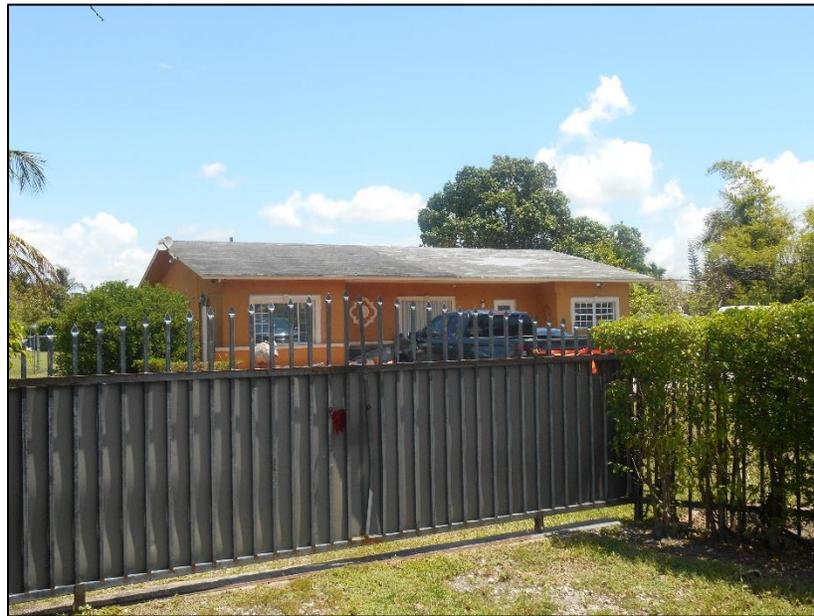
This circa 1954 building is located at the northwest corner of SR 994/Quail Roost Drive and SW 132nd Place in Section 2 of Township 56 South, Range 39 East, on the Goulds (1988) USGS quadrangle map (Figure 10-40). The one-story Masonry Vernacular residence is clad in stucco and has a gabled tile roof. The house’s windows are six-over-six single-hung with plaster trim; several of the windows were enclosed with shutters. Along the house’s southern elevation, there were several instances of decorative plaster, including the aforementioned window trim, a raised decorative line under the windowline, and a motif adjacent to the front door. The building has had minimal alterations (Miami-Dade County Property Appraiser 2022). The house exhibits a common design type found throughout Florida. Limited research has revealed no historical associations with significant persons or events. Therefore, the property is considered individually ineligible for inclusion in the National Register under Criteria A, B, C, or D, or as part of a potential historic district.

Figure 10-40: 13295 SW 200th Street (8DA20719), c. 1954, considered National Register–ineligible, facing north

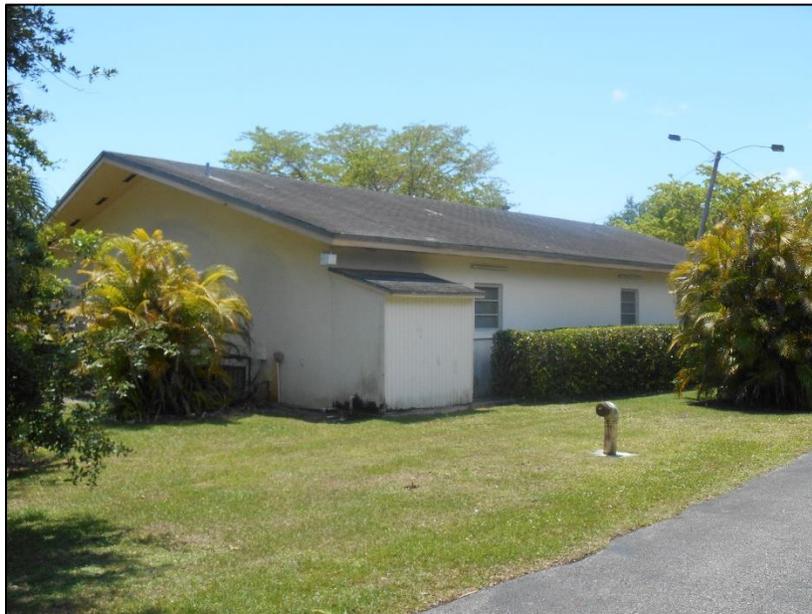
This circa 1974 building is located south of SR 994/Quail Roost Drive, west of the roadway’s intersection with SW 127th Avenue, in Section 11 of Township 56 South, Range 39 East, on the Goulds (1988) USGS quadrangle map (Figure 10-41). The one-story Masonry Vernacular church building is clad in stucco and has a rectangular exterior plan and a gabled tile roof. The church’s windows visible from the public ROW are three-pane awning windows. The building has minimal decoration or ornamentation. The church has had minimal alterations (Miami-Dade County Property Appraiser 2022) and exhibits a common design type found throughout Florida. Limited research has revealed no historical associations with significant persons or events. Due to the lack of historical and architectural significance, this building does not meet the requirements for Criteria Consideration A for religious properties. Therefore, the property is considered individually ineligible for inclusion in the National Register under Criteria A, B, C, or D, or as part of a potential historic district.

Figure 10-41: Church of Christ on Quail Roost Drive (8DA20720), c. 1974, considered National Register–ineligible, facing south

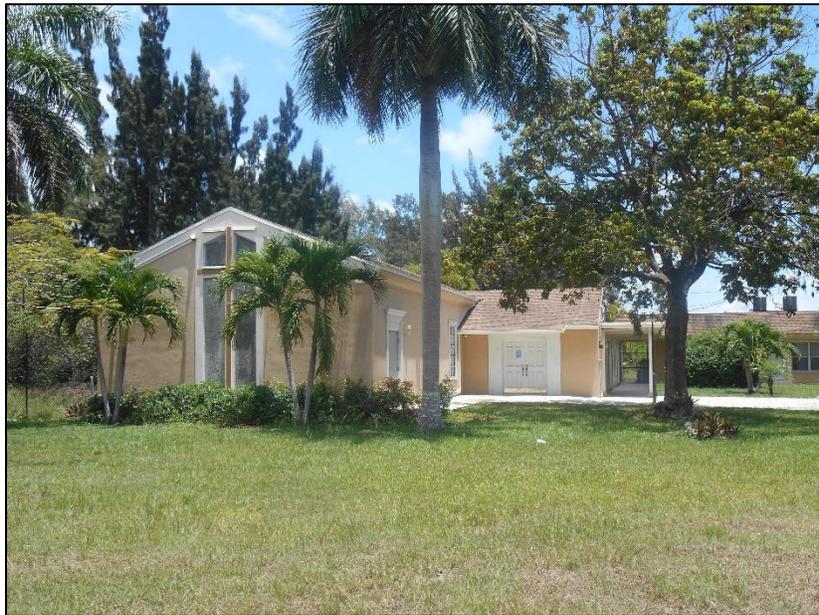
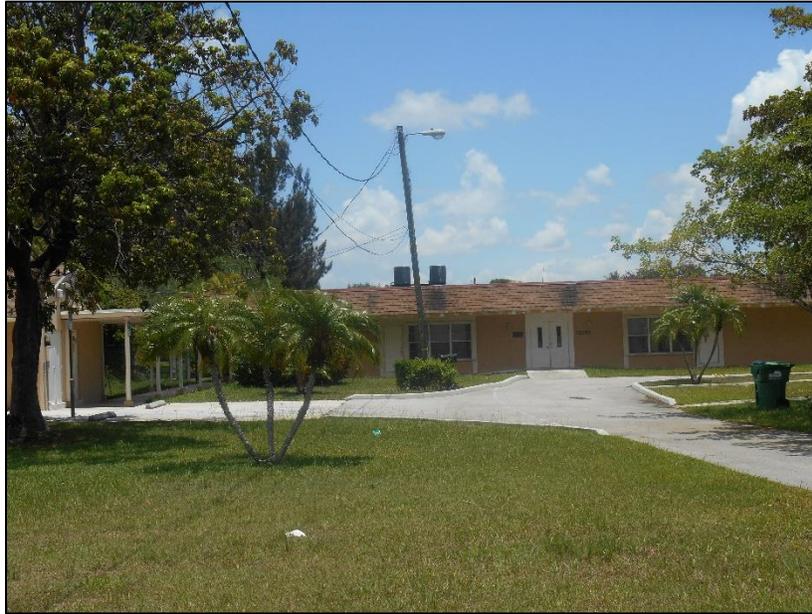
This circa 1961 building is located north of SR 994/Quail Roost Drive, west of the roadway’s intersection with SW 127th Avenue, in Section 11 of Township 56 South, Range 39 East, on the Goulds (1988) USGS quadrangle map (Figures 10-42 and 10-43). The one-story Mid-Century Modern church consists of two buildings connected by a covered walkway. The sanctuary building is T-shaped with a gabled tile roof and a shed roof at the main entrance. The second building has a flat mansard tile roof. The sanctuary building is adorned with a large cross but has few other distinctive features. The overall church buildings have minimal decoration or ornamentation. The church has had minimal alterations (Miami-Dade County Property Appraiser 2022) and exhibits a common design type found throughout Florida. Limited research has revealed no historical associations with significant persons or events. Due to the lack of historical and architectural significance, this building does not meet the requirements for Criteria Consideration A for religious properties. Therefore, the property is considered individually ineligible for inclusion in the National Register under Criteria A, B, C, or D, or as part of a potential historic district.

Figure 10-42: Peace United Methodist Church (8DA20721), c. 1961, considered National Register–ineligible, facing north

Figure 10-43: Peace United Methodist Church (8DA20721), c. 1961, considered National Register–ineligible, facing north

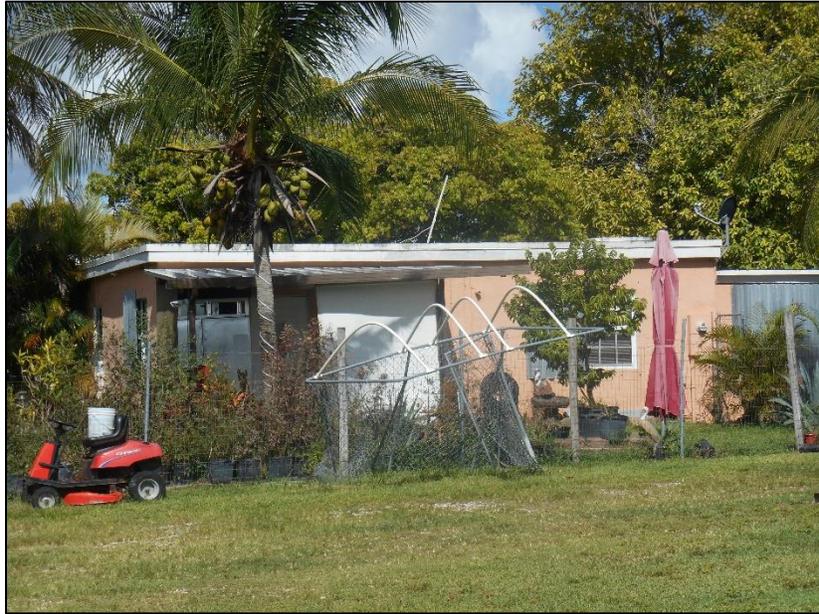
This circa 1952 building is located west of SW 127th Avenue south of the roadway’s intersection with SR 994/Quail Roost Drive in Section 11 of Township 56 South, Range 39 East, on the Goulds (1988) USGS quadrangle map (Figure 10-44). The one-story Masonry Vernacular residence is clad in stucco and has a flat roof. A small portion of the resource was visible from the public ROW, and the main entrance was not visible, but the portion visible had six-over-six single-hung windows. The building has had minimal alterations (Miami-Dade County Property Appraiser 2022) and exhibits a common design type found throughout Florida. Limited research has revealed no historical associations with significant persons or events. Therefore, the property is considered individually ineligible for inclusion in the National Register under Criteria A, B, C, or D, or as part of a potential historic district.

Figure 10-44: 20200 SW 127th Avenue (8DA20722), c. 1952, considered National Register–ineligible, facing west

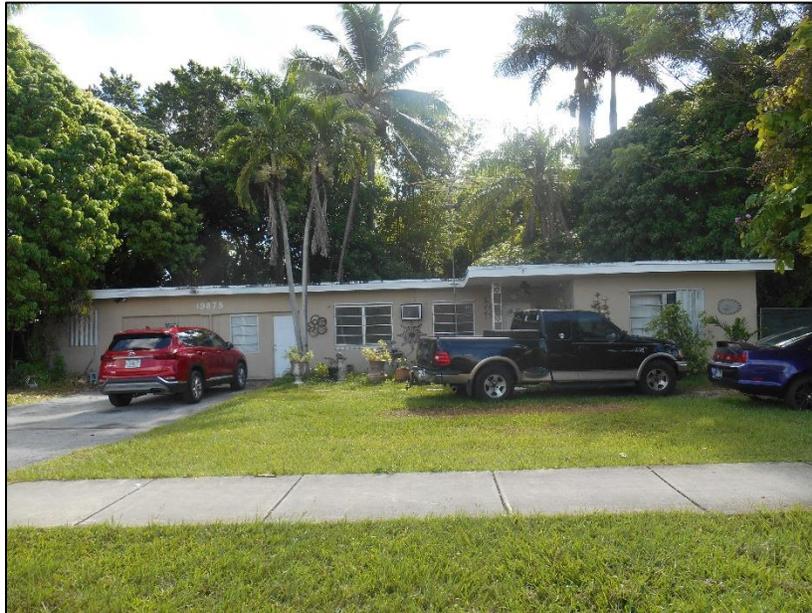
This circa 1954 building is located east of SW 127th Avenue north of the roadway’s intersection with SR 994/Quail Roost Drive in Section 1 of Township 56 South, Range 39 East, on the Goulds (1988) USGS quadrangle map (Figure 10-45). The one-story Masonry Vernacular residence is clad in stucco and has a flat roof. The house’s main entrance is flush with the rest of the front elevation, but is covered by a projection of the roofline, which is supported by a decorative column. The house also has a two-car garage. The house features awning windows. The building has had minimal alterations (Miami-Dade County Property Appraiser 2022) and exhibits a common design type found throughout Florida. Limited research has revealed no historical associations with significant persons or events. Therefore, the property is considered individually ineligible for inclusion in the National Register under Criteria A, B, C, or D, or as part of a potential historic district.

Figure 10-45: 19875 SW 127th Avenue (8DA20723), c. 1954, considered National Register–ineligible, facing east

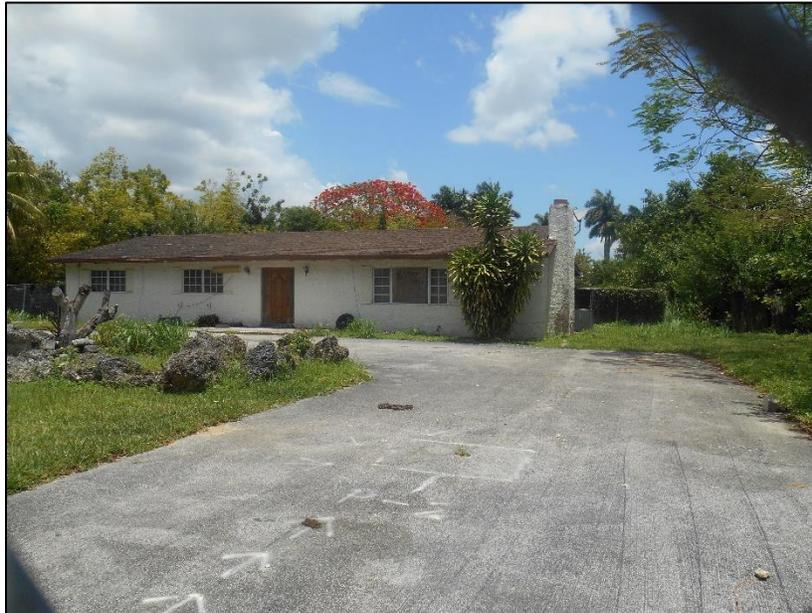
This circa 1970 building is located north of SR 994/Quail Roost Drive, east of the roadway’s intersection with SW 127th Avenue, in Section 1 of Township 56 South, Range 39 East, on the Goulds (1988) USGS quadrangle map (Figure 10-46). The one-story Masonry Vernacular residence is clad in stucco and has a gabled roof. The house’s main entrance is flush with the rest of the front elevation but is covered by a projection of the downward-sloping roofline. The house features nine-pane fixed windows and a picture window with four metal 2-light awning windows on either side on the southern elevation. The building has had minimal alterations (Miami-Dade County Property Appraiser 2022) and exhibits a common design type found throughout Florida. Limited research has revealed no historical associations with significant persons or events. Therefore, the property is considered individually ineligible for inclusion in the National Register under Criteria A, B, C, or D, or as part of a potential historic district.

Figure 10-46: 12685 SW 200th Street (8DA20724), c. 1971, considered National Register–ineligible, facing north

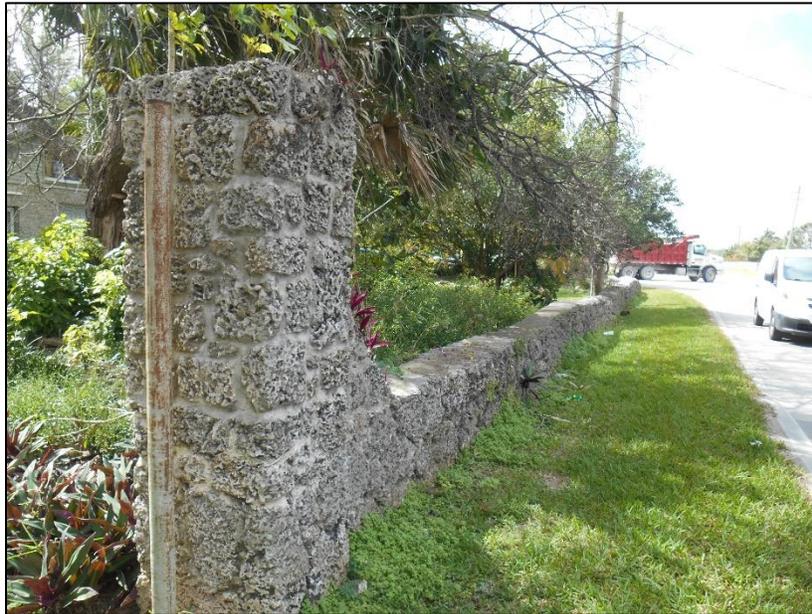
Figure 1: Oolitic limestone exterior wall, located at the northeastern corner of the National Register–eligible and locally designated Talbott Estate (8DA2789). Facing West.

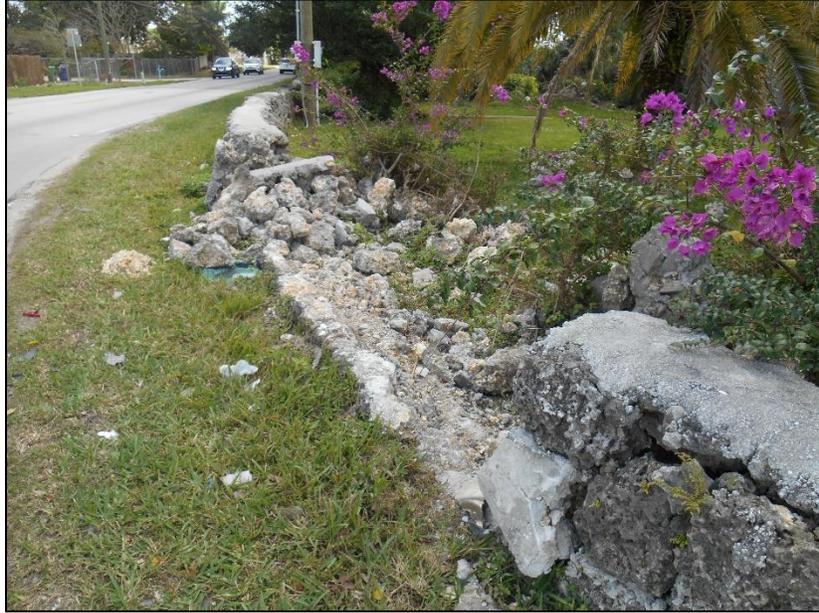
Figure 2: Damaged segment of oolitic limestone exterior wall, located at the northwestern corner of the National Register–eligible and locally designated Talbott Estate (8DA2789), at the intersection of SW 134th Avenue/Talbot Road and SW 200th Street/Quail Roost Drive. Facing East.

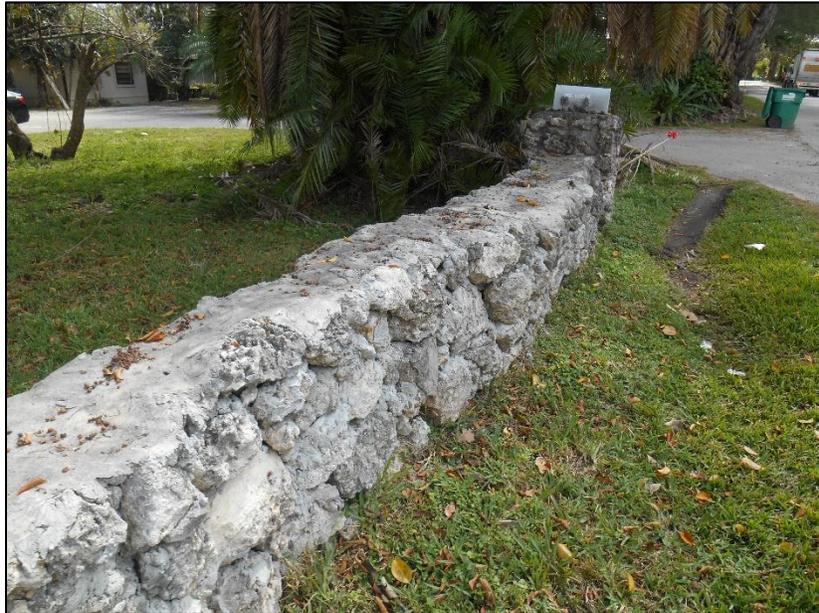
Figure 3: Oolitic limestone exterior wall, located at the western driveway entrance to the National Register–eligible and locally designated Talbott Estate (8DA2789). At this entrance, multiple mailboxes are incorporated into the wall. Facing South.

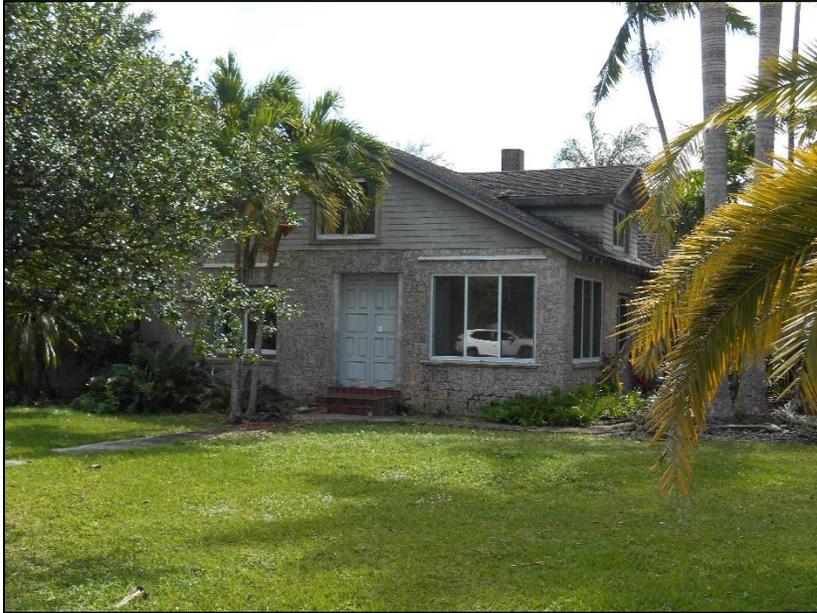
Figure 4: Northern elevation of the main house of the National Register–eligible and locally designated Talbott Estate (8DA2789). The doorway features thin oolitic limestone columns flanking the entrance. Facing South.

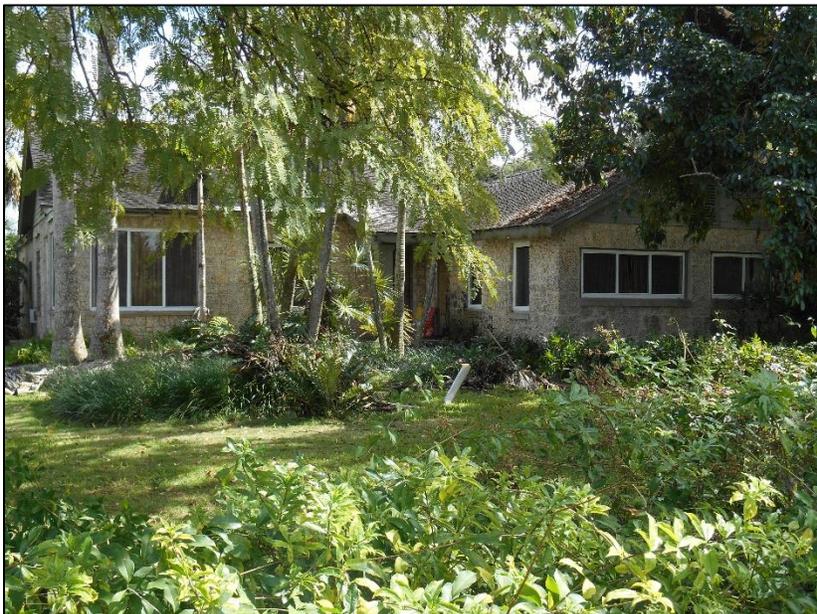
Figure 5: Western elevation of the main house of the National Register–eligible and locally designated Talbott Estate (8DA2789). This entrance features a covered porch supported by a wooden column. Facing East.

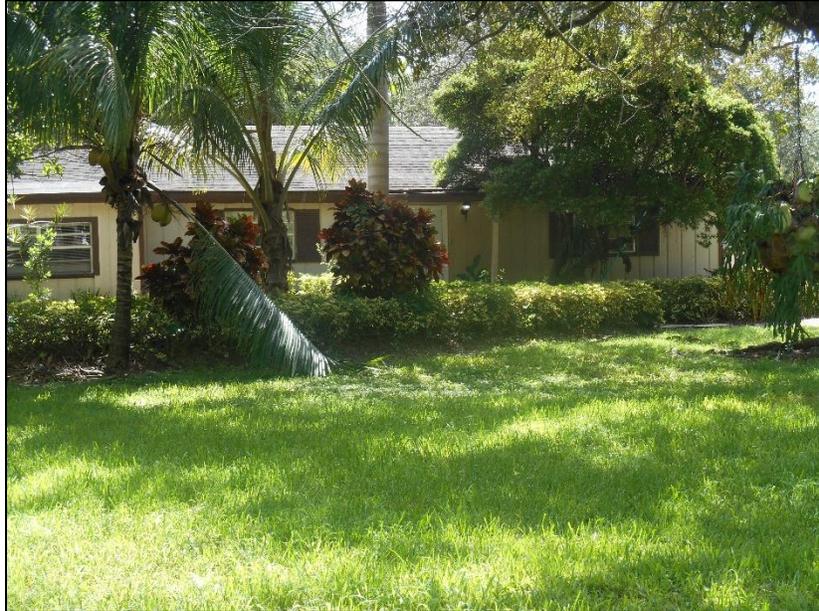
South of the Talbott Estate's main house is a gable-roofed former shed building, originally built in 1940. (Figure 6), which has been enclosed since the historic period. While the Miami-Dade County designation report for the Talbott Estate noted that the shed as of 1983 had corrugated metal and oolitic limestone facing, none of these features were now visible on the building from the public right-of-way (Metropolitan Dade County Historic Preservation Board 1983). The one-story shingle-roofed wood-frame L-shaped outbuilding, which has been given the address 20001 SW 134th Avenue/Talbot Road, now has wood facing and jalousie windows. It has been entirely converted from its original shed use into a habitable building. This conversion occurred in 1987, after the Talbott Estate was locally designated by Miami-Dade County. The total conversion of the shed has rendered it non-contributing to the Talbott Estate resource.

Figure 6: Enclosed shed building south of the the main house on the National Register–eligible and locally designated Talbott Estate (8DA2789). Facing East.

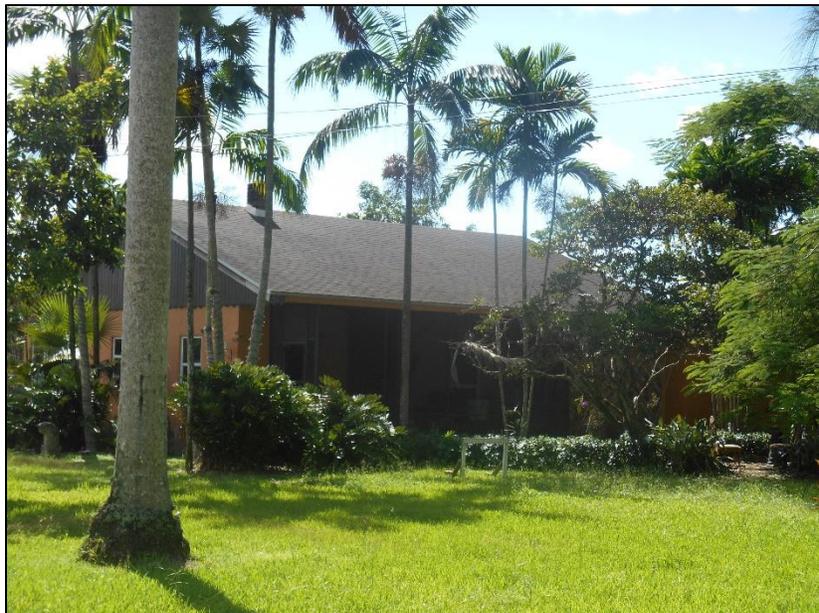
South of the former shed building is a gable-roofed stucco cottage (Figure 7), built in 1959. While the building does not feature much ornamentation along its northern elevation (Figure 8), the western elevation is a facing of brickwork laid in a diagonal pattern. The

Figure 7: Northwestern corner of the cottage outbuilding south of the converted shed on the National Register–eligible and locally designated Talbott Estate (8DA2789). Facing Southeast.

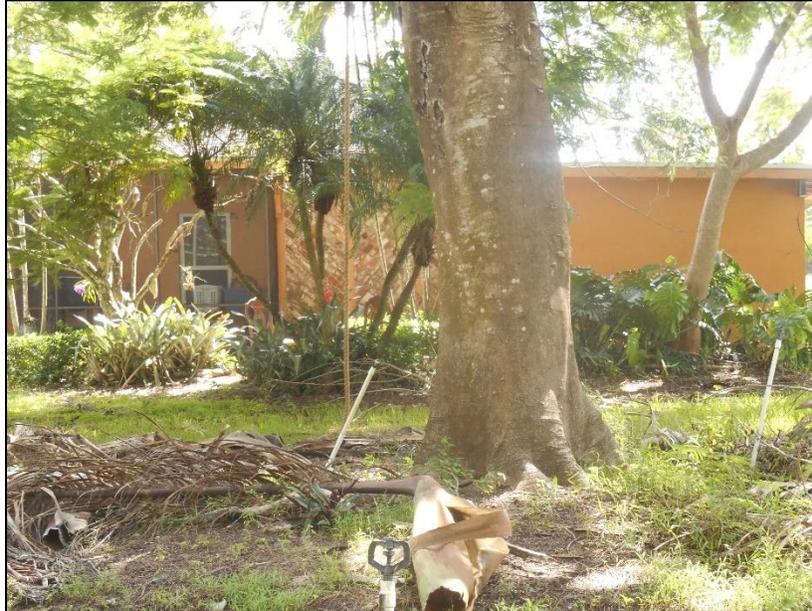
Figure 8: Western elevation of the cottage outbuilding south of the converted shed on the National Register–eligible and locally designated Talbott Estate (8DA2789). The decorative brickwork on the western wall of this building is visible in this photograph. Facing East.

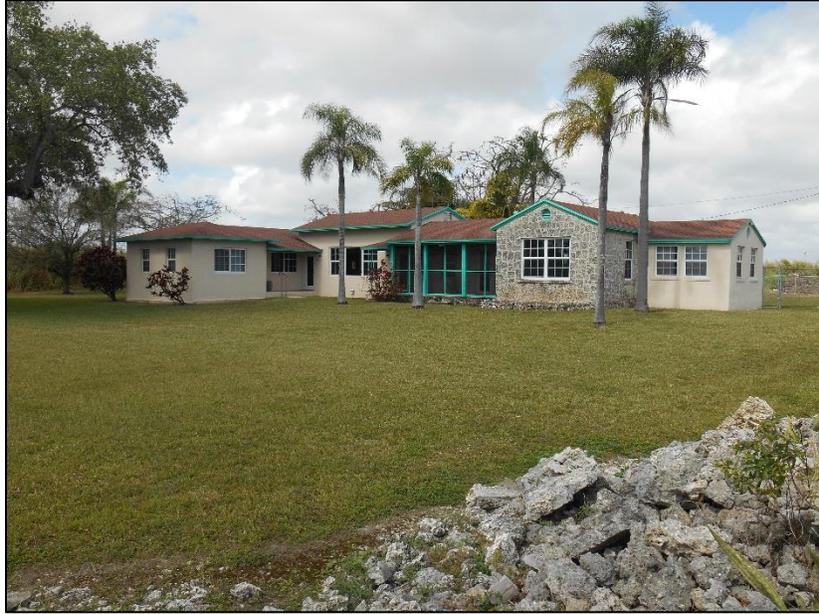
Figure 1: Southern elevation of the National Register–eligible MacDonell Residence (8DA20712), with a damaged segment of the parcel’s oolitic limestone wall in the foreground. Facing Northwest.

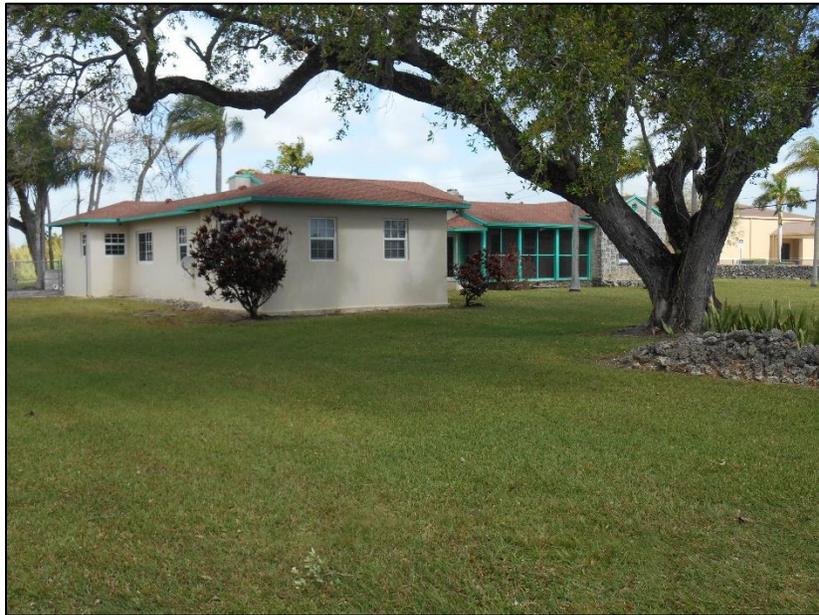
Figure 2: Western elevation of the National Register–eligible MacDonell Residence (8DA20712). Facing Northeast.

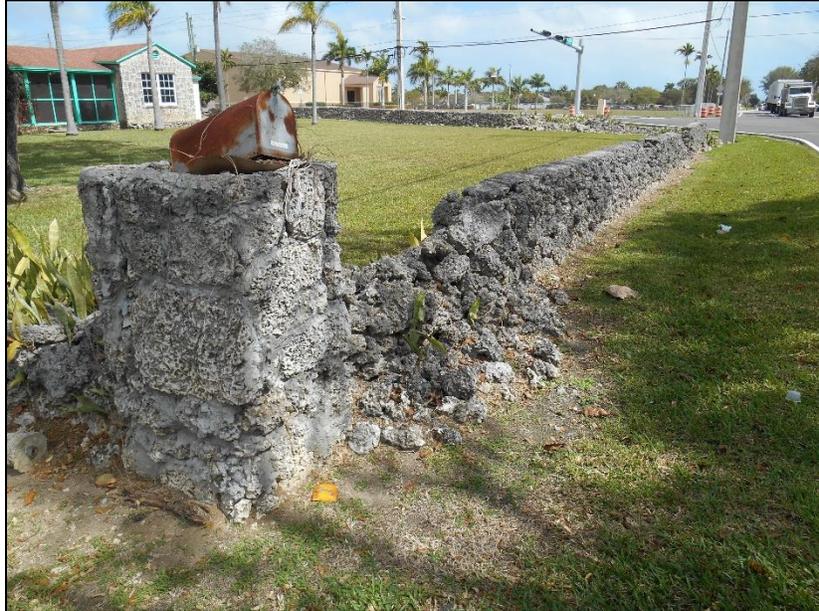
Figure 3: Damaged segment of oolitic limestone exterior wall, located at the southwestern corner of the National Register–eligible MacDonell Residence (8DA20712). Facing Northeast.

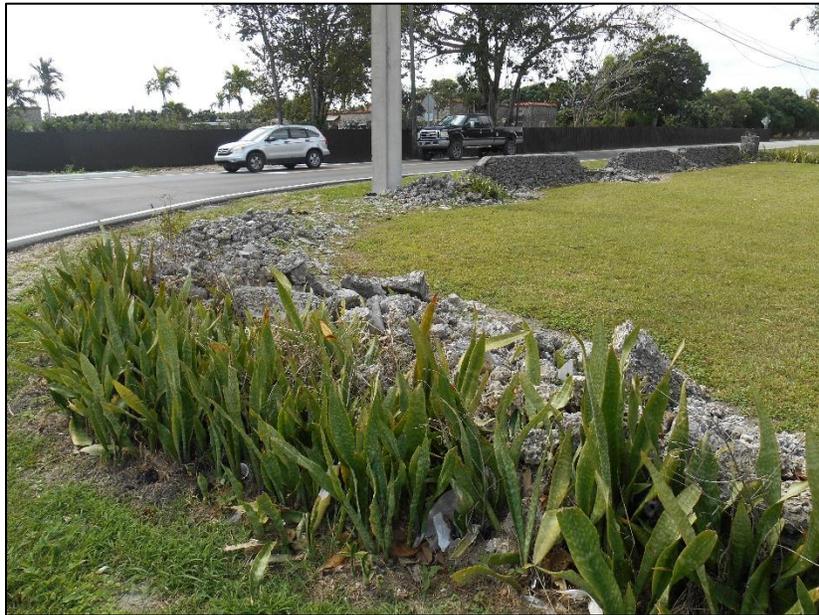
Figure 4: Damaged segment of oolitic limestone exterior wall, located at the southeastern corner of the National Register–eligible MacDonell Residence (8DA20712), at the intersection of SR 825/SW 137th Avenue/Lindgren Road and SW 200th Street/Quail Roost Drive. Facing Southwest.

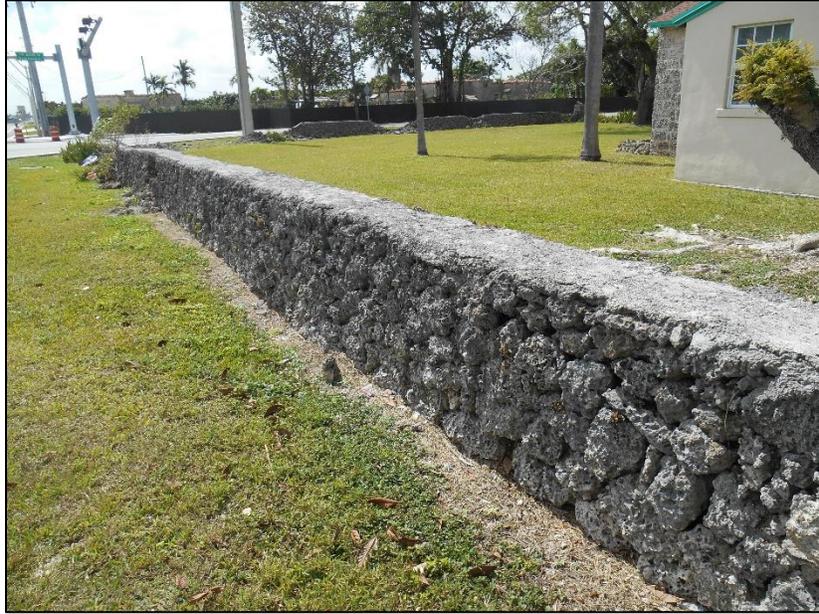
An oolitic limestone wall (Figures 3-5) extends along the southern and eastern ends of the property. From the street corner, the wall extends approximately 130 feet both north and west. The southeast corner of the wall, as well as a section along the southern wall, have been significantly damaged. The wall is punctuated by piers marking breaks along its southern and eastern sides.

Figure 5: Segment of oolitic limestone exterior wall, located along eastern edge of the National Register–eligible MacDonell Residence (8DA20712). Facing South.

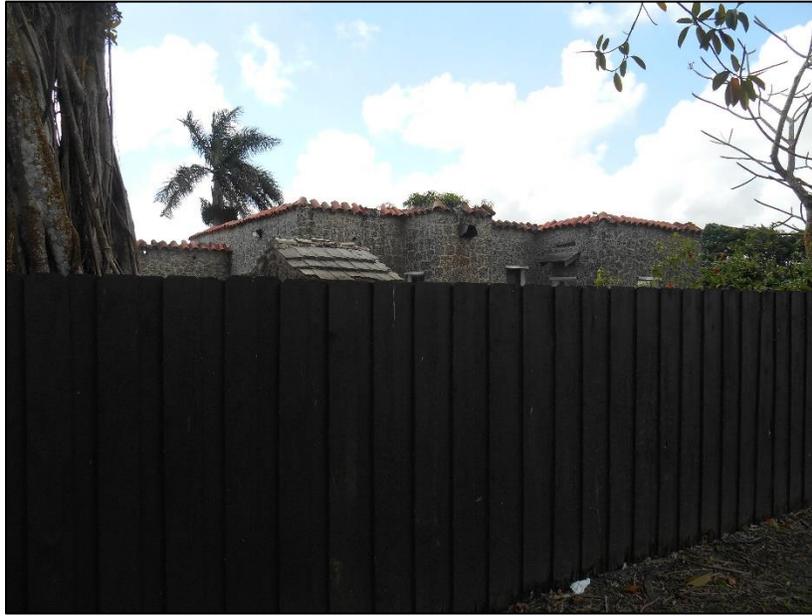
Figure 1: Northern elevation of the National Register–eligible building at 20000 SW 137th Avenue (8DA20713). The gabled topper of the parcel’s oolitic limestone wall is visible in the foreground, behind the privacy fence. Facing South.

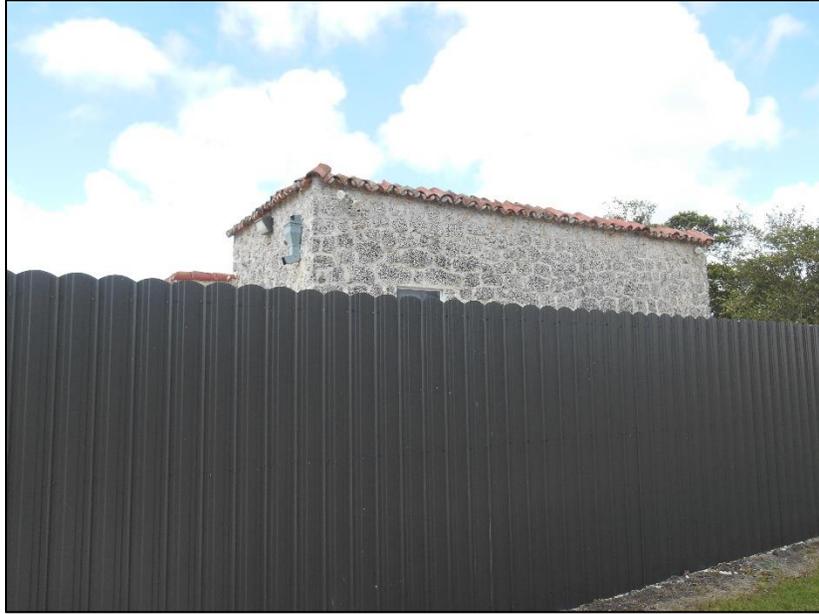
Figure 3: Eastern elevation of the southeastern outbuilding on the property containing the National Register–eligible building at 20000 SW 137th Avenue (8DA20713). Facing West.

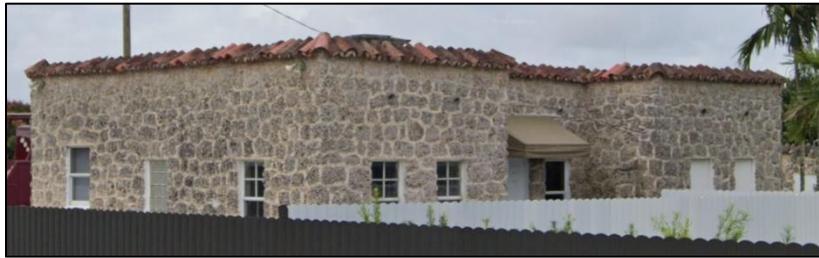
Figure 4: Northern elevation of the southeastern outbuilding on the property containing the National Register–eligible building at 20000 SW 137th Avenue (8DA20713). March 2021 Google Streetview photograph. Facing Southwest.

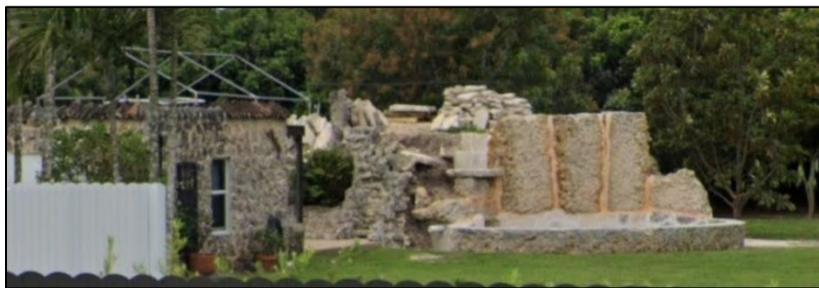
Figure 5: Southwestern outbuilding on the property containing the National Register–eligible building at 20000 SW 137th Avenue (8DA20713). This outbuilding is in a ruinous state. March 2021 Google Streetview photograph. Facing Southwest.

The outbuilding at the southwest corner of the property was not visible from the public right-of-way due to the privacy fence, but a March 2021 Google Streetview photograph (Figure 5) shows the outbuilding to be in a ruinous state, though clearly made of the same oolitic limestone as the other elements of the parcel.

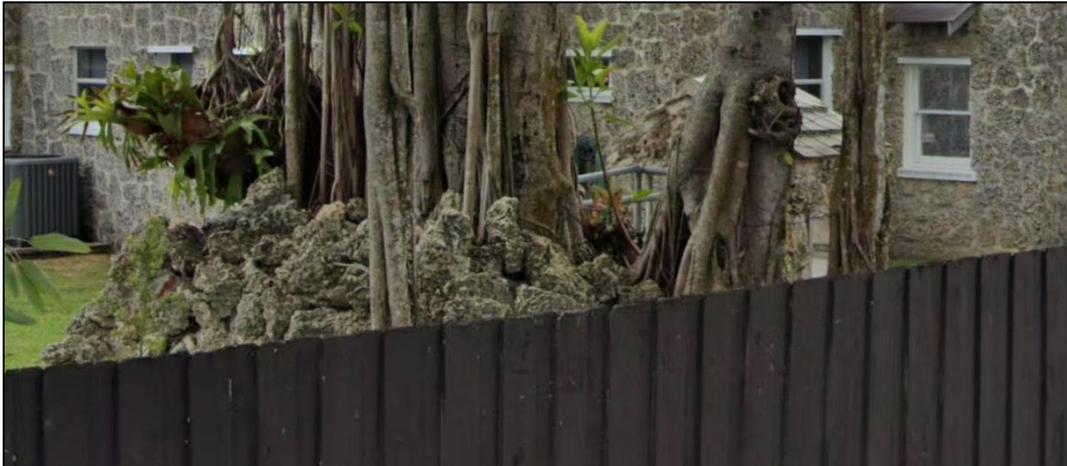
Figure 6: Surviving material from historic oolitic rock perimeter walls on the property containing the National Register–eligible building at 20000 SW 137th Avenue (8DA20713). The walls are located north of the main house on the property, near the parcel boundary. April 2022 Google Streetview photograph. Facing South.

At the northern end of the parcel, north of the main house, remains two small segments of oolitic rock wall (Figure 6), which would have marked the boundaries of the property during the historic period. These wall segments were not visible from the public right-of-
