Atlantic Isles Lagoon Bridge (Bridge No. 874218) Project Development and Environment (PD&E) Study

From Atlantic Isles West of SR A1A to Atlantic Avenue

Miami-Dade County, Florida

City of Sunny Isles Beach
Historic Preservation Board
Consultation Meeting

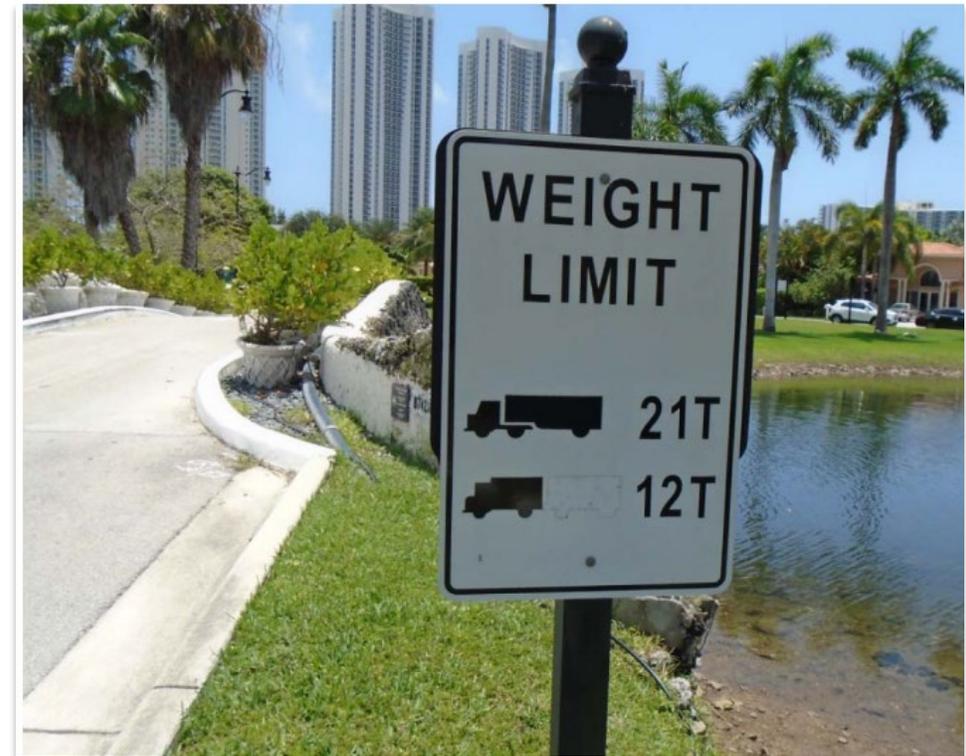
Project Background

- Bridge constructed in 1925
- Low-level bridge with cast-in-place reinforced concrete arch
- 1999 – load rating analysis performed
- Bridge inspected annually

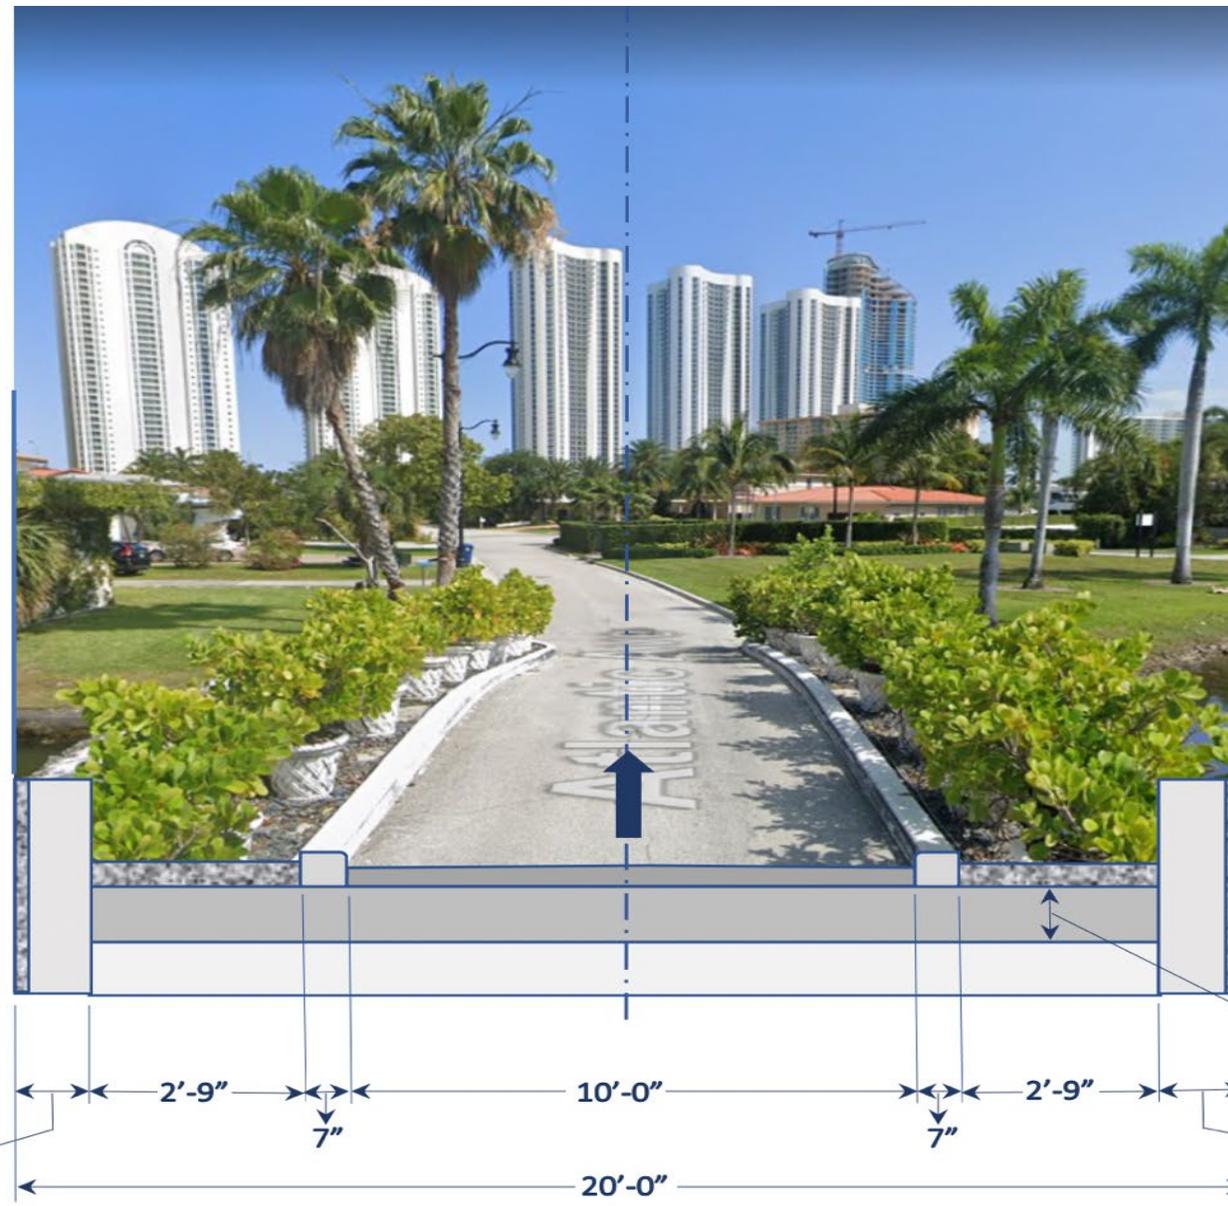
Existing Typical Section for Bridge No. 874218

1'-8" Barrier Wall with Oolitic Limestone Surfacing

Limerock Fill Varies From 8.5"-1'-1"

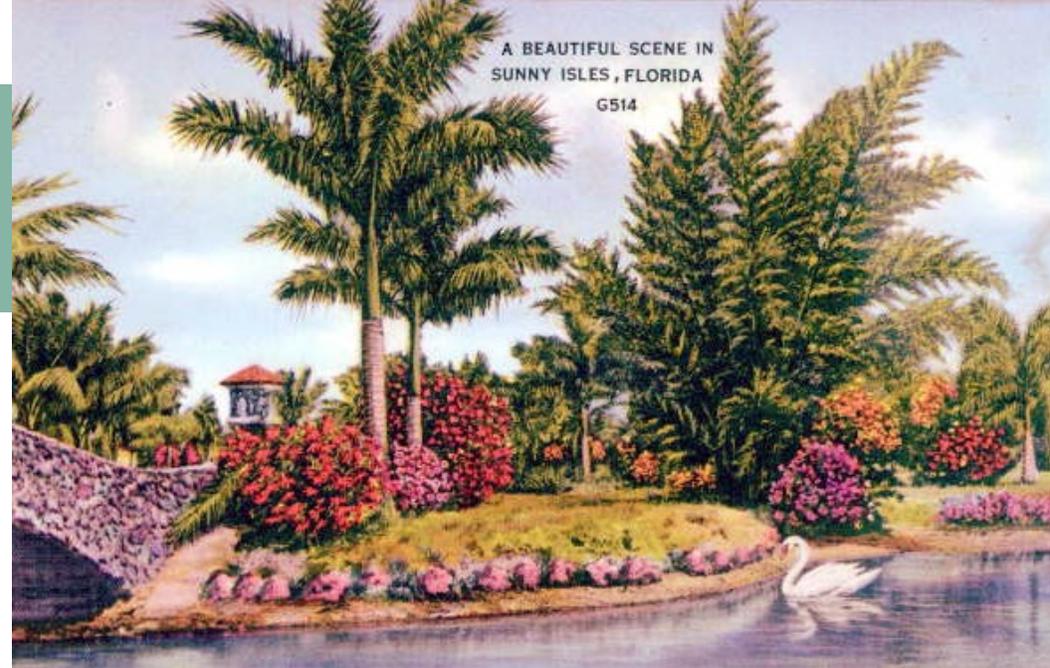
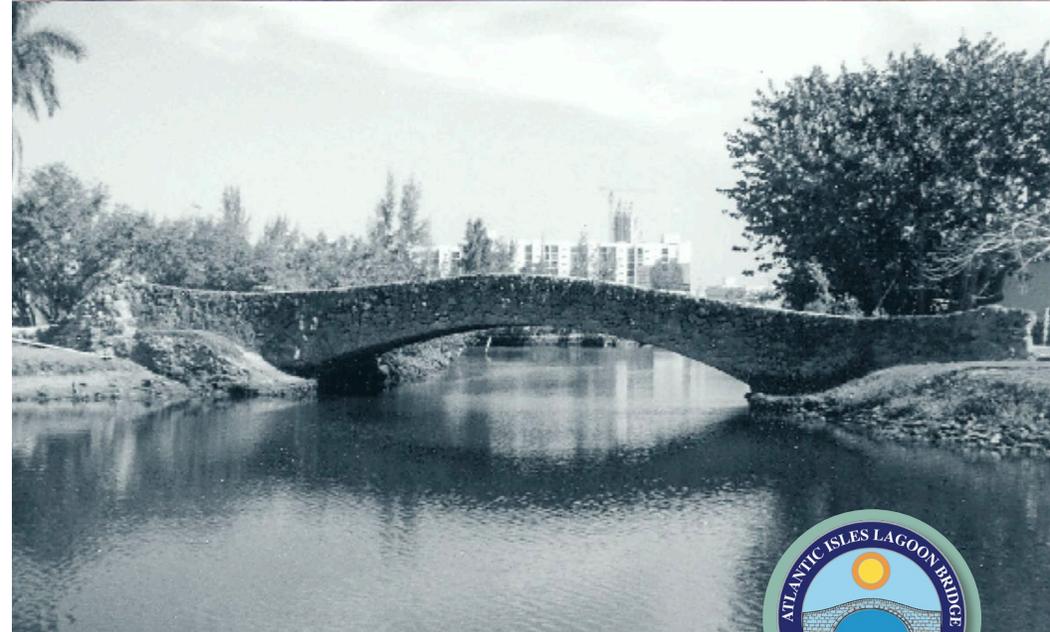
Atlantic Isle Historic Importance

- Atlantic Isle island was constructed during the Florida Boom Period (1917–1929) and the original design included these resources:
 - Atlantic Island Bridge
 - Lake of the Isles (Lagoon)
 - Atlantic Island Park
- Atlantic Island Bridge Historic Elements
 - Only remaining historic bridge of the three originally constructed on the island in 1925
 - Bridge’s oolitic limestone quarried in Miami-Dade County (unique application for a bridge)
 - Irregular whitewashed stucco on the interior of the bridge
 - Early example of an arch deck bridge

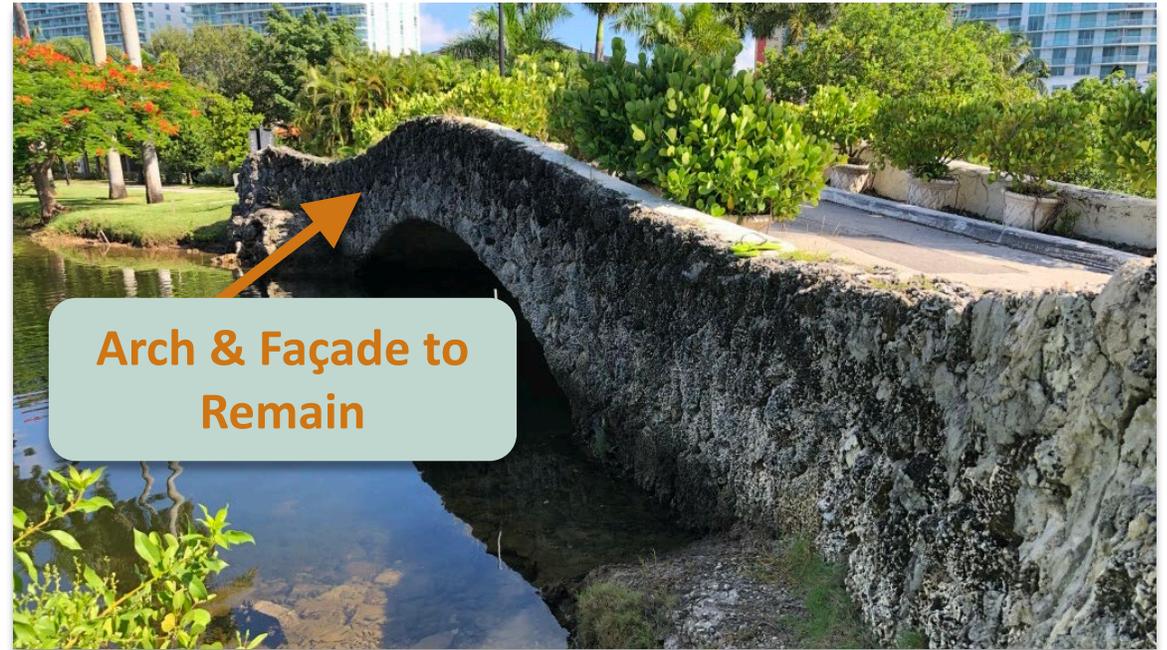
Build Alternative 1 - Rehabilitation

Advantages:

- Provides new bridge riding surface and structural arch
- Provides new bridge foundations
- Maintains existing bridge façade (oolitic limestone)
- Maintains existing arch
- Load restrictions removed
- New bridge components life = 75 years

Disadvantages:

- Does not rehabilitate façade
- Significant construction risks
 - Bridge façade could crumble
 - Potential for bridge settlement
- Remaining historic bridge elements life ~ 15 to 25 years
- Frequent future maintenance of bridge façade
- High construction costs compared to replacement

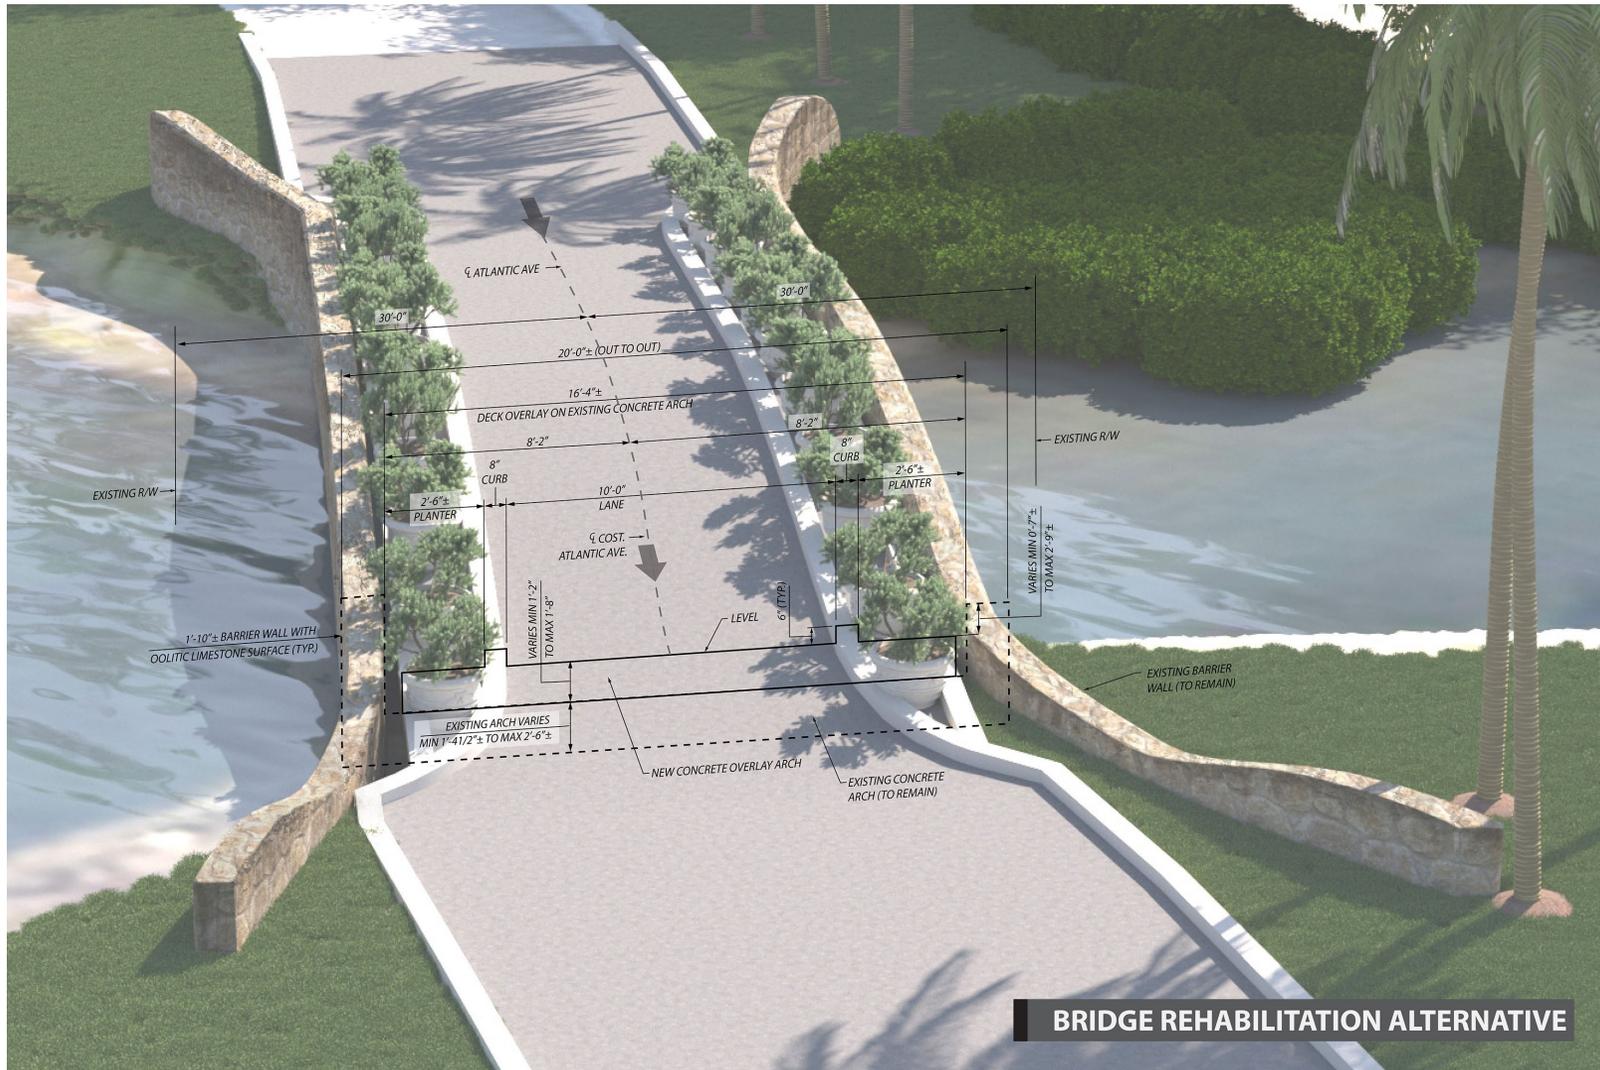
Typical Section

Build Alternative 1 – Rehabilitation

BRIDGE REHABILITATION ALTERNATIVE

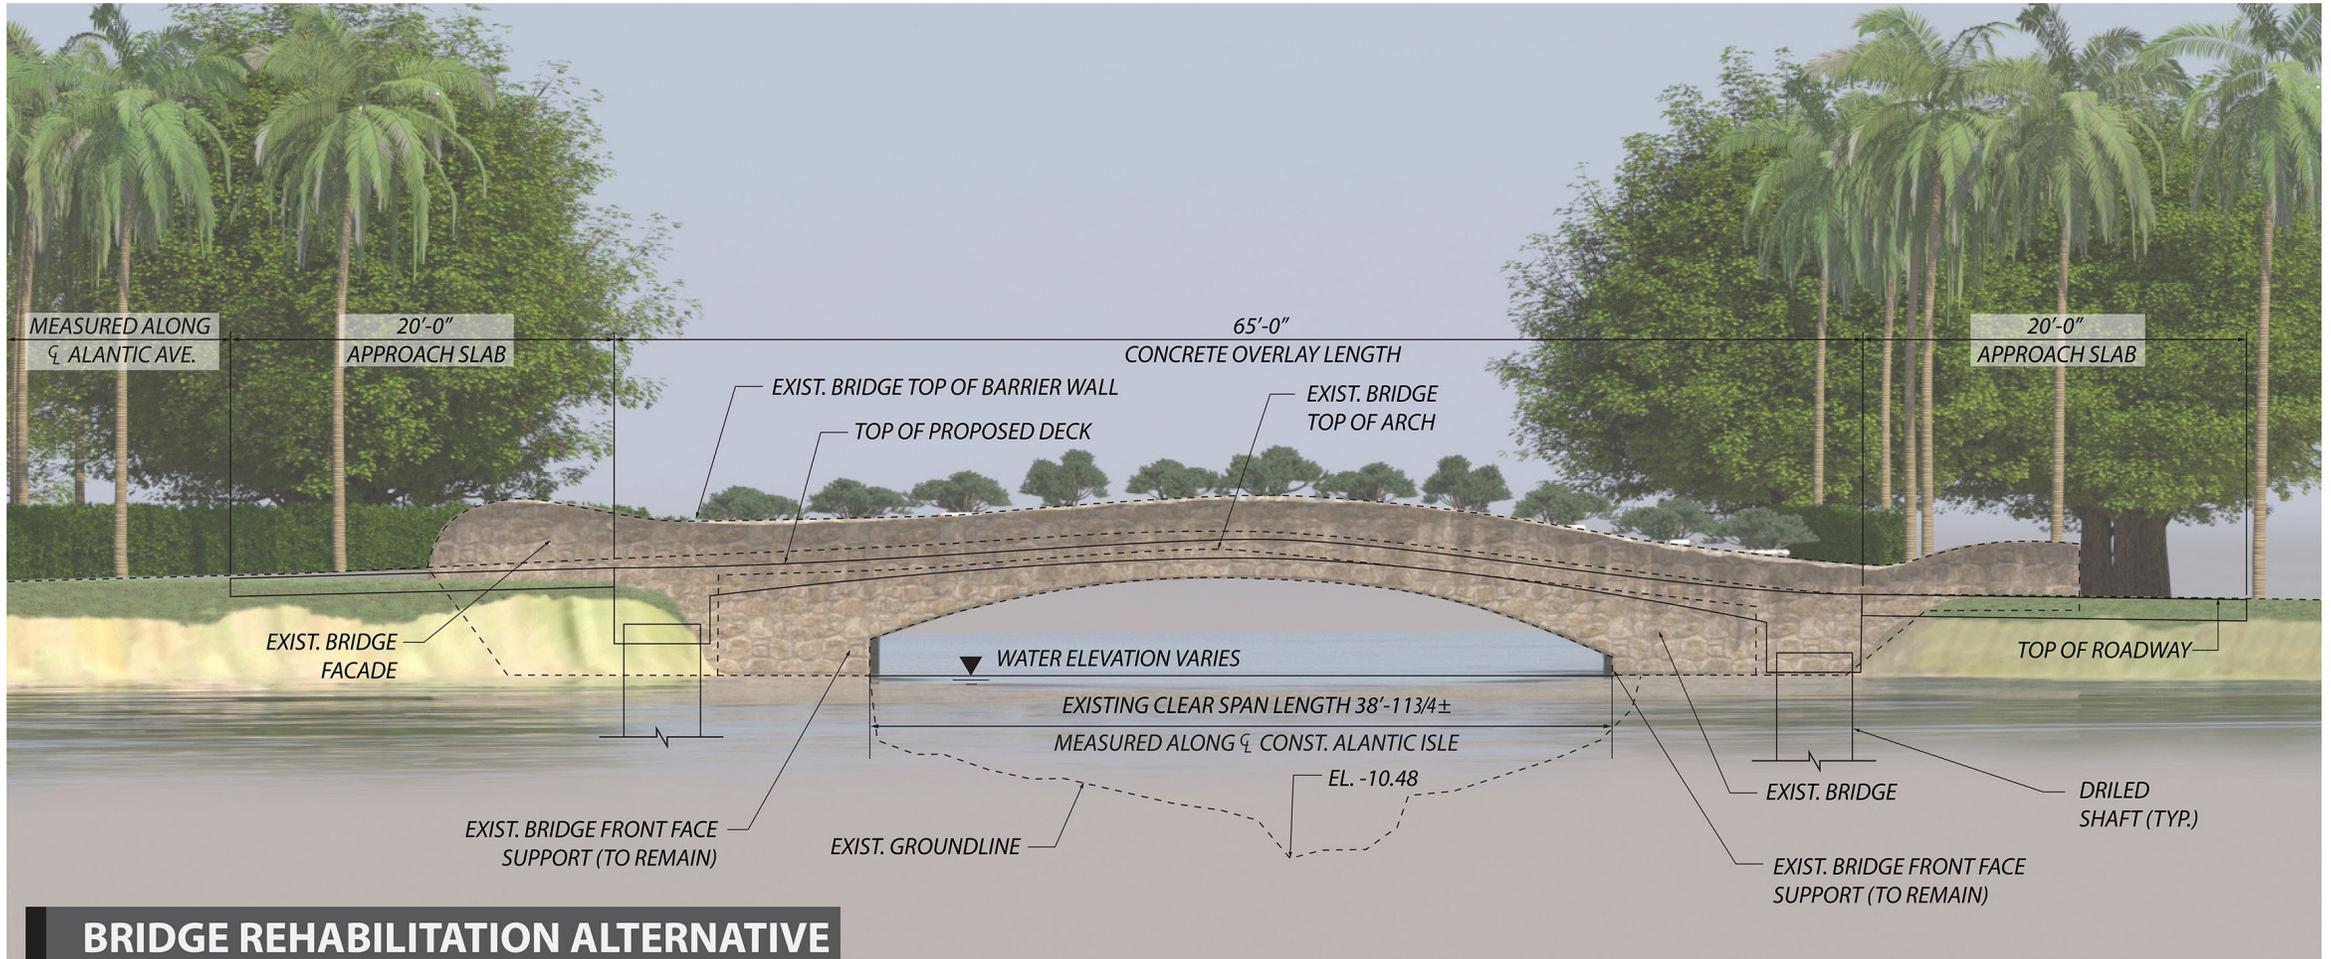
Elevation View

Build Alternative 1 – Rehabilitation

BRIDGE REHABILITATION ALTERNATIVE

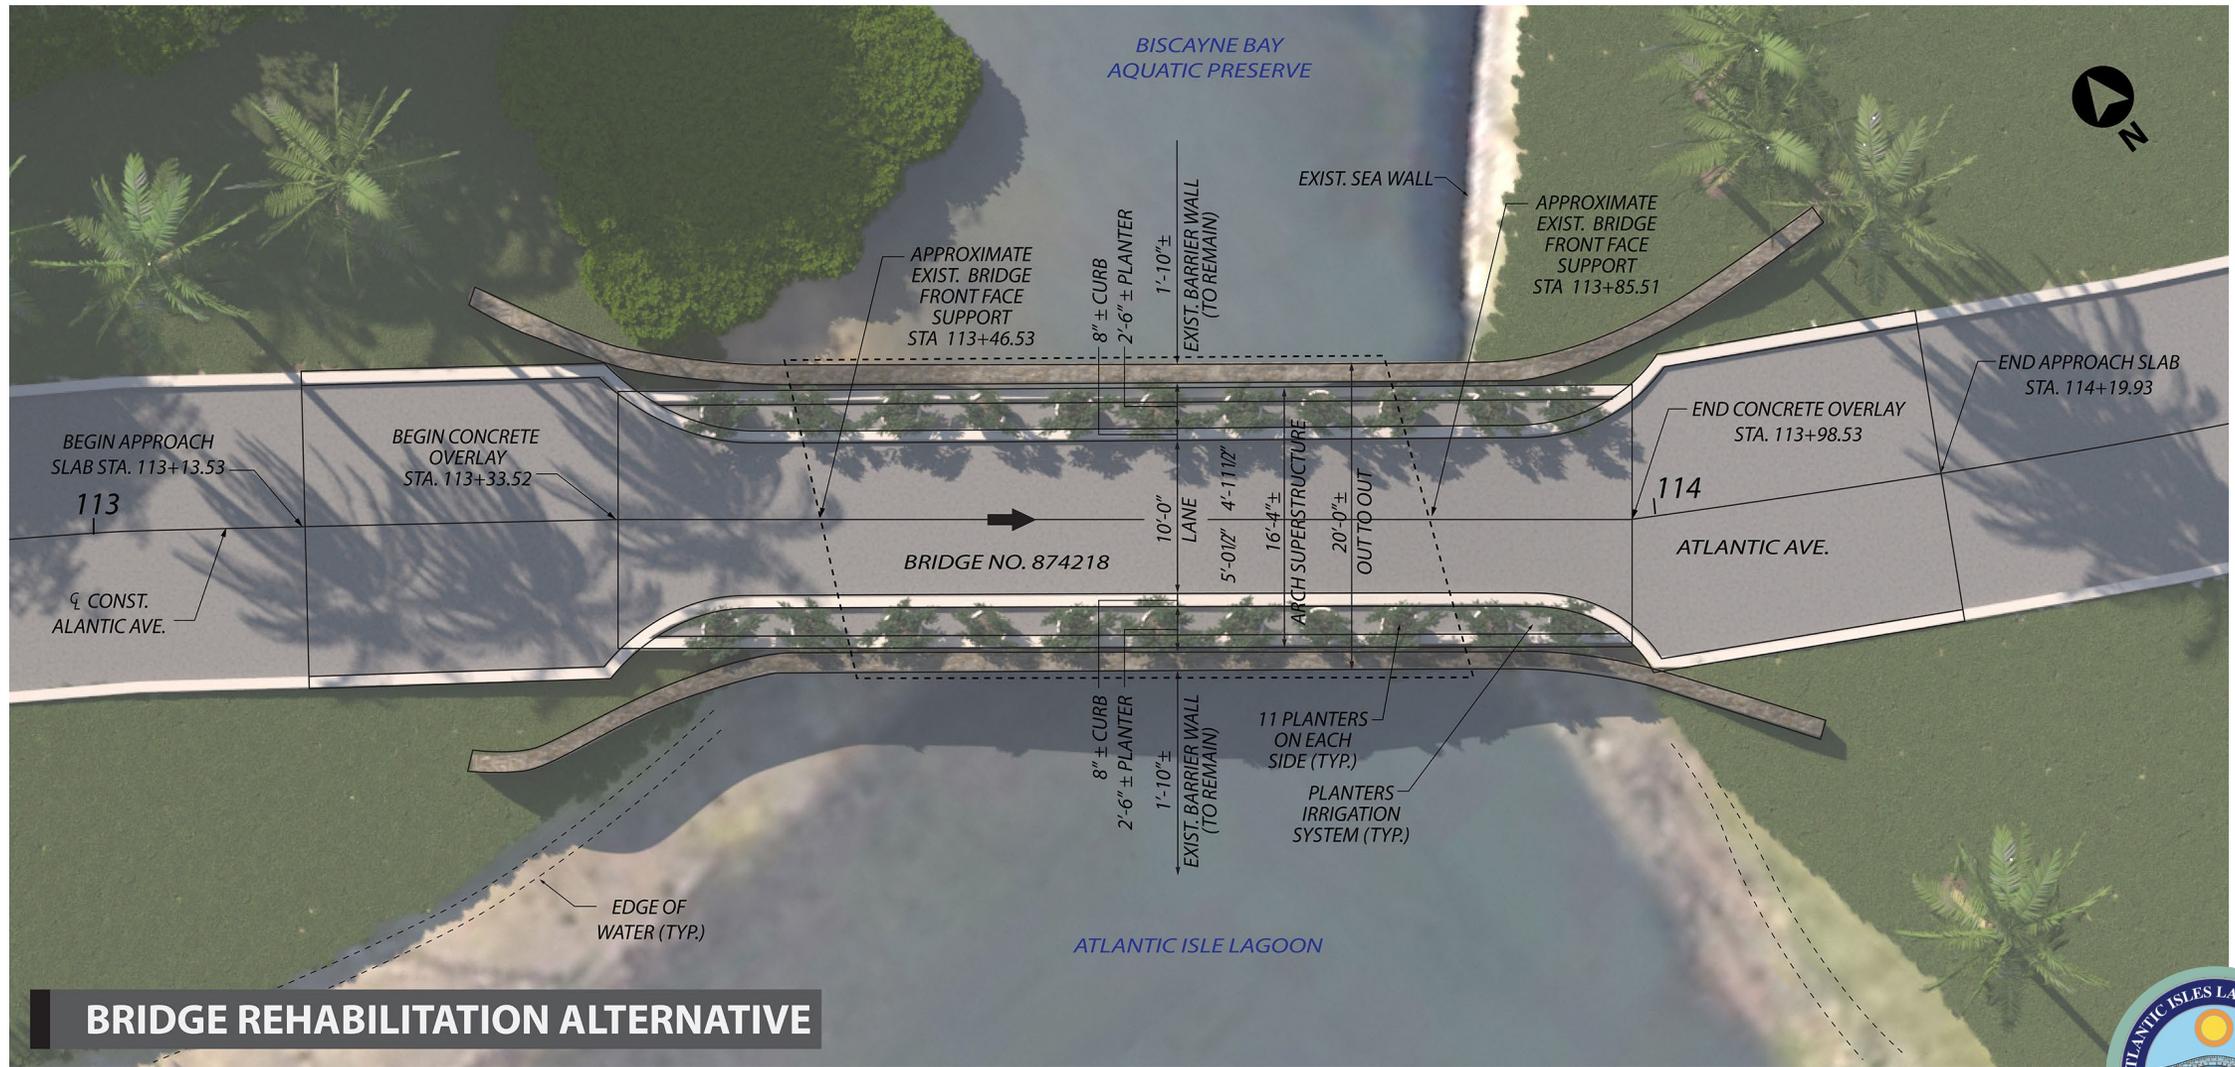
Plan View

Build Alternative 1 – Rehabilitation

BRIDGE REHABILITATION ALTERNATIVE

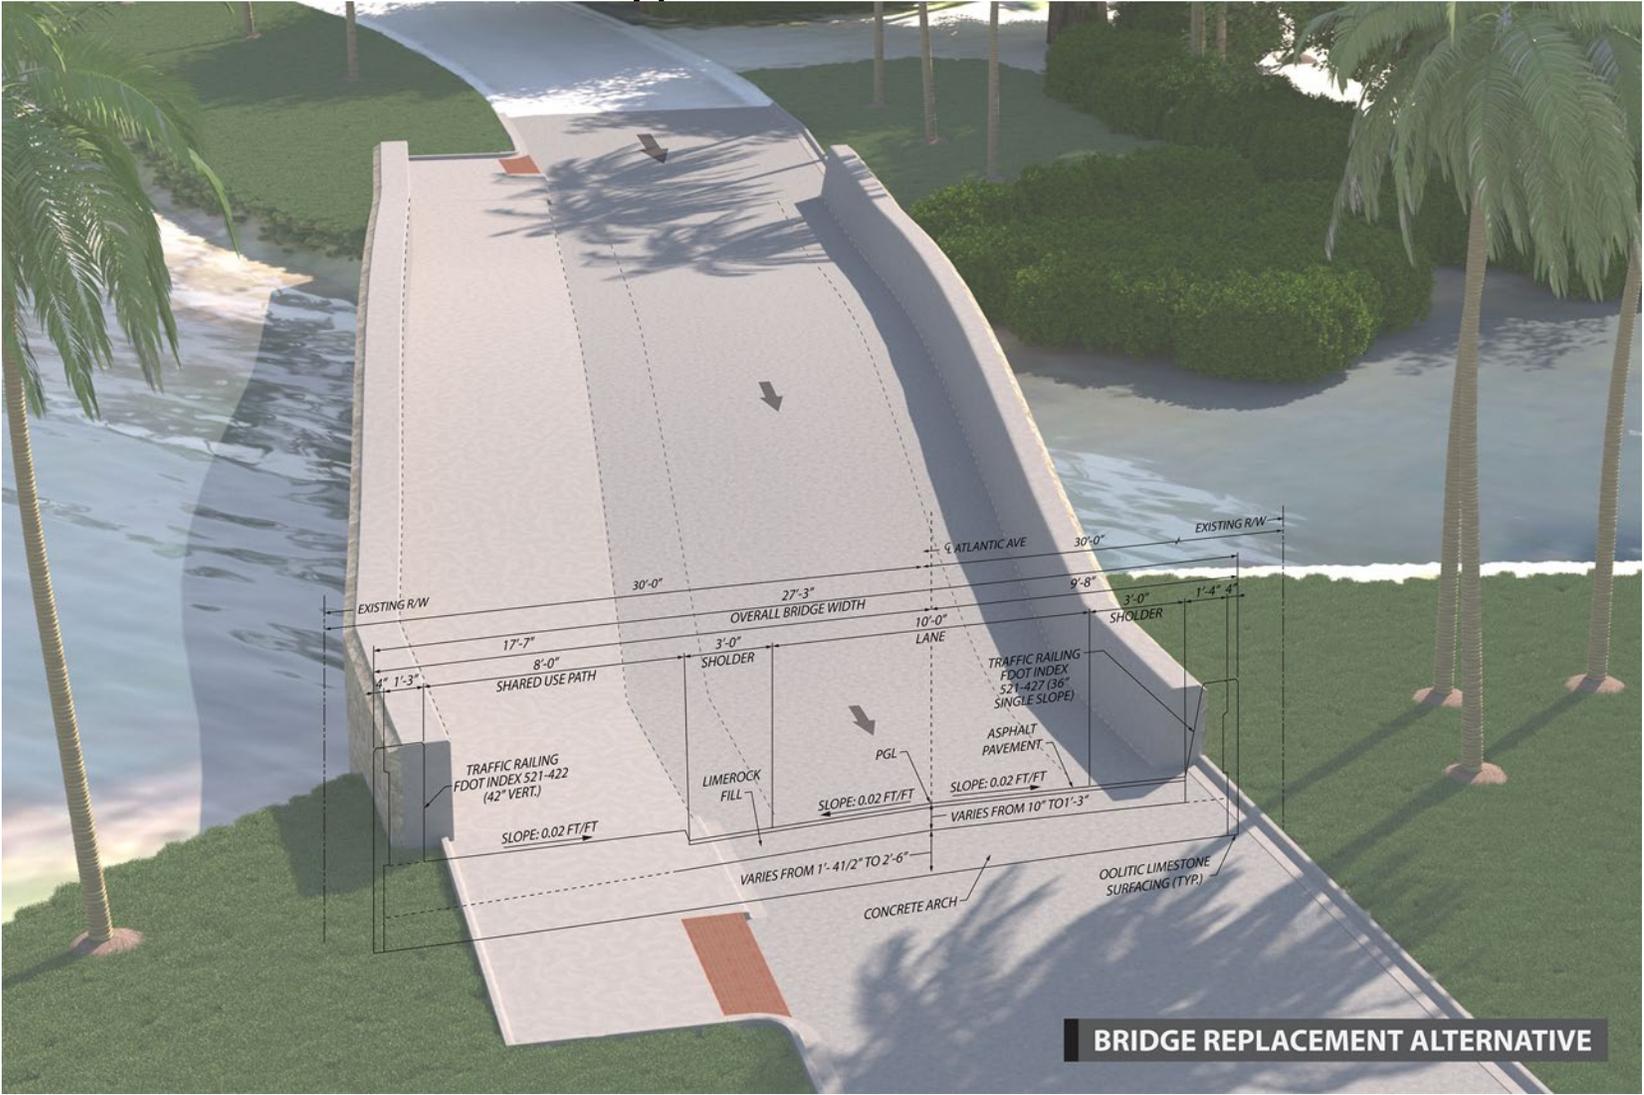
Typical Section

Build Alternative 2 – Replacement

Build Alternative 2 - Replacement

Advantages:

- Meets current Florida Greenbook criteria
- Improves bridge operations and safety
- Adds 8-ft-wide shared use path
- Design could mimic historical character of existing bridge if desired
- Lower construction & maintenance costs (compared to Rehabilitation Alternative)
- Oolitic limestone could be reused (or locally sourced)
- Bridge life = 75 years
- Load restrictions removed

Disadvantages:

- Historic bridge is gone
- May have slightly different profile than existing bridge

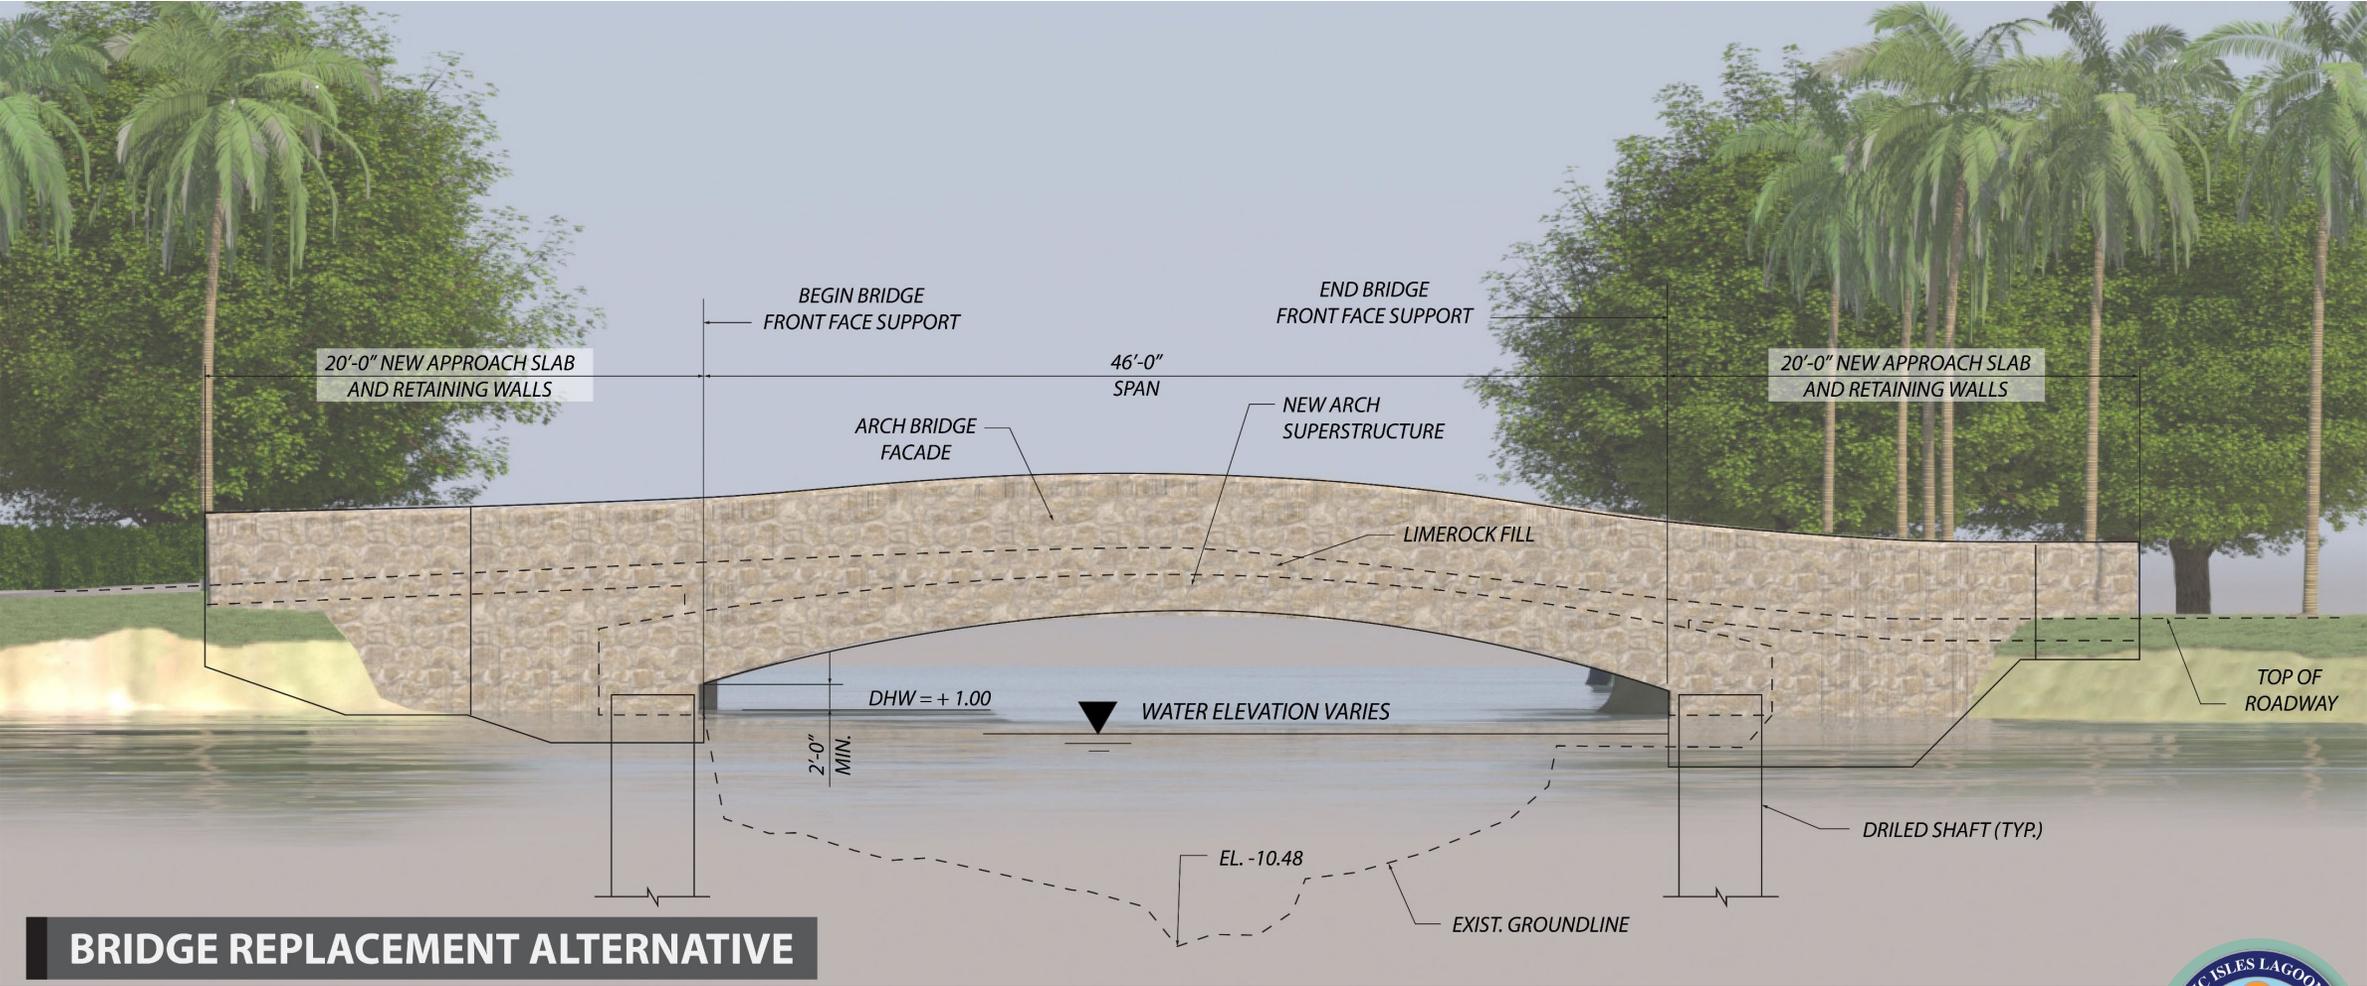
Elevation View

Build Alternative 2 – Replacement

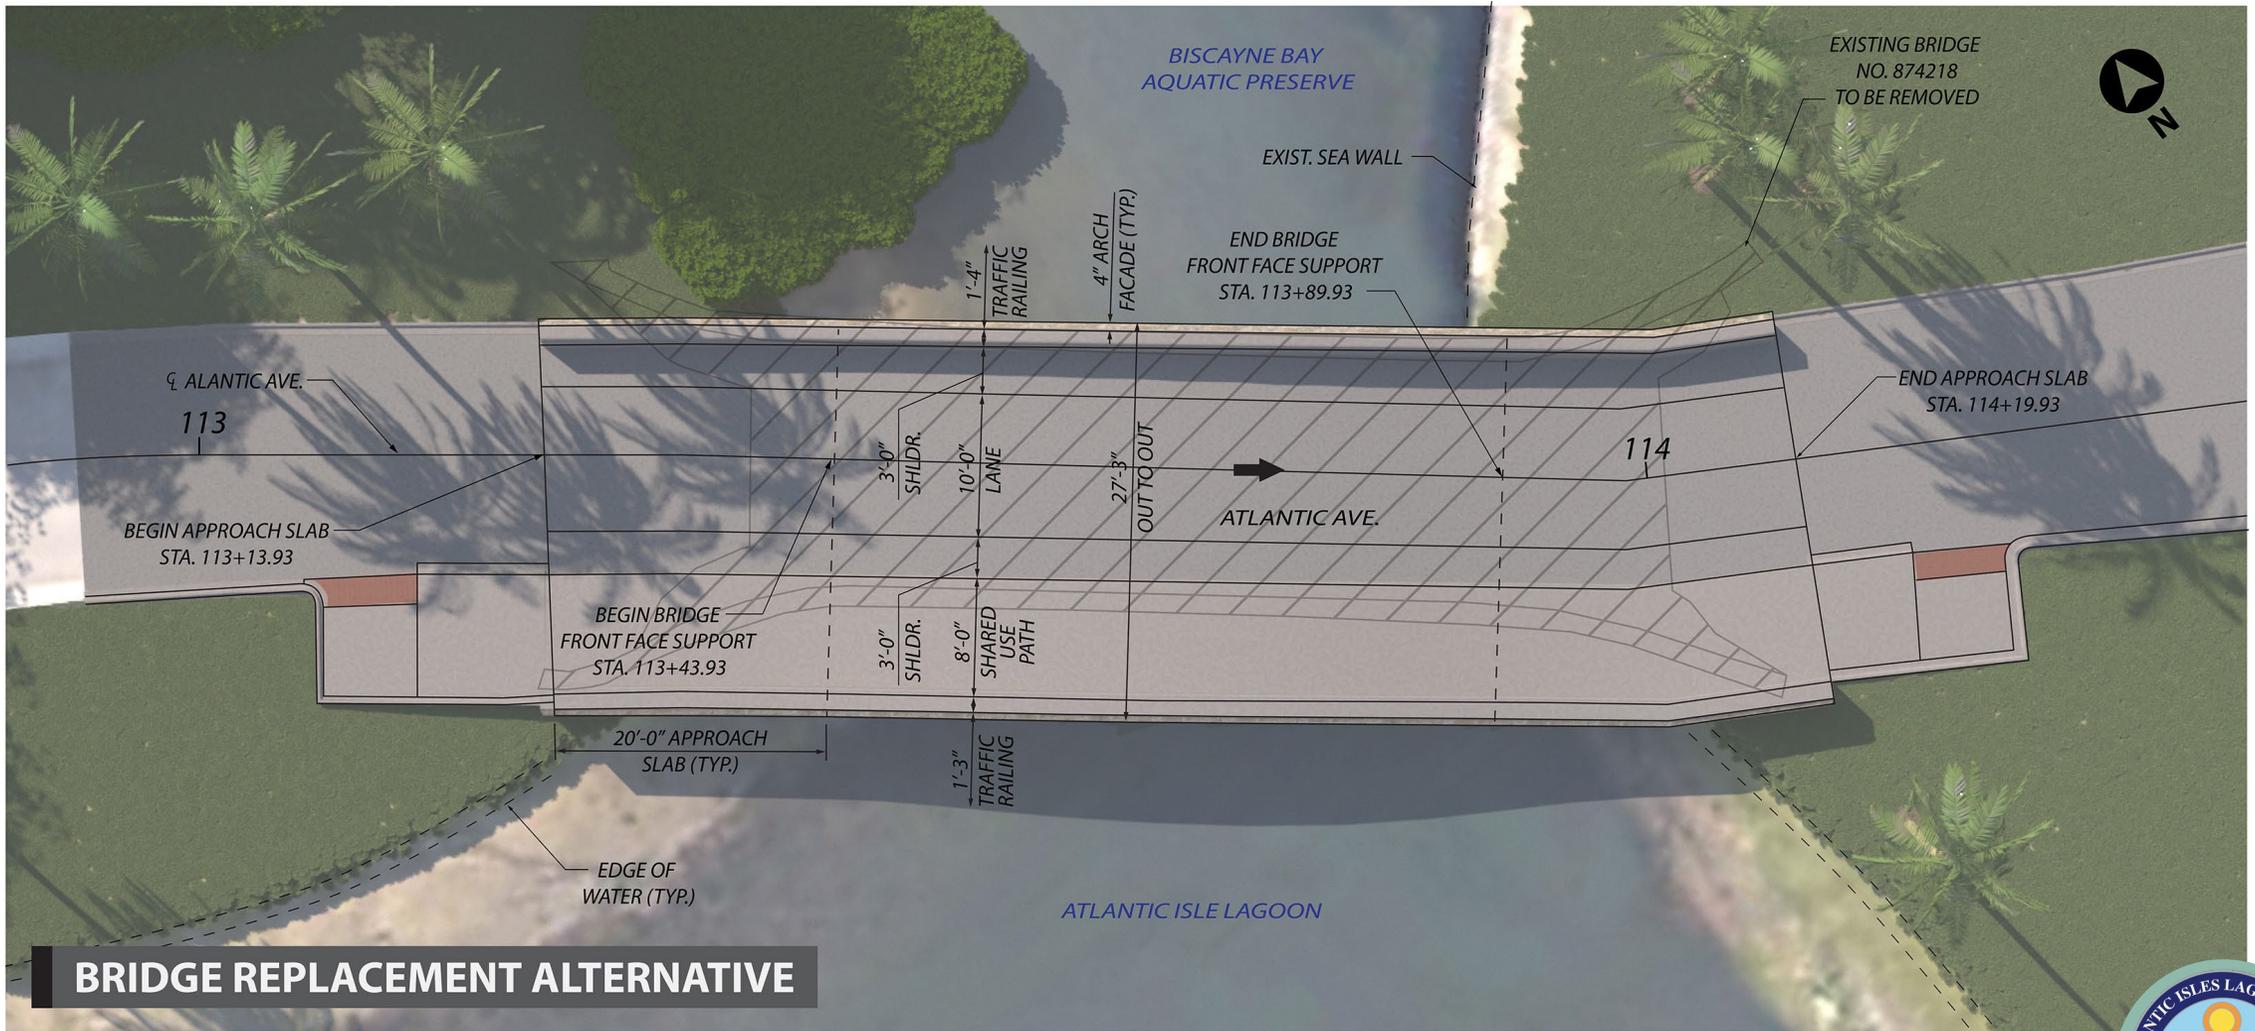
Build Alternative 2 – Replacement Plan View

BRIDGE REPLACEMENT ALTERNATIVE

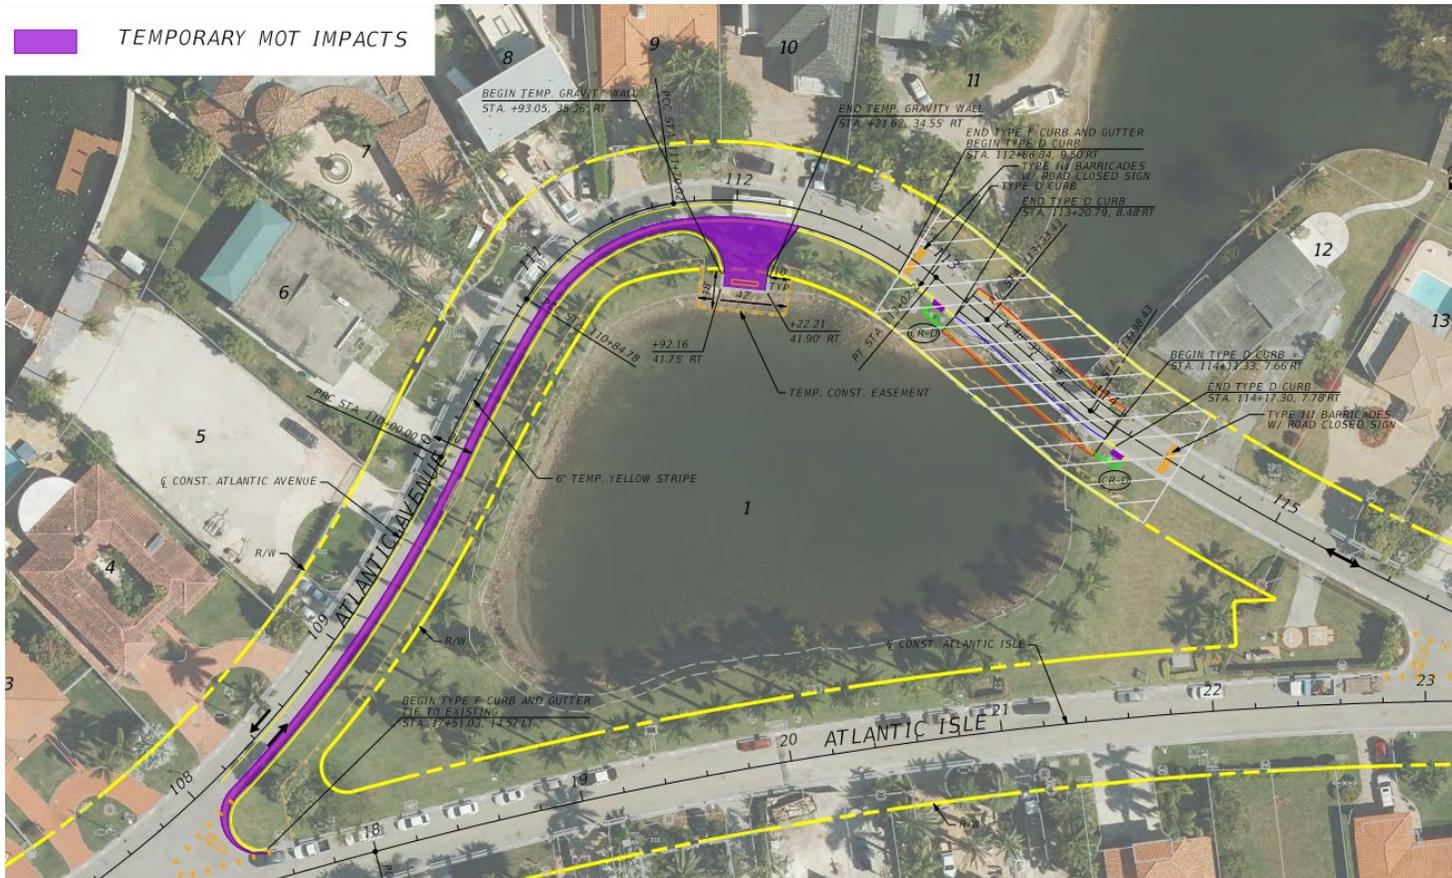
Temporary Maintenance of Traffic Considerations

- MOT impacts are the same for both Build Alternatives
- Temporary impacts include:
 - Right-of-Way impacts
 - Atlantic Island Park impacts
