Natural Resources Evaluation

Florida Department of Transportation

VENETIAN CAUSEWAY

Limits of Project: FROM NORTH BAYSHORE DRIVE TO PURDY AVENUE

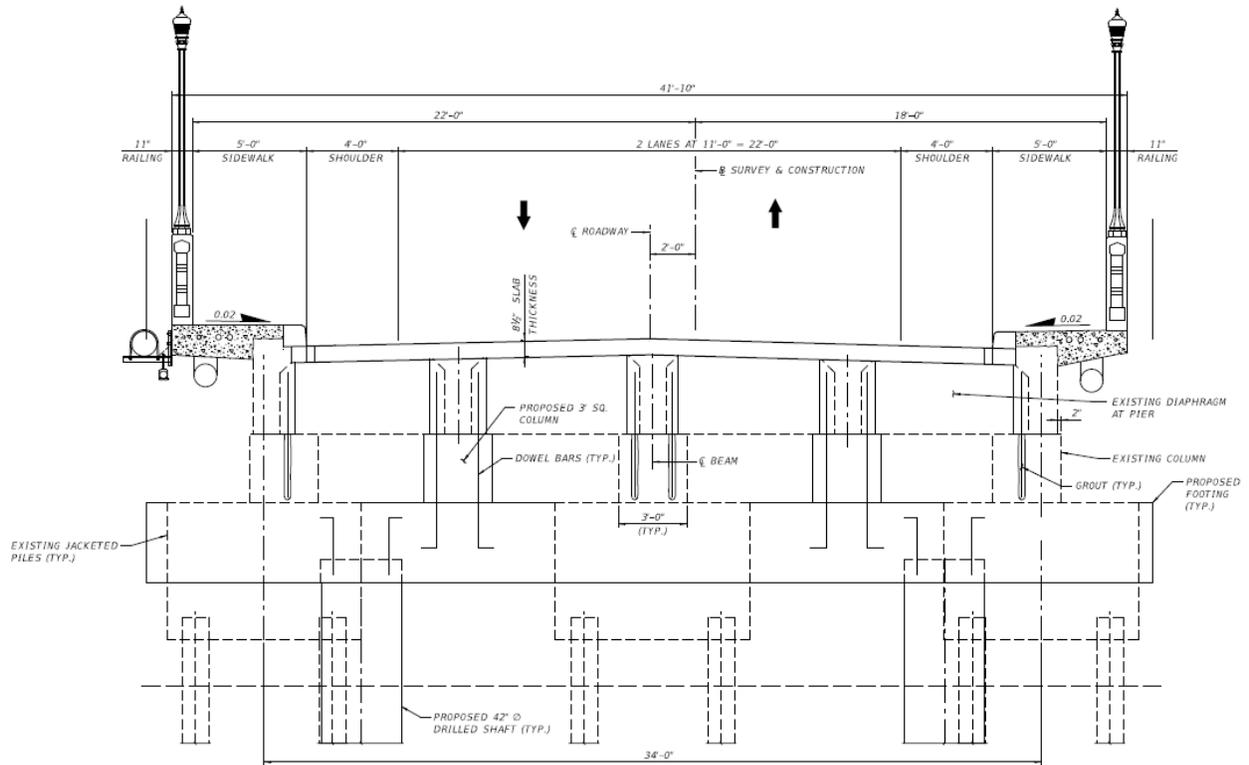
Figure 1-2 Rehabilitation Alternative 4: Beam and Foundation Strengthening Concept

- Strengthened beams, cast-in-place deck and strengthened foundation would provide adequate resistance to meet current FDOT/American Association of State Highway Transportation Officials (AASHTO) live load requirements.
- Strengthened foundation to meet the standards for scour resistance, wave force resistance (classified as Extremely Critical) and vessel impact resistance (classified as Critical). Refer to the Bridge Hydraulics/ Design Scour Report dated May 27, 2016.
- Cathodic protection impressed current system for the beams and diaphragms. Refer to Conceptual Cathodic Protection Design for Bridge Superstructure and Substructure Components dated June 15, 2015.
- Bridges would be closed one at a time during construction, and detours would be provided.
- Utility services would be maintained on the bridge during its construction time.

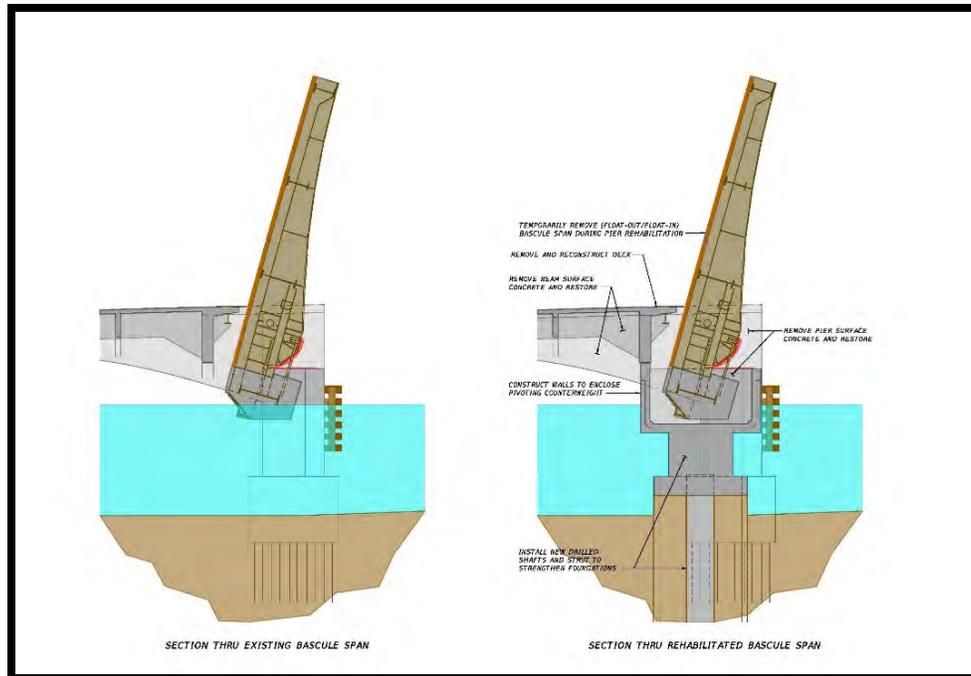
Figure 1-4 Bridge 10 Bascule Leaf Rehabilitation Concept

- Recondition Drive Train (Improve Reliability/Reduce Maintenance):
 - Replace Steel Coating System
 - Use Metalized Primer for Enhanced Corrosion Resistance
 - Recondition Gear Boxes
 - Replace Gaskets, Breathers, and Sight Glasses
 - Recondition Bearings
 - Clean and Polish Surfaces
 - Replace Lubrication Ports, Flush and Clean

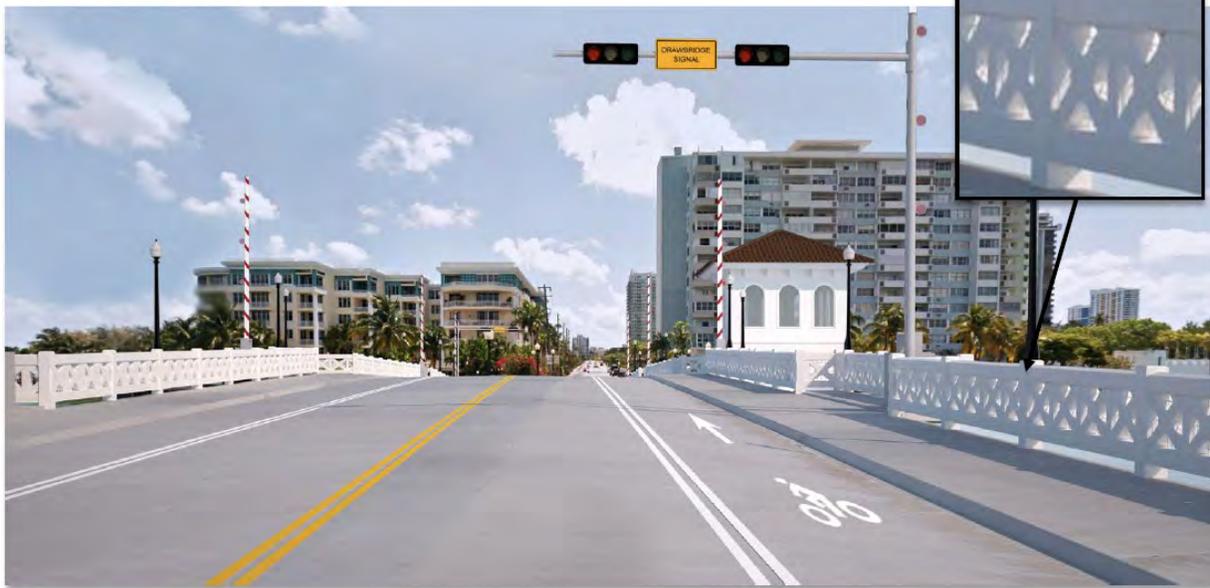
Figure 1-5 Replacement Alternative T1: Typical Section

T1 – Venetian Railing

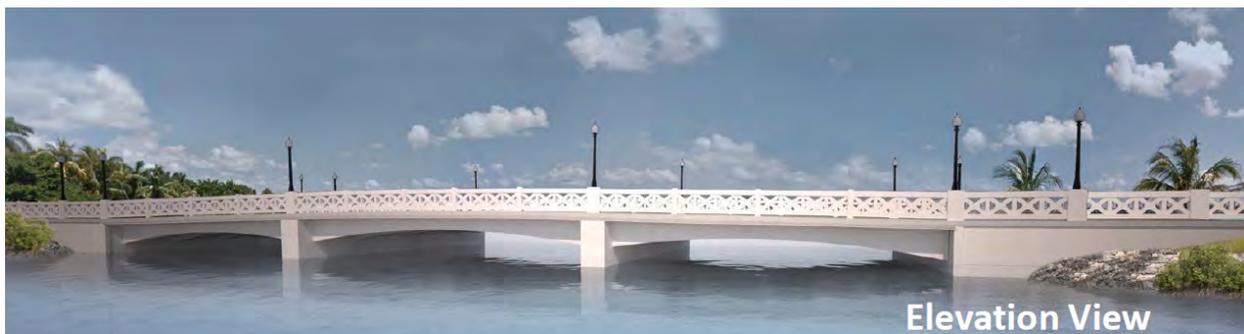
Figure 1-6 Replacement Alternative 7: Arched Beam Elevation View

The Arched Beam superstructure replacement alternative supports the required AASHTO HL-93 load. The HL-93 truck consists of a “design truck plus design lane load” or “design tandem plus design lane load”, whichever is the worst case. The design truck is a 3-axle HS20 truck with weight limit of 36 tons, the design tandem is a military truck with twin axles of 12.5 tons each, and the design lane load consist of a 9.3KN/m uniformly distributed in the longitudinal direction. The structural system mimics the dimensions and appearance of the original structure. The superstructure consists of variable depth arched beams. The variable depth beams are approximately 2 feet deep at midspan and 4 feet deep at beam ends (See Figure 1-6).

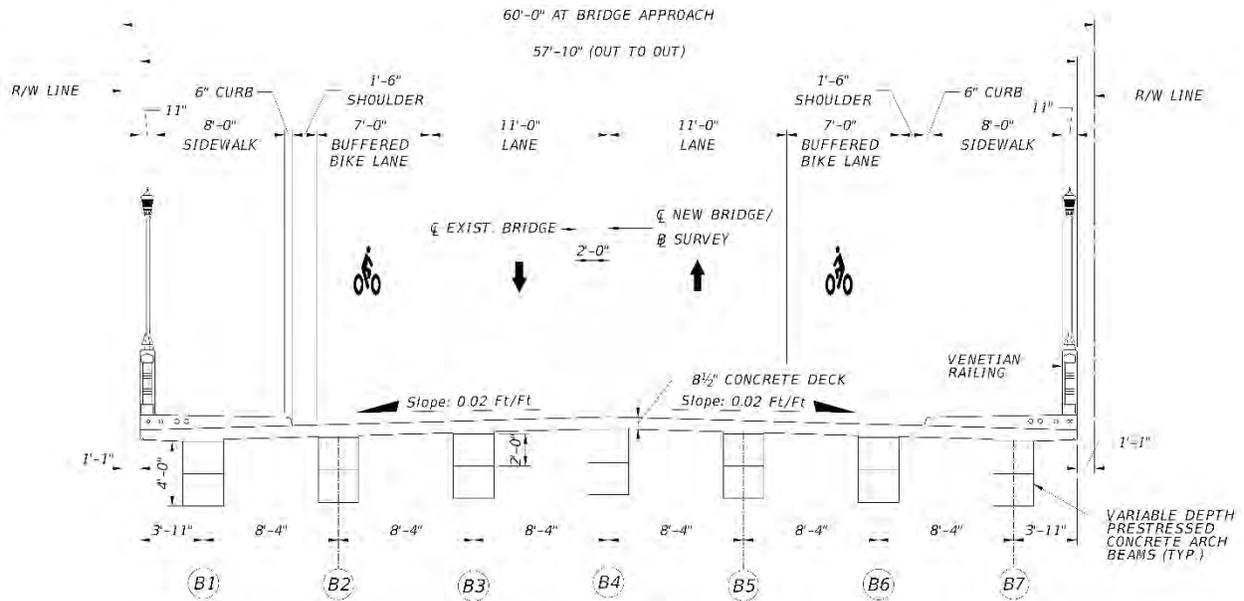
Figure 1-7 Replacement Alternative 7: Arched Beam Typical Section

The proposed approach span bridge section would be increased 16 feet from the existing 41-foot 10-inch wide section. The 57-foot 10-inch-wide bridge section includes two 8-foot sidewalks, two 1-foot 6-inch shoulders, two 7-foot. buffered bicycle lanes and two 11-foot travel lanes (See Figure 1-7).

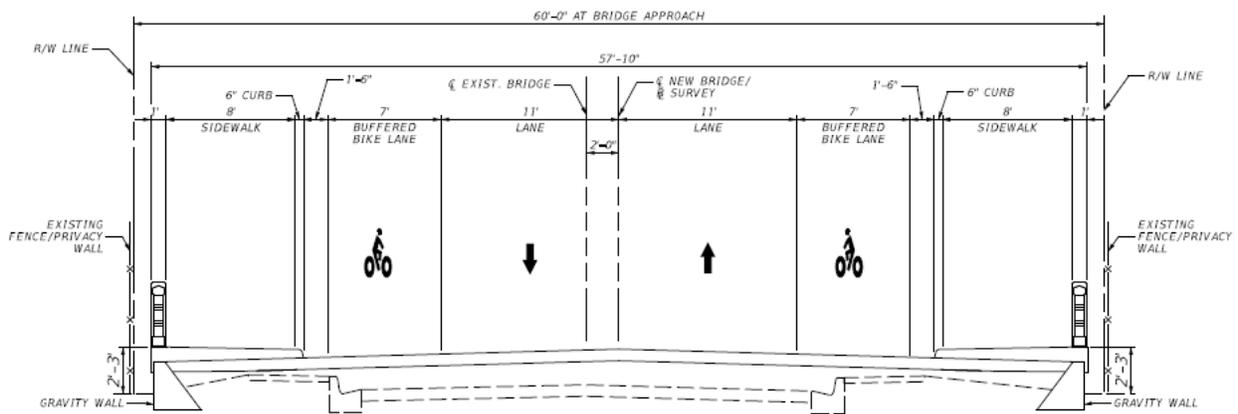
Figure 1-8 Replacement Alternative 7: Raised Bridge Profile

Bridge height affects the extent of potential impacts to right-of-way and connecting streets. The vertical alignment of the new fixed bridges would be raised a minimum of 1 foot above the existing clearance to Biscayne Bay. The raised bridge profile will require modifications to the roadway approaches. (See Figure 1-8)

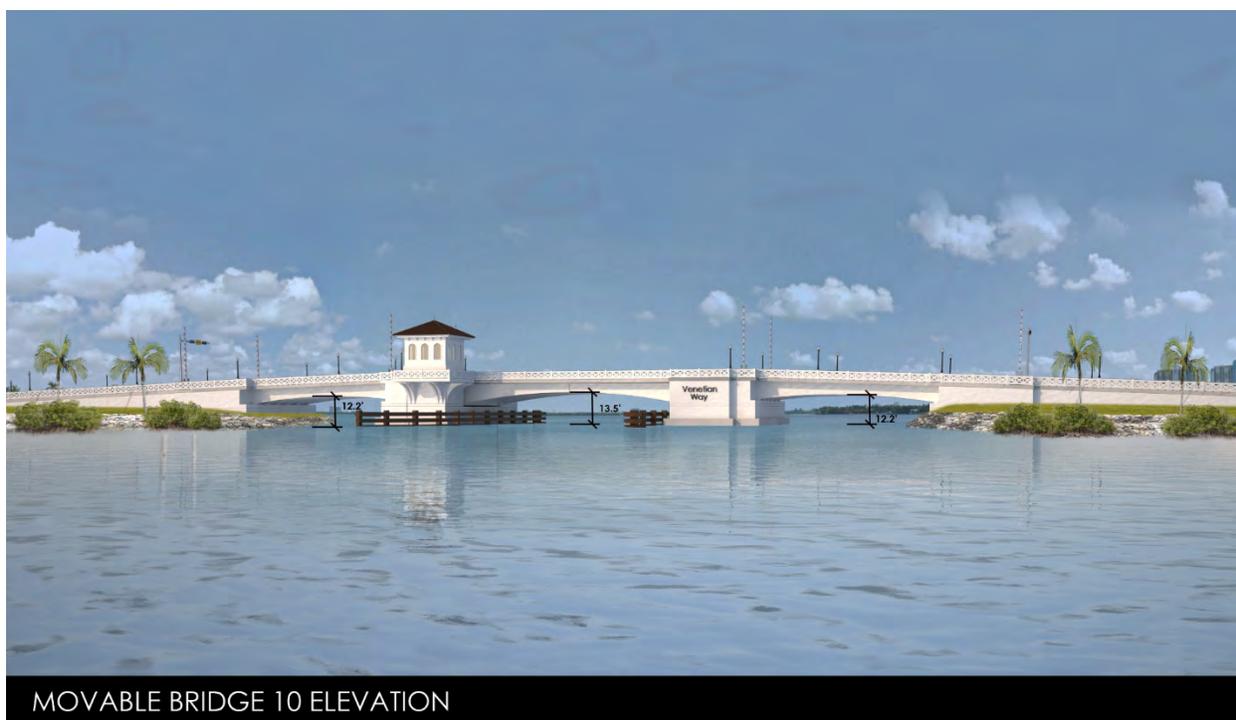
Figure 1-9 Replacement Alternative M4: Double Leaf Bascule Bridge

A 75-foot horizontal clearance between fenders is proposed for the movable span replacement option. This provides improved safety at the Venetian Causeway site and is consistent with bridges located to the north and south of the causeway. In order to span the proposed 75-foot wide navigation channel, the bascule span will require a minimum overall structure depth (controlled by the depth of the main girders) of approximately 10 feet at the face of the fenders (See Figure 1-9).

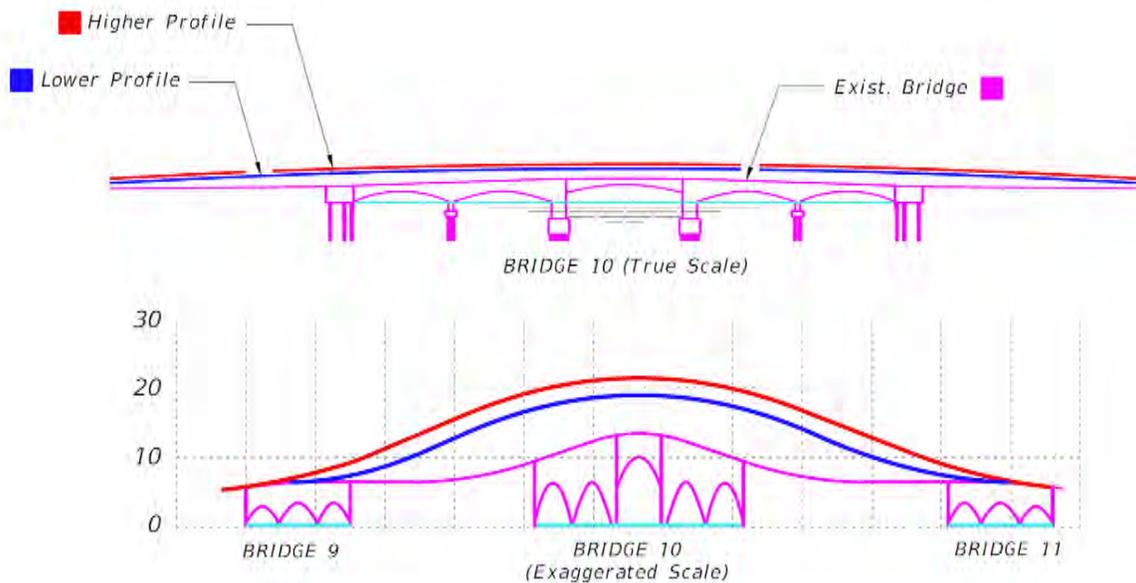
BRIDGE 10 - VERTICAL PROFILE ALTERNATIVES

Vertical profiles were prepared for the above alternatives to determine where each alternative would tie back into existing grade on the approach roadways. Both proposed profiles have a maximum vertical grade of five percent to meet ADA requirements for pedestrians (Figure 1-10).

NAVIGATION CLEARANCE POINT	VERT. CLEAR. (ABOVE MEAN HIGH WATER)		
	EXISTING	HIGHER	LOWER
at Fender	6.0'	13.0'	10.5'
at Center	10.0'	16.0'	13.5'
DECK ELEVATION AT PEAK	13.45'	21.45'	18.96'

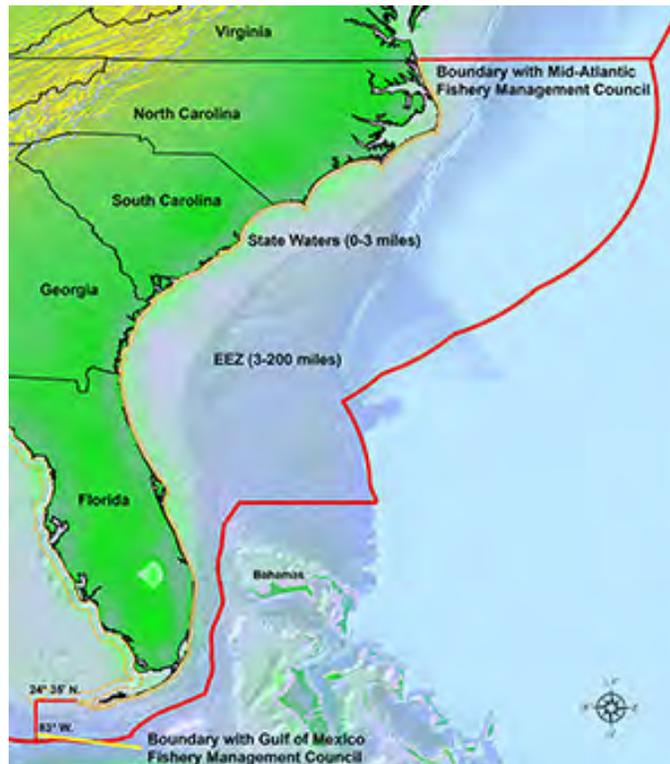
Figure 6-1 Marine Areas Managed by the South Atlantic Fishery Management Council (SAFMC)

SAFMC's EFH designation for snapper-grouper species applies to all waters from the United States Exclusive Economic Zone (EEZ) to the landward most influence of the tide, from the Virginia/North Carolina border to the Dry Tortugas in the Florida Keys (See **Figure 6-1** for the SAFMC Management Boundary Line). Several representative species from the Snapper-Grouper fishery known to occur within the project area in Biscayne Bay include gray snapper, mutton snapper, white grunt and hogfish (*Lachnolaimus maximus*). Biscayne Bay provides vital nursery habitat for many coastal bay and coral-reef fishes and both young fish and adults utilize the shoreline habitats in the Bay for forage and protection.

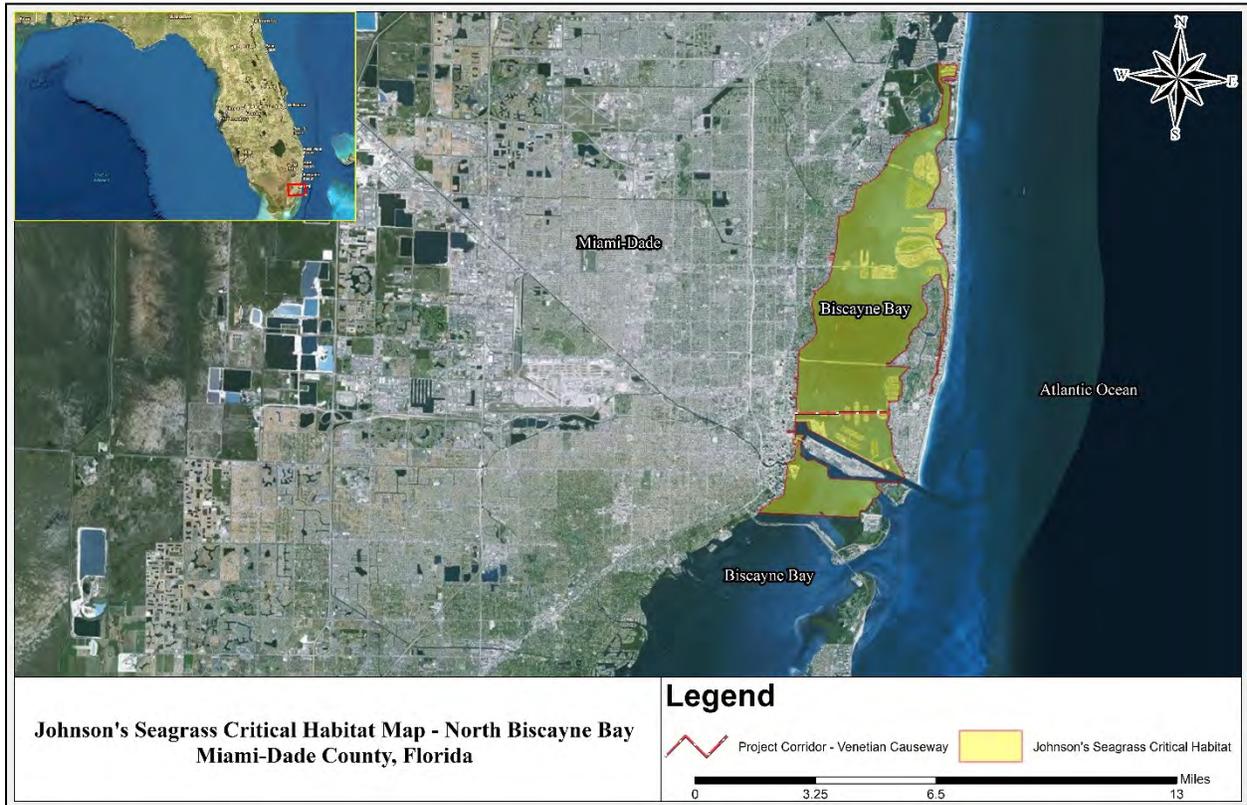
Figure 6-3 Johnson's Seagrass Critical Habitat within the Project Area (Biscayne Bay).

may be used during construction. The 2014 study did not cover the westernmost 750 feet of Bridge No. 1 as this area was under emergency construction repairs at the time of the survey and was inaccessible. However, the 2017 field investigation included this area. This project is located within Johnson's Seagrass critical habitat (See **Johnson's Seagrass (*Halophila johnsonii*) Critical Habitat Map Figure 6-3**); therefore, the survey was conducted during Johnson's Seagrass growing season, which has been determined by NMFS to be June 1-September 30 (NOAA NMFS, 2010).

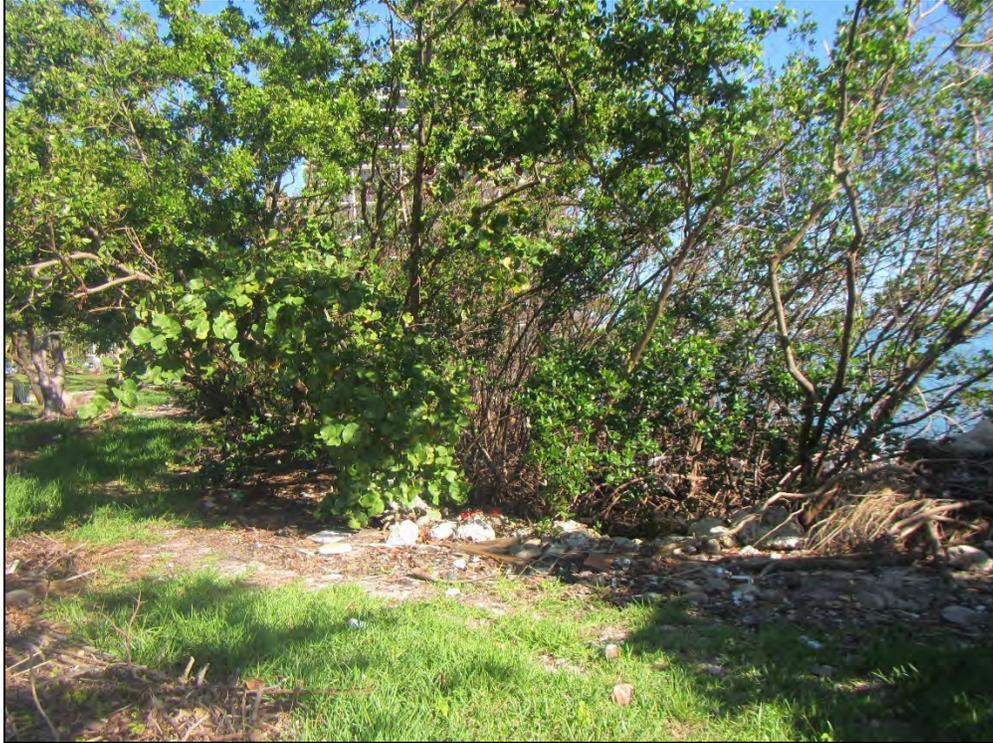
Photo 1 – Pedestrian Wetlands Survey: Biscayne Island Mangrove Wetland

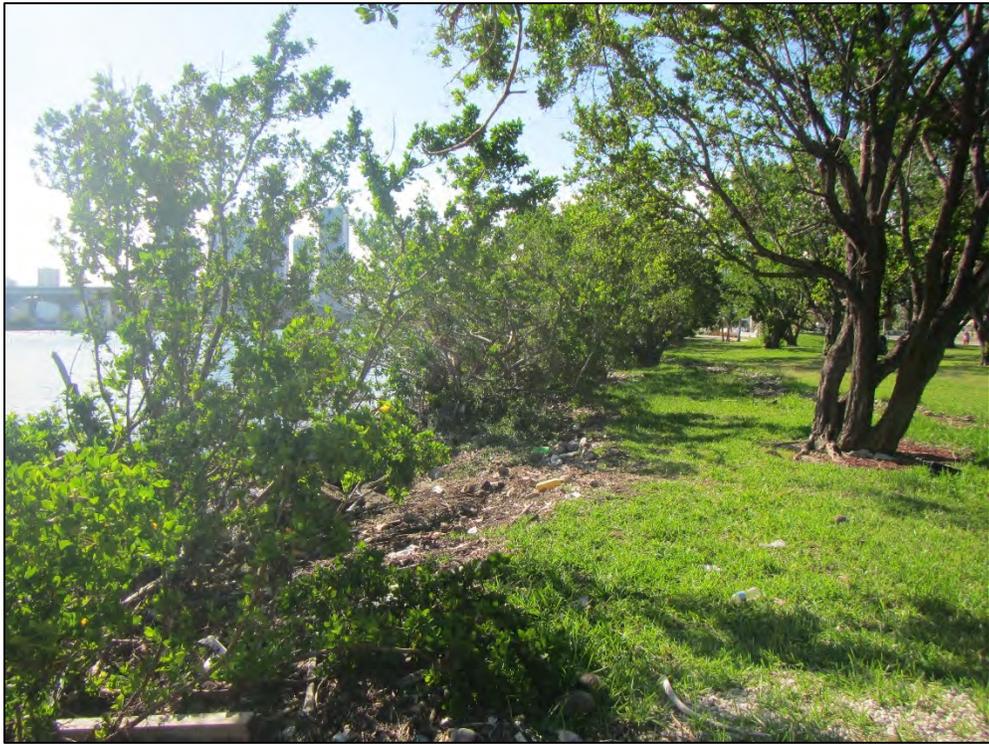
Figure 2 – Pedestrian Wetlands Survey: Biscayne Island Mangrove Wetland

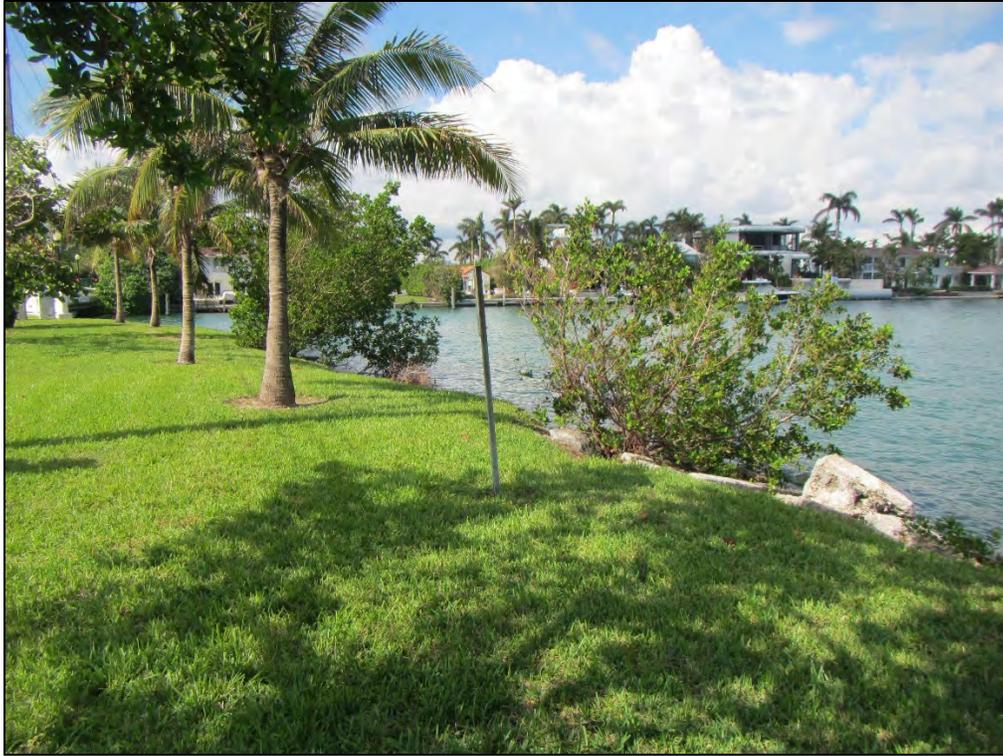
Figure 3 – Pedestrian Wetlands Survey: Underdeveloped Spoil Island Mangroves and Buttonwoods Growing in the Intertidal Zone

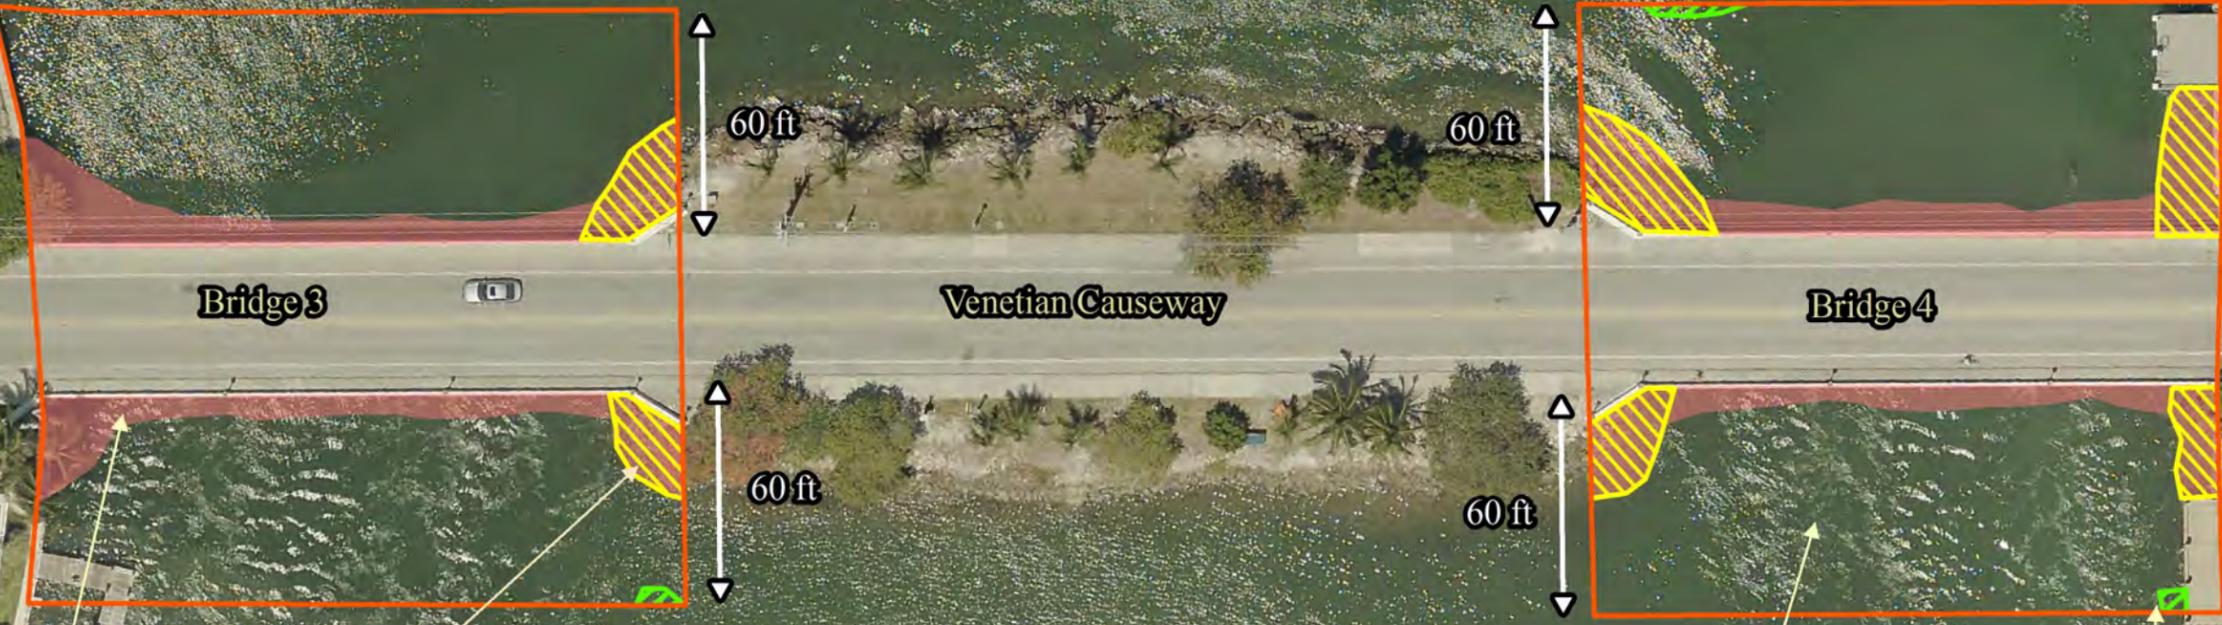
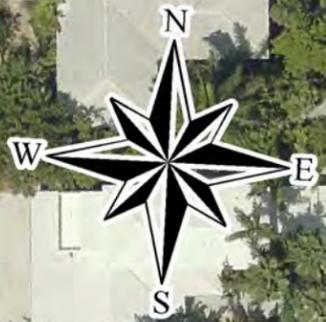
**Benthic Survey
 Representative Methodology**

Note: Paddle grass, *Halophila decipiens* was observed around the northwestern limit of the survey area at Bridge 4 as well as at the southeastern limits of the survey areas at both Bridges 3 and 4. The seagrass coverage ranged from 1-10% and continued outside the survey area. The benthic conditions in the survey areas without hatching were mainly sandy bottom with shell fragments with varying coverage of green, red and/or brown macroalgae and sponges.

Community 1: The Shallow, Littoral Zones, Bridge Pilings & Rip-Rap/Rubble/Hard Debris Areas

Community 2: The Deeper Water, Sandy Bottom with Shell Fragments Areas

Each bridge was surveyed via perpendicular transects from the bridge edges out to 60 feet starting at the end bents. Diver 1 would lay the transect tape, signal to the second diver (Diver 2) to swim the transect line and Diver 2 would record benthic observations along the transect including substrate, depth, species observations, and estimated densities of benthic resources. While Diver 2 was swimming the transect line, Diver 1 would investigate areas outside the limits of the transect to cover the maximum extent of the bay bottom. Diver 1 would then relay to Diver 2 any notable benthic occurrences that may not have been present (or visible) along the transect line. This transect process was repeated at consecutive bridge pilings (or every other piling if benthic conditions had been determined to be uniform per the previous transect data and meandering swims) to the opposite end bent and was performed on both the north and south sides of each bridge. A third diver (Diver 3) surveyed the areas underneath the bridges as well as each bridge piling and documented coral/sponge coverage, substrate, and depth (See **Figure 2: Benthic Survey Representative Methodology & Limits**).

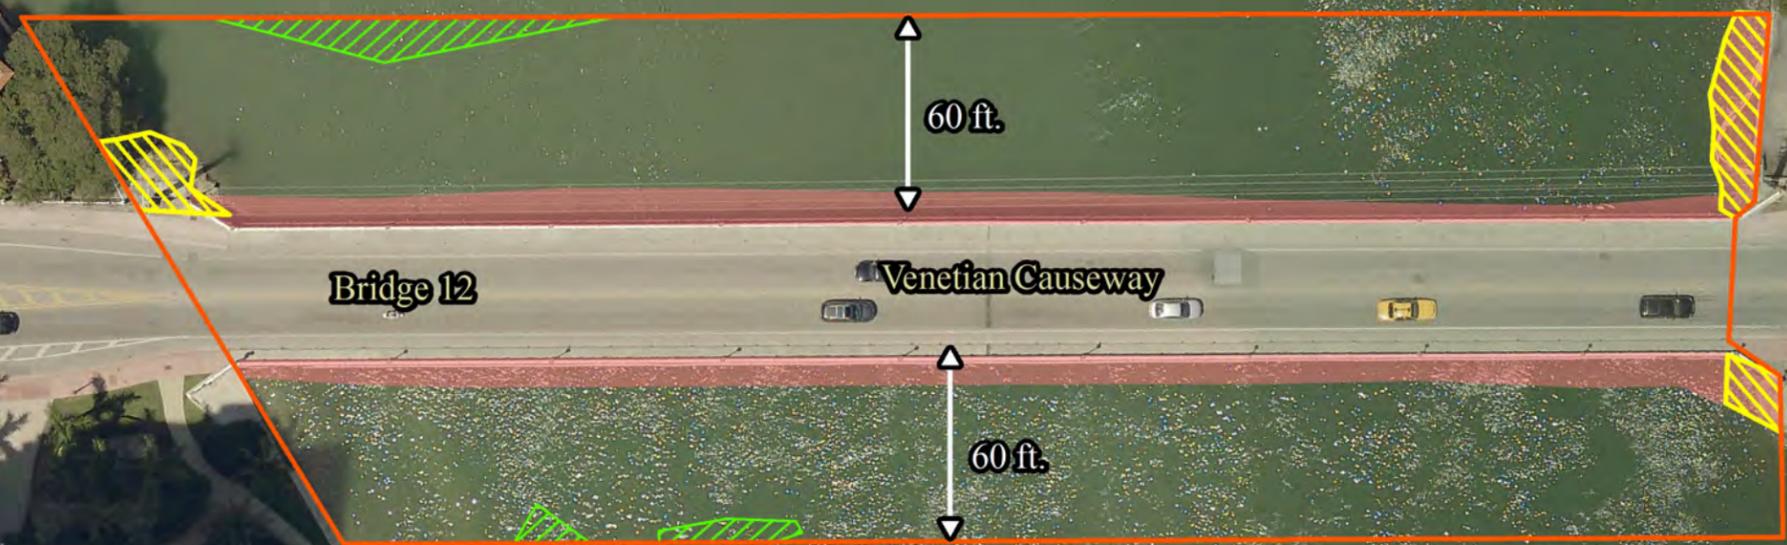
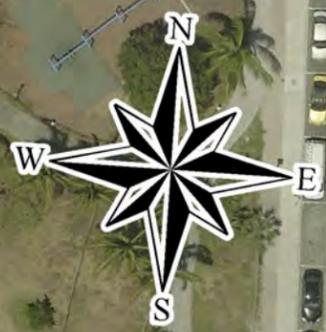
Note: Paddle grass, (*Halophila decipiens*), was the only seagrass species observed in the survey limits. The seagrass area towards the northwest quadrant of the survey area continues north outside the survey limits. The seagrasses in the southwestern portion of the survey area were both isolated patches comprising a few square feet. Overall density of the seagrass in the areas documented inside the survey area ranged from 1-25% coverage. The benthic conditions in the survey areas with no hatching were mainly sandy bottom with shell fragments and had varying coverage of green, red, and/or brown macroalgae and sponges.

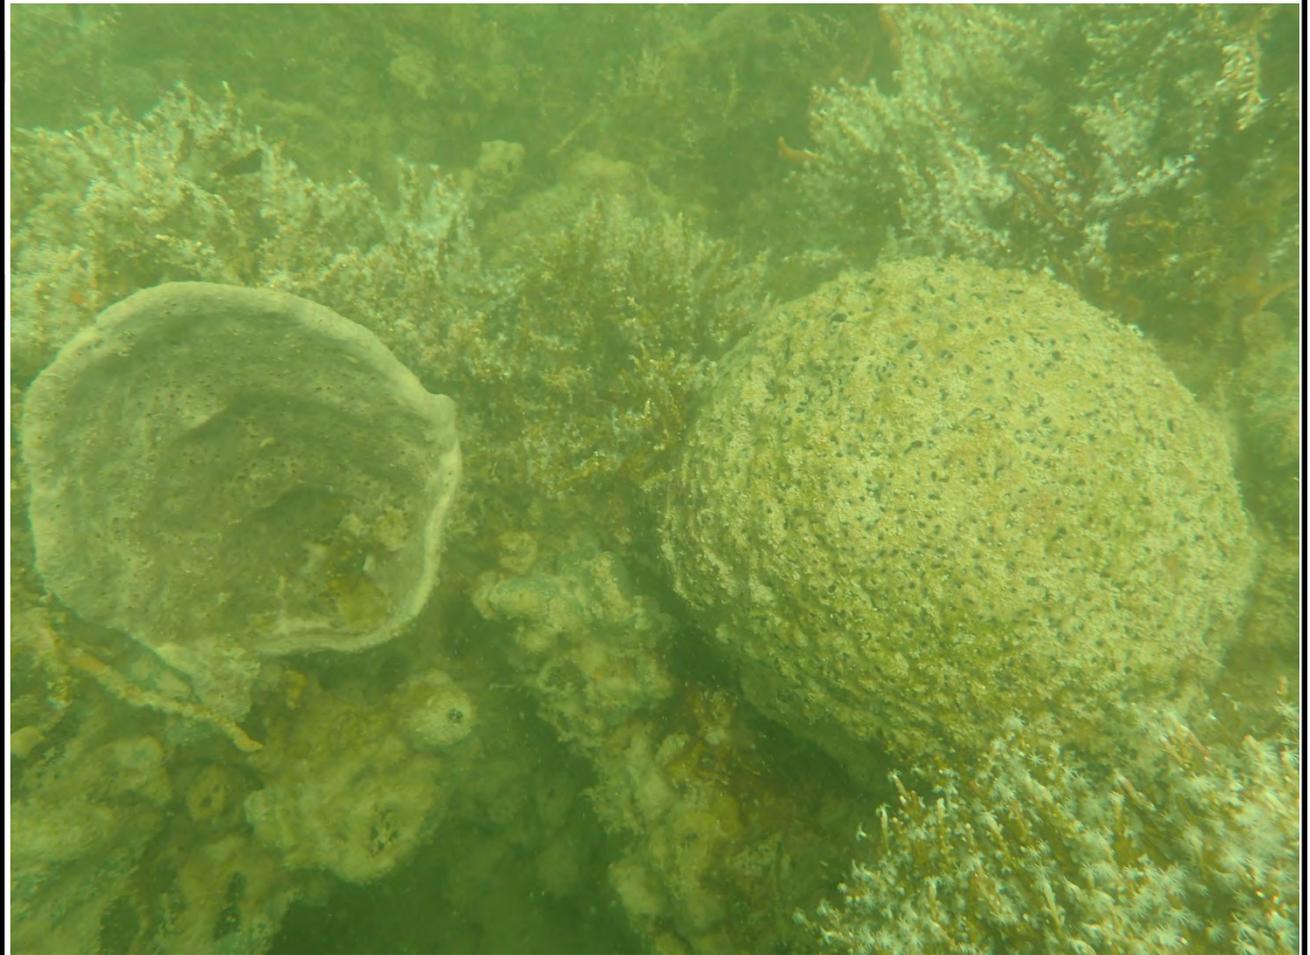
Notes: The photograph shows an example of the dense sponge, octocoral, and tunicate coverage that is present within Community no.1. This Community was found around the shallow, littoral zone, bridge pilings and rip-rap/rubble/hard debris areas.

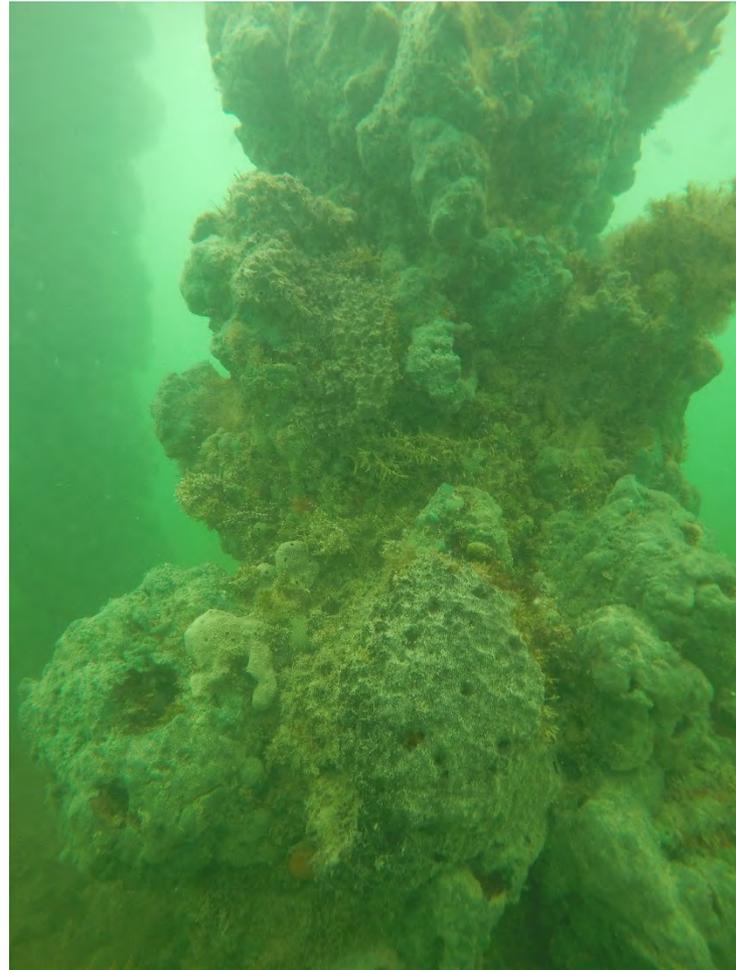
Notes: The photograph shows the typical conditions of a bridge piling in Community no. 1 (specifically part of the fender system at Bridge 10). Nearly 100% coverage by various sponges, octocorals, and tunicates was documented on nearly all the bridge pilings throughout the Venetian Causeway. No corals were observed on any of these bridge structures (i.e. pilings, end bents and fenders).

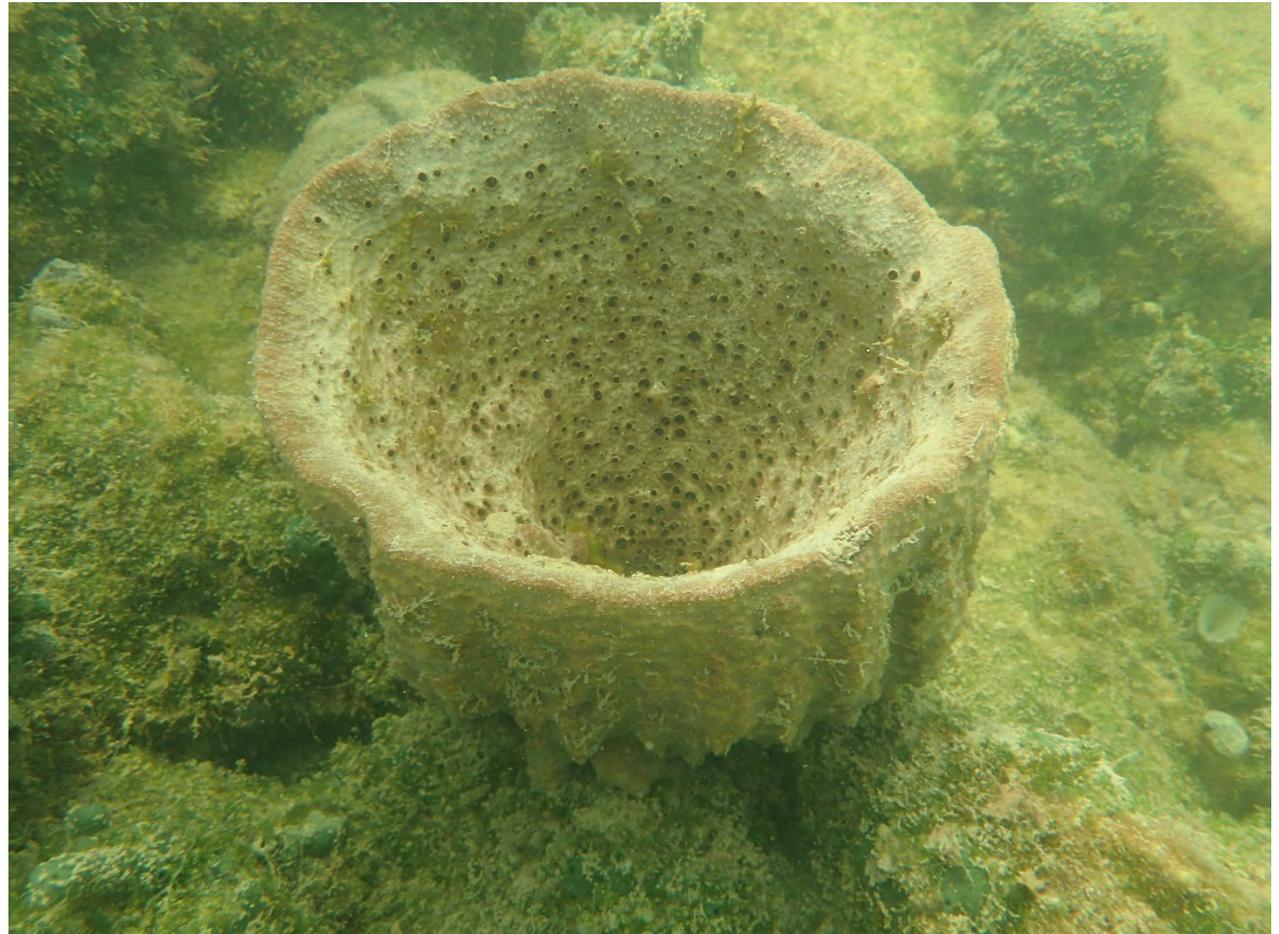
Notes: The photograph documents some of the variety of coverage observed in Community no.1 as the rip-rap shown here is mostly covered in macroalgae with only one vase sponge.

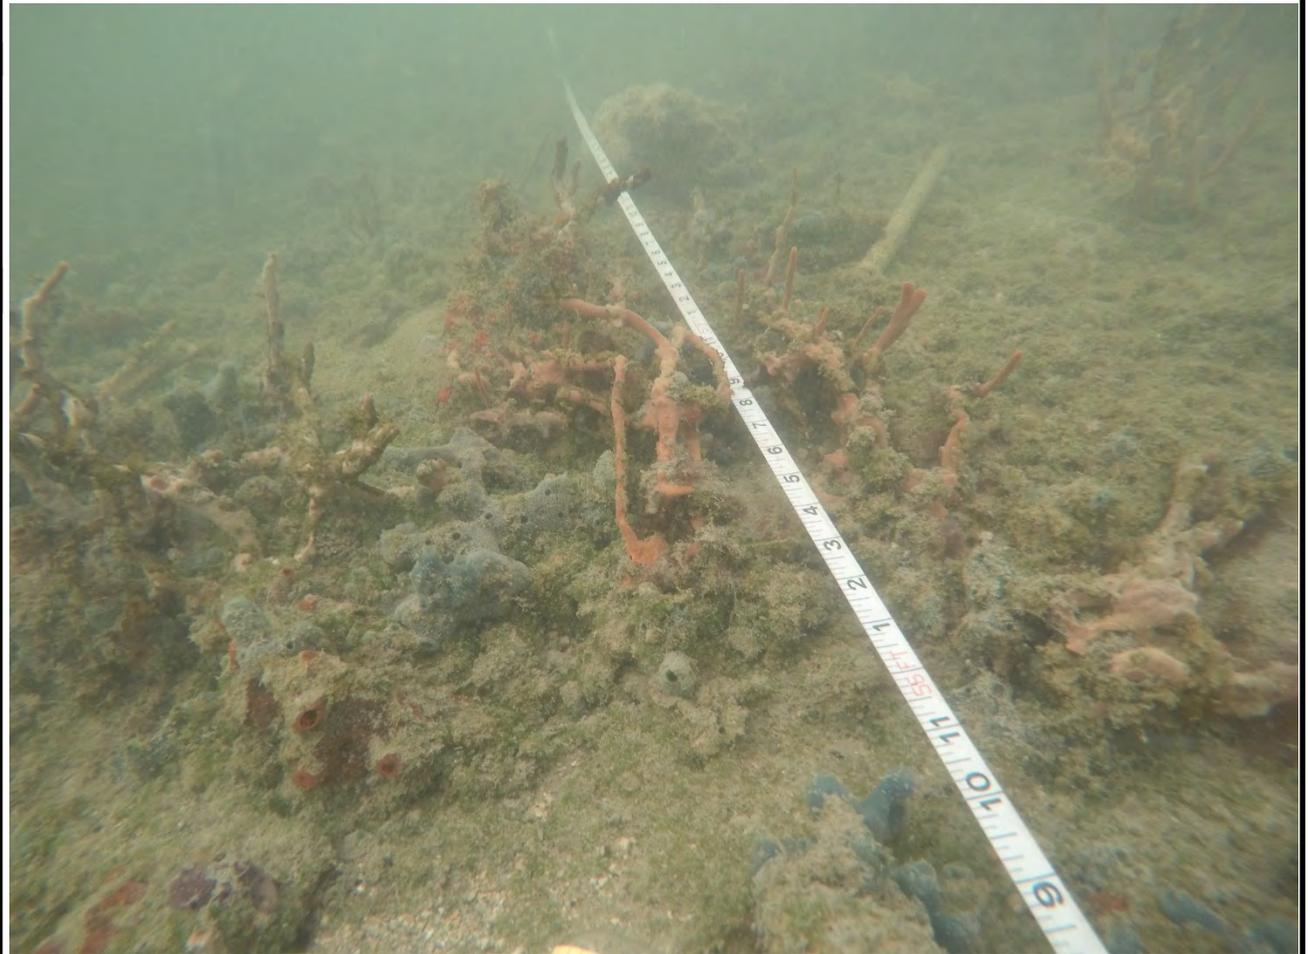
Notes: The photograph shows the conditions along a typical transect conducted at the Venetian Causeway Bridges. This photograph depicts Community no. 2; sandy bottom with shell fragments substrate along with varying sponge and algal coverage.

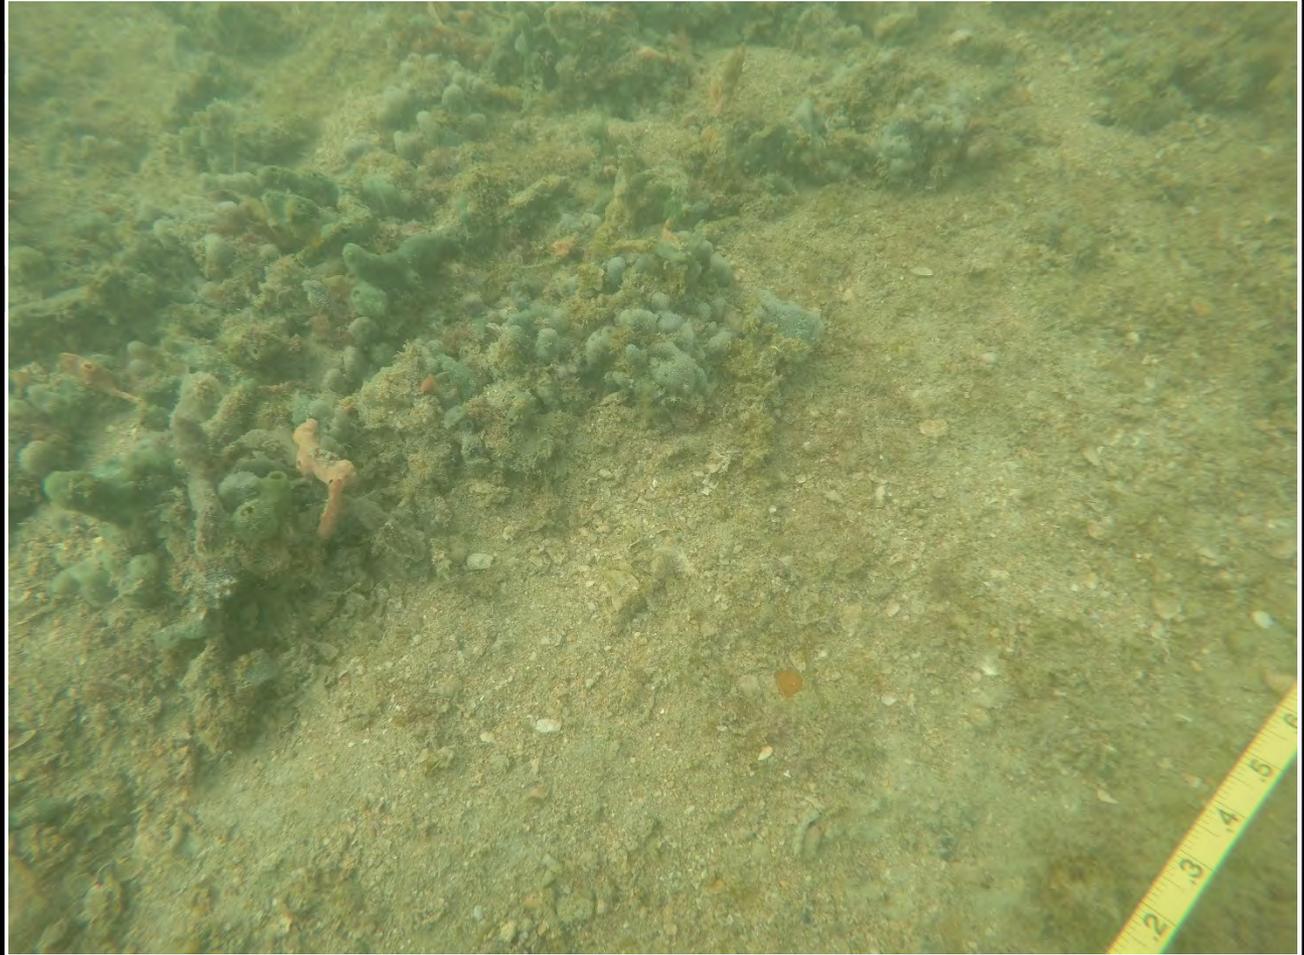
Notes: The photograph also shows the conditions observed in Community no. 2; sandy bottom with shell fragments substrate along with varying sponge and algal coverage. The sponges in this community tend to aggregate on or around other (i.e. become more densely populated) and/or colonize scattered debris along the bottom.

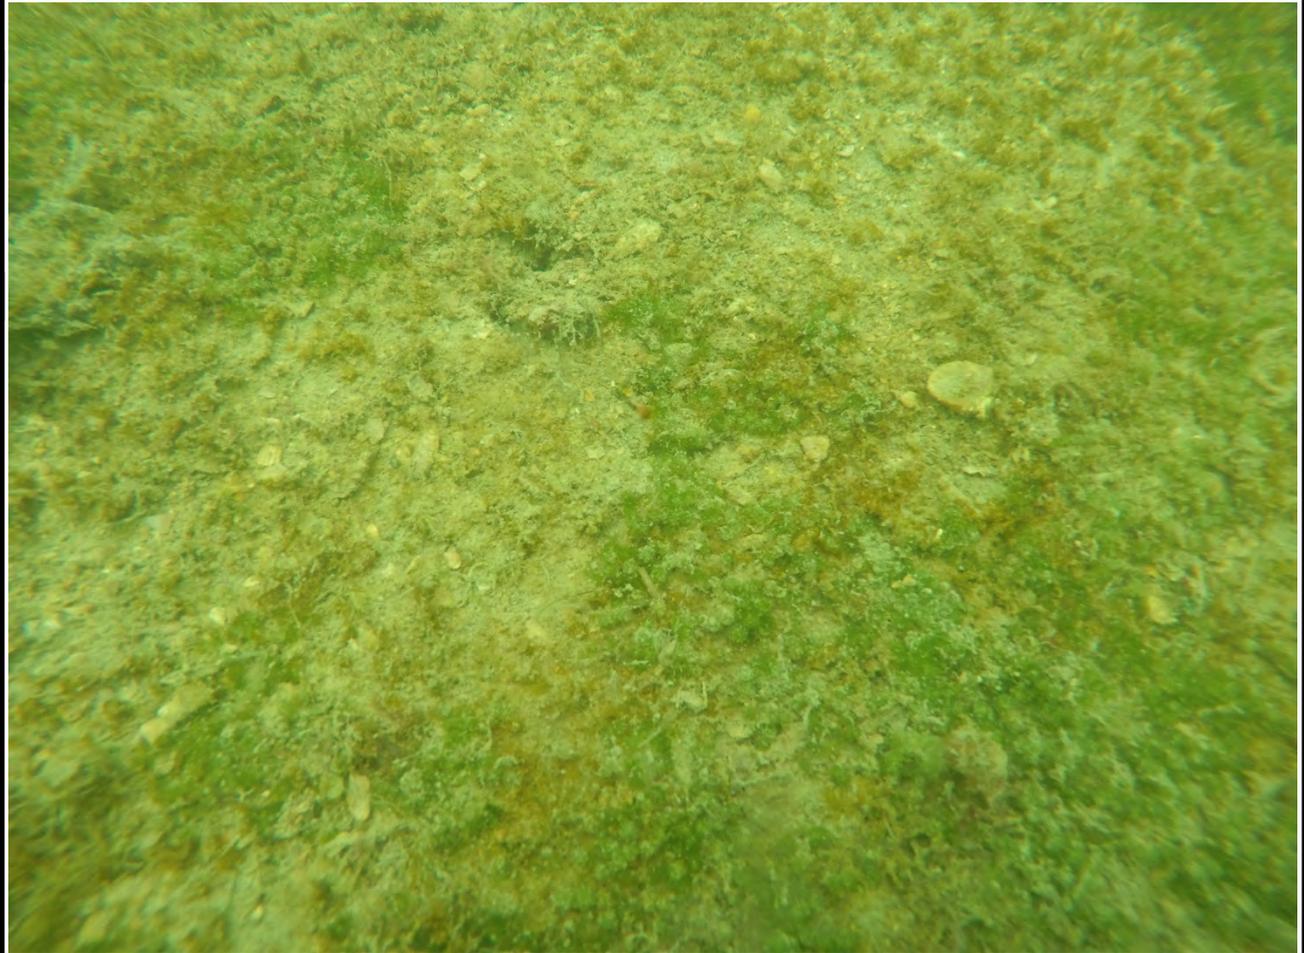
Notes: The photograph shows another example of conditions observed in Community no. 2. This sandy bottom with shell fragments substrate was observed near the area where this community transitions to Community no. 3.

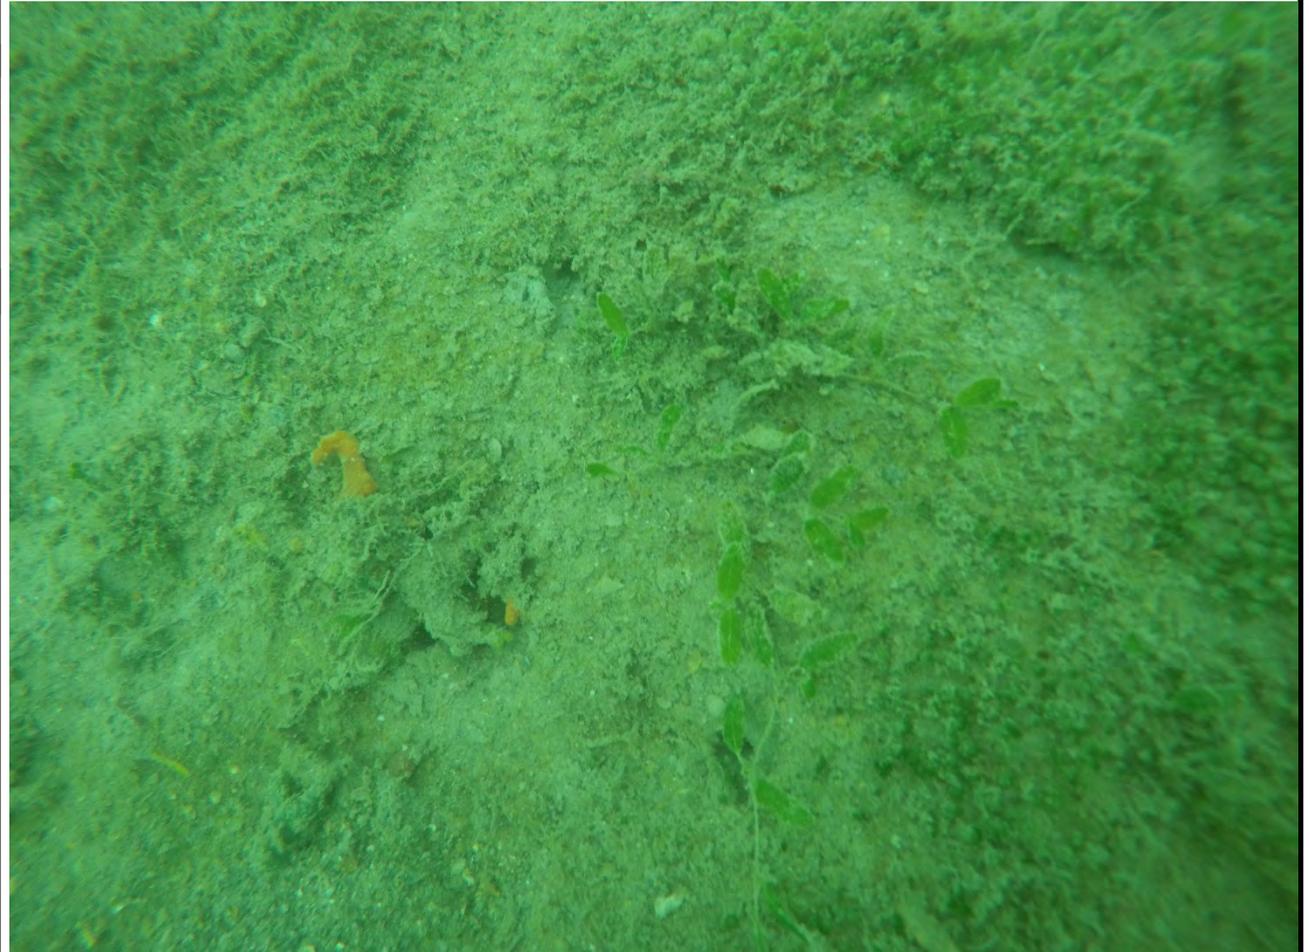
Notes: The photograph shows a small patch of paddle grass (*Halophila decipiens*) with varying coverage of green algae. These conditions were typical of Community no. 3 and tend to occur near the northern-southern edges of the survey areas, around 55-60 feet from the bridge edges.
