VENETIAN CAUSEWAY
(Venetian Way)
Project Development & Environment (PD&E) Study
FROM NORTH BAYSHORE DRIVE TO PURDY AVENUE

Project Advisory Group (PAG)

Meeting No. 1

September 18, 2014

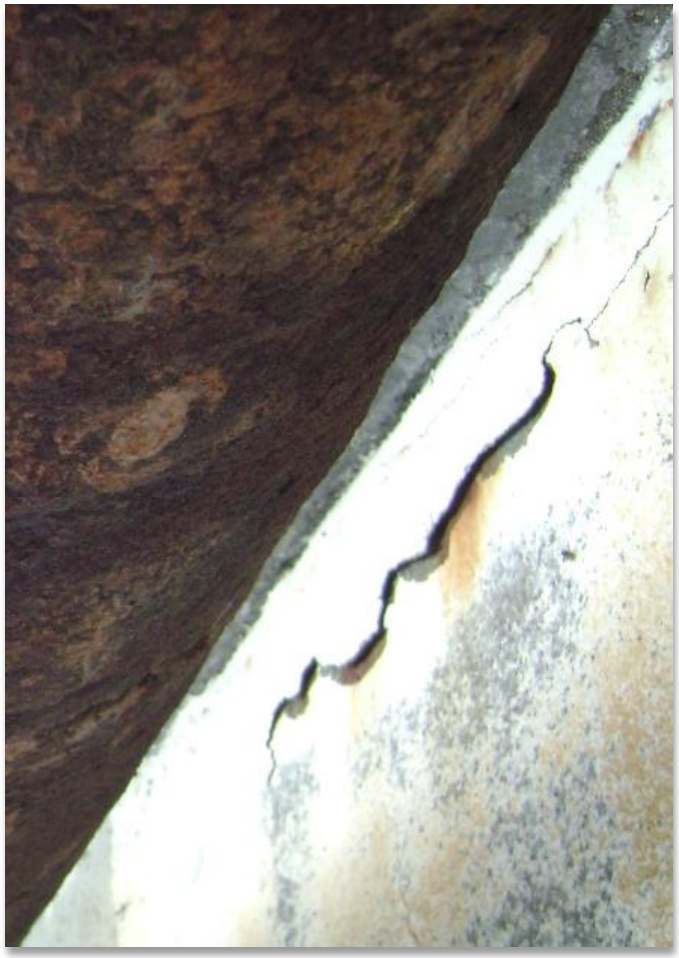
- Cracks – minor in Beams & Substructures
- Surface Corrosion- in exposed Reinforcing steel bars

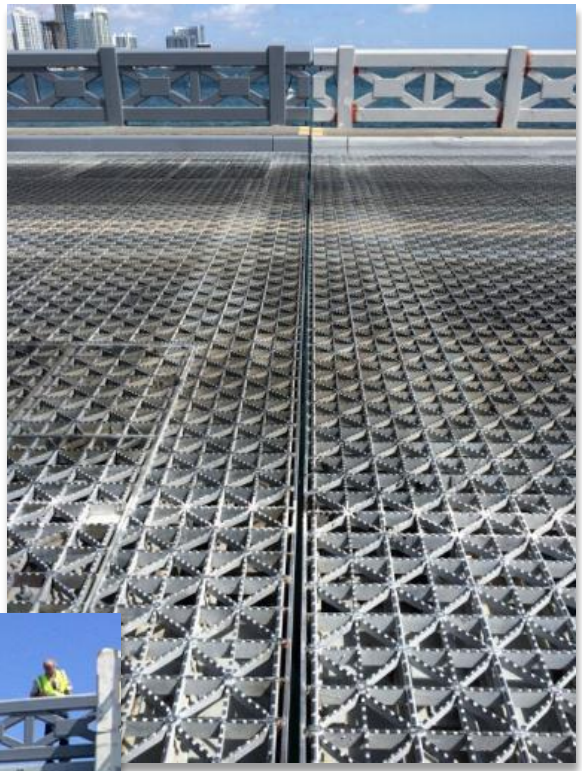
West Bascule (874459) – Main Span

- **Overall in Good Condition**
  - Bascule Span Replaced 1999
  - 12-ft Vert. Clearance at Fender
  - 16-ft Vert. Clearance at Center

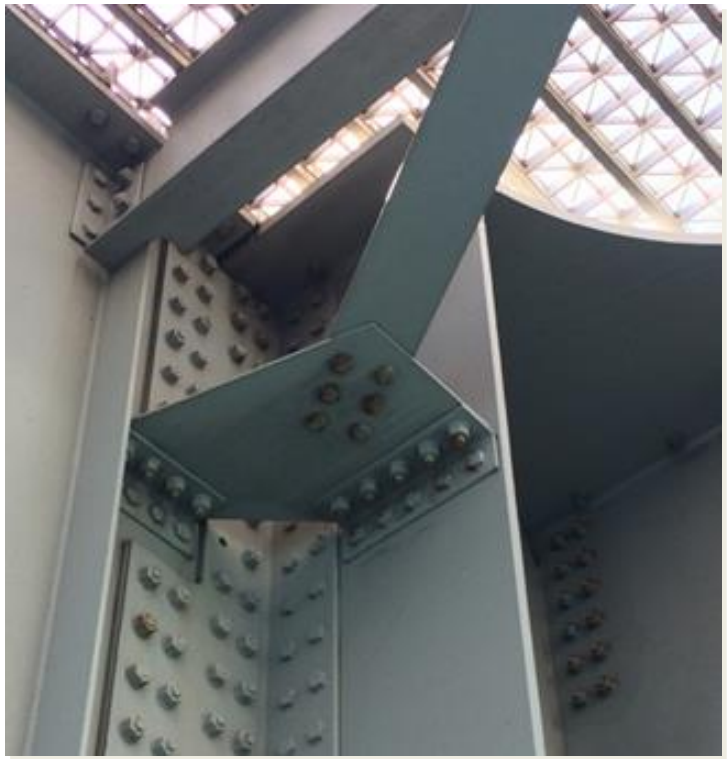
West Bascule (874459) – Main Span

- **Steel Bascule Leaf**
  - Minor Steel Corrosion
  - Protective Coatings/Paint Needs Replacement

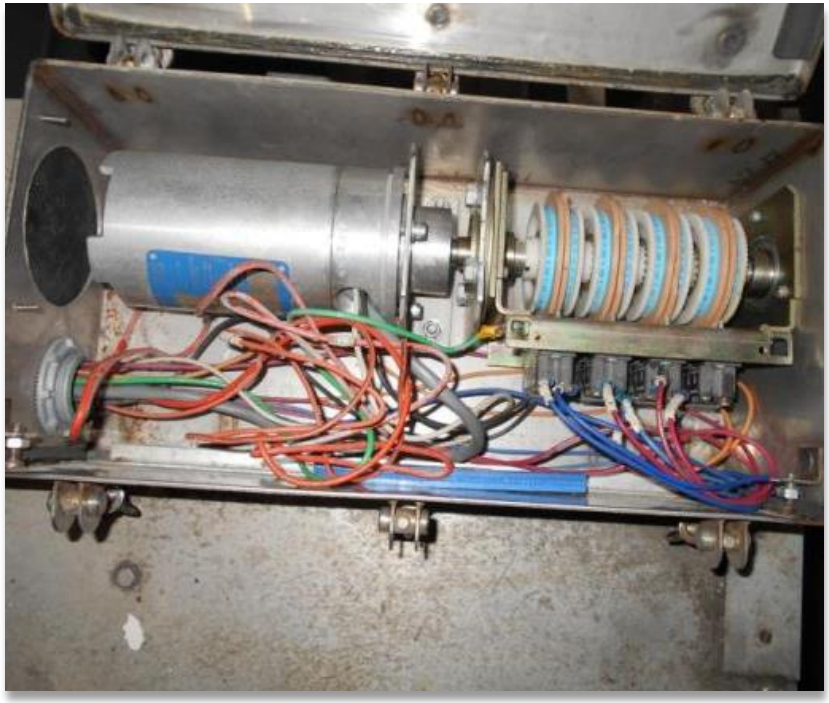
West Bascule (874459) – Main Span

- **Electrical-Mechanical**
  - Minor Conduit and Wiring Issues
  - Minor Hydraulic Fluid Leaks
  - Moderate Wear of Span Lock Shoes

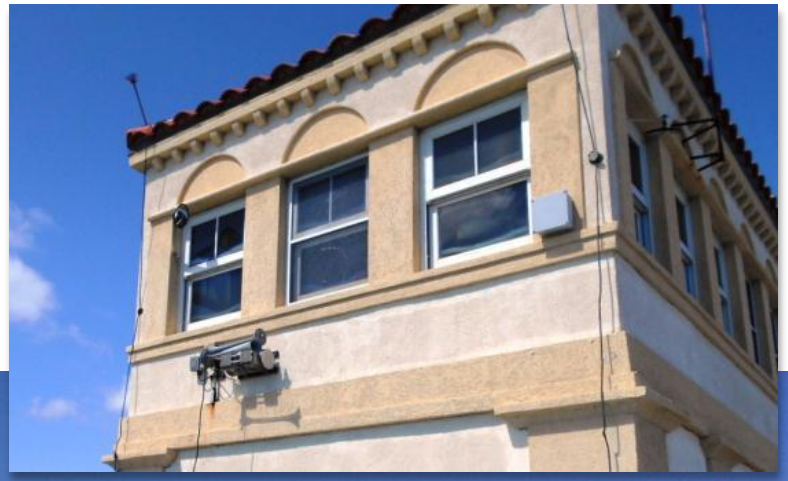
West Bascule (874459) – Main Span

- **Control House**
  - Windows Need Replacement

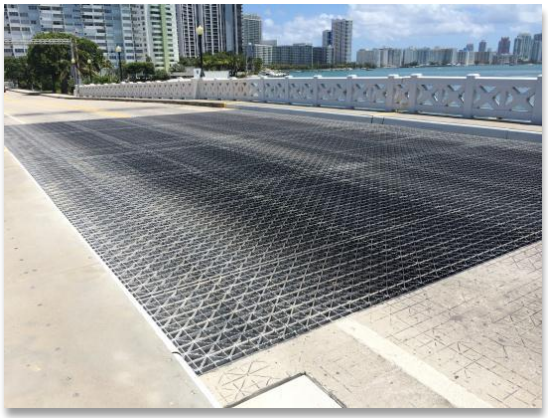
East Bascule (874474) – Main Span

- **Undesirable Roadway Features**
  - Steel Open Grid Deck
    - Poor Skid Resistance
    - Not Bicycle Friendly
    - Noisy
    - Maintenance Concerns
  - Deck Joints in Shoulder
    - Potential Bicycle Hazard
