# **Location Hydraulics Report**

FM No. 449007-1-22-01

State Road 934/NE 79<sup>th</sup> St (John F. Kennedy Causeway), Project Development and Environment Study

Limits of Project: From West of Pelican Harbor Drive (MP 1.077) and East of Adventure Avenue (MP 1.947)

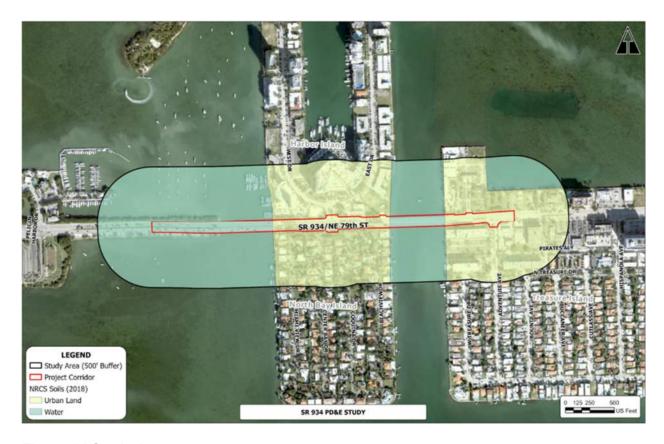
Figure 1 | Study Area

The project's western study limits fall within the City of Miami, while the eastern study limits fall within North Bay Village. Outside the project limits, NE 79th Street is expected to remain as a six-lane urban principal arterial. Therefore, to align with the existing configuration and accommodate additional lanes being dropped or added at the intersections, the logical termini for this project involve NE 79th Street from west of Pelican Harbor Drive (western terminus) to east of Adventure Avenue (eastern terminus). These logical termini also allow for full inclusion of the intersection footprints.

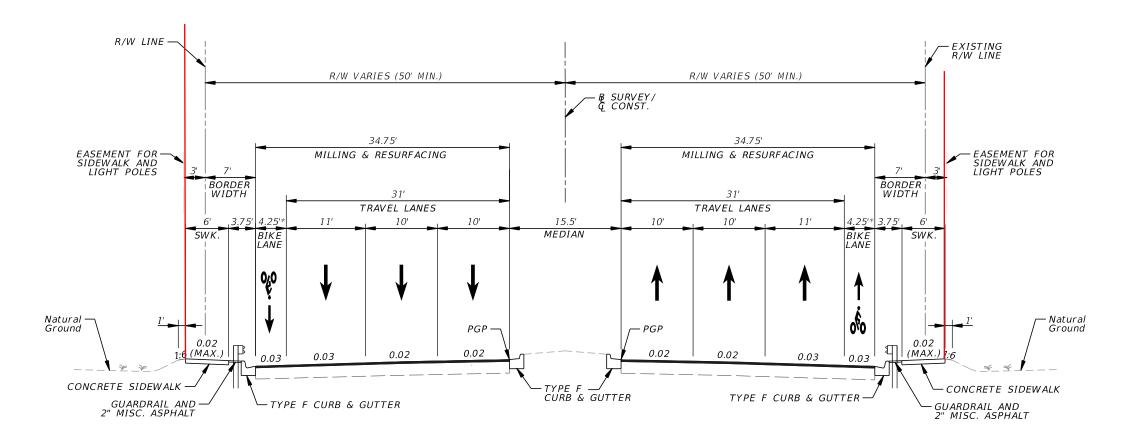
# **Proposed Typical Section**

TYPICAL SECTION

SR 934 / NE 79th STREET / JOHN F. KENNEDY CAUSEWAY

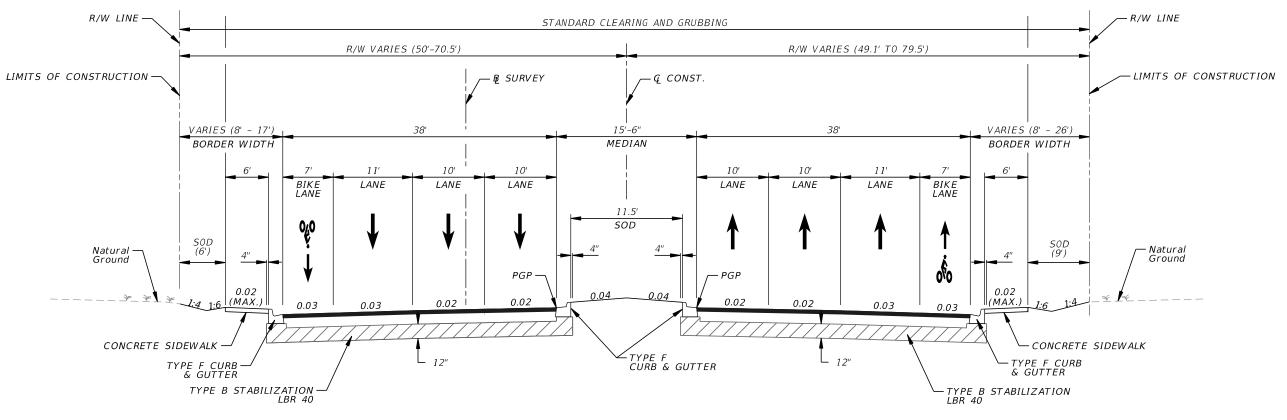
## **Proposed Typical Section**

TYPICAL SECTION

SR 934 / NE 79th STREET / JOHN F. KENNEDY CAUSEWAY

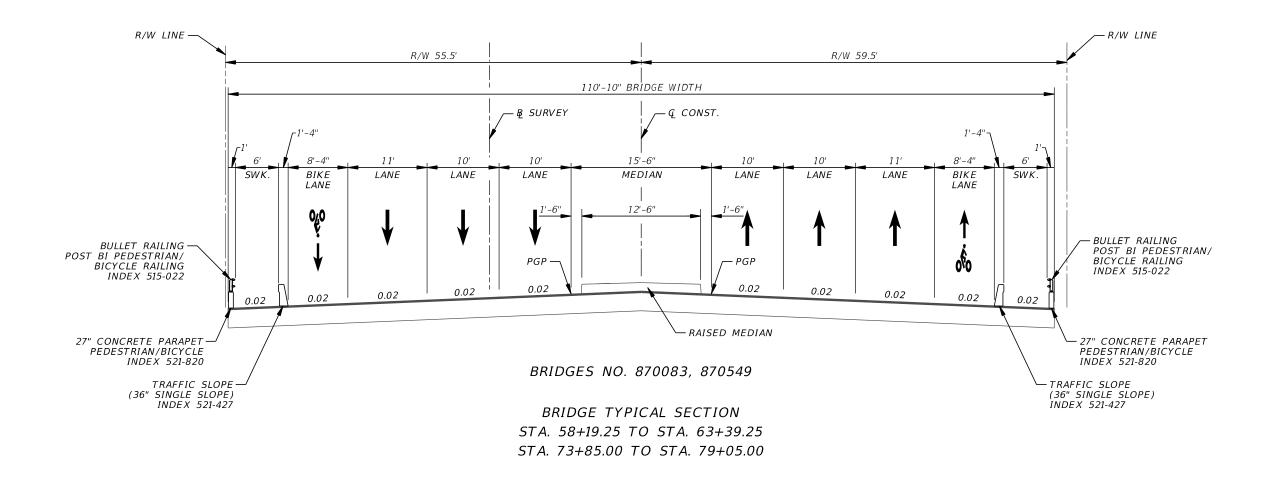
## **Proposed Typical Section**

CURRENT YEAR: 2023 AADT = 81700
ESTIMATED OPENING YEAR: 2030 AADT = 85400
ESTIMATED DESIGN YEAR: 2050 AADT = 95600
K= 7.3% D=54.2% T= 2.4% (24 HOUR)
DESIGN SPEED= 35 MPH
TARGET SPEED= 35 MPH
POSTED SPEED= 30, 35 MPH
CONTEXT CLASSIFICATION= C5
