Atlantic Isle at West of SR A1A
Bridge No. 874218
Project Development and Environment Study

Draft Preliminary Engineering Report

FDOT District Six

Atlantic Isle Bridge (Bridge No. 874218) Atlantic Avenue, Sunny Isles Beach, FL

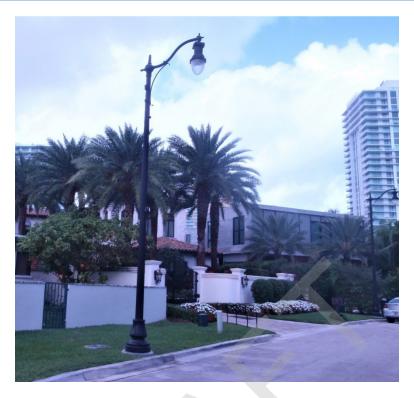
Existing light pole structures are on the north sides of Atlantic Isle and Atlantic Avenue. They are antique pendant/teardrop-style fixtures. Figure 2-7 presents a typical light pole. The light poles are set back from the back of the roadway curb between 1.5 and 4 feet as observed during a field visit. The light poles contain FDOT electric pull-boxes.

Figure 2-7. Existing Lighting

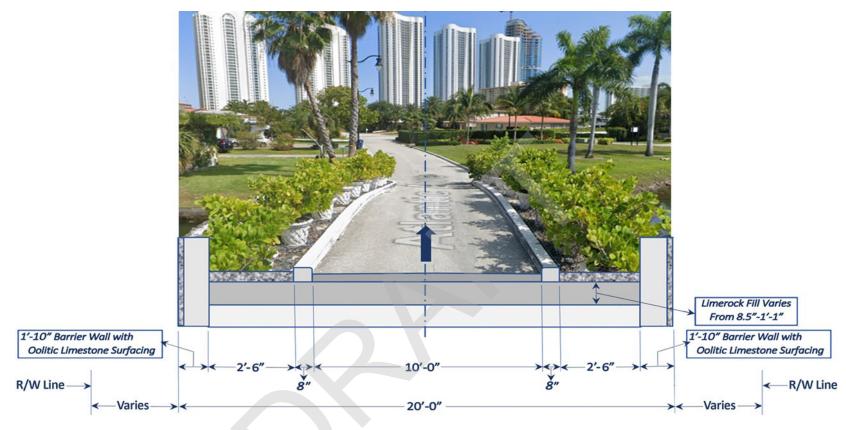
Figure 2-13. Existing Atlantic Avenue Bridge (No. 874218) Typical Section

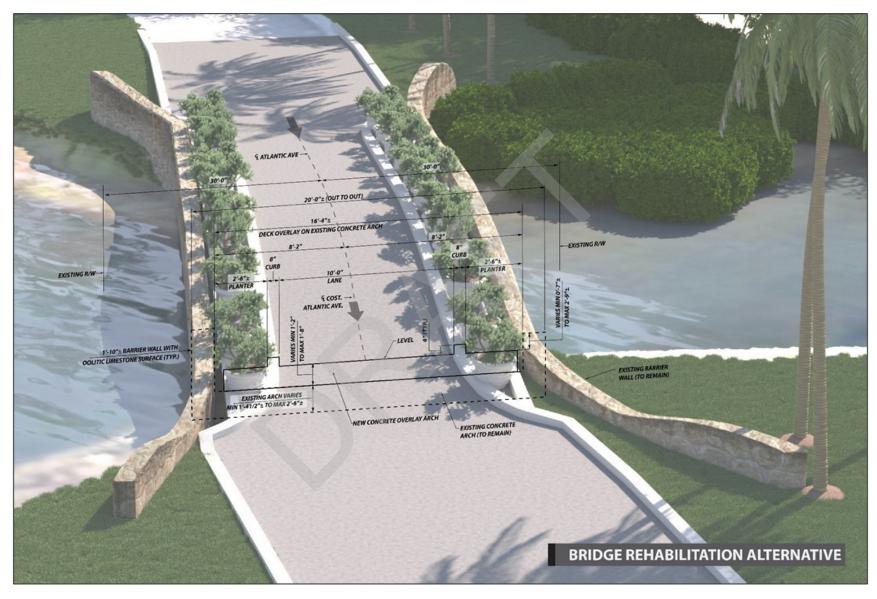
Figure 5-1. Build Alternative 1 – Rehabilitation, Proposed Typical Section (Facing Northwest)

This alternative involves rehabilitation of the existing bridge superstructure, providing a new CIP-reinforced concrete arch structure, and maintaining one-way travel on the bridge. The roadway width will be maintained, but the typical section and vertical roadway geometry will be impacted to accommodate the retrofitted structure depth. The proposed new arch would extend beyond the ends of the existing concrete arch and foundations to avoid the existing foundation removal costs and the associated risks that could impact the adjacent residential property foundations and structures. A new bridge substructure (abutments and foundations) would be constructed to support the rehabilitated bridge superstructure. During construction, the existing substructure and the superstructure will remain to support the existing concrete arch and exterior limestone facade.

The Rehabilitation Alternative does not address the bridge's functional deficiencies (substandard traffic barriers) because that would require removal and replacement of the arch spandrel walls, which could compromise the integrity of the already deteriorating bridge. The existing roadway limerock base and pavement would be removed and replaced with a concrete riding surface provided by the new arch structure. With the bridge rehabilitation, one-way travel on the bridge would be maintained. The rehabilitated bridge typical section would remain as is, consisting of a single 10-foot-wide travel lane, 8-inch-wide curbs, 2.5-foot-wide planter easements, and 1-foot 10-inch-wide barriers on each side of the bridge. The vertical direction of the typical section will be impacted because the roadway profile will be higher at the bridge section to accommodate the additional thickness of the new structural arch.

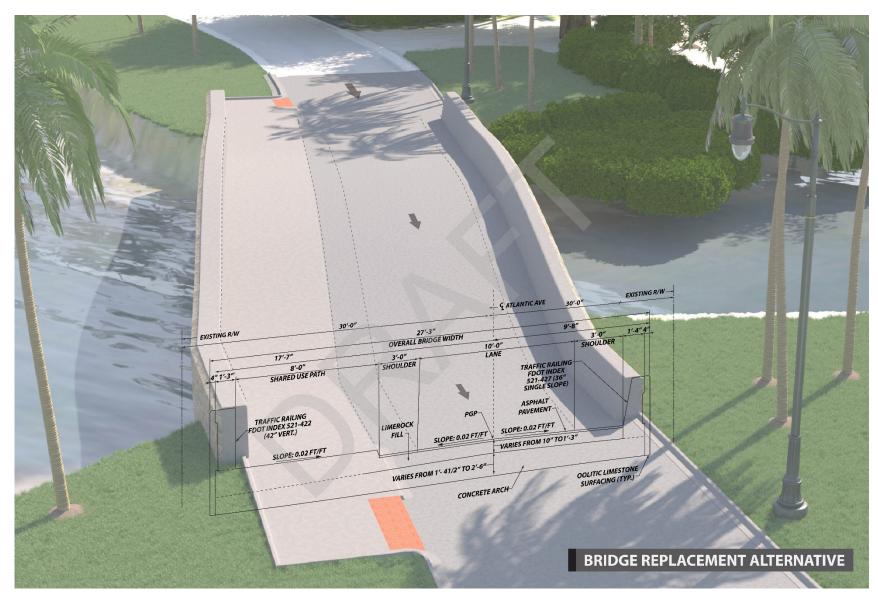
Figure 5-2. Build Alternative 2 – Replacement, Proposed Typical Section (Facing Northwest)

The Replacement Alternative involves replacing the entire bridge to address the structural and functional deficiencies of the existing superstructure and substructure to enhance operations and remove load restrictions. This would require demolition of the existing bridge and replacement of the bridge at the same location to minimize overall environmental impacts. The proposed bridge typical section would be approximately 27 feet wide to accommodate one 10-foot-wide travel lane, one 8-foot-wide shared-use path, 3-foot-wide shoulders, and concrete traffic railings on both sides. A shared-use path would separate pedestrians from vehicular traffic.

New approach retaining walls would replace the existing retaining walls. A new, non-structural oolitic limestone facade would be placed along the exterior faces of the traffic railings and retaining walls to provide aesthetics similar to the existing bridge. A slightly longer bridge span may be required to span over portions of the existing unknown foundations, which may not be able to be removed, to eliminate potential conflicts and enhance constructability.

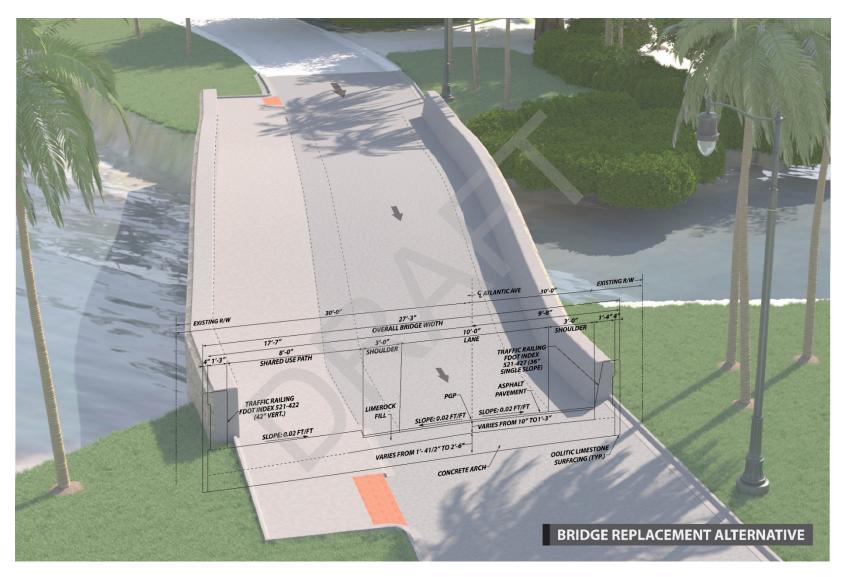
Figure 7-1. Bridge Replacement Alternative Typical Section (Facing Northwest)

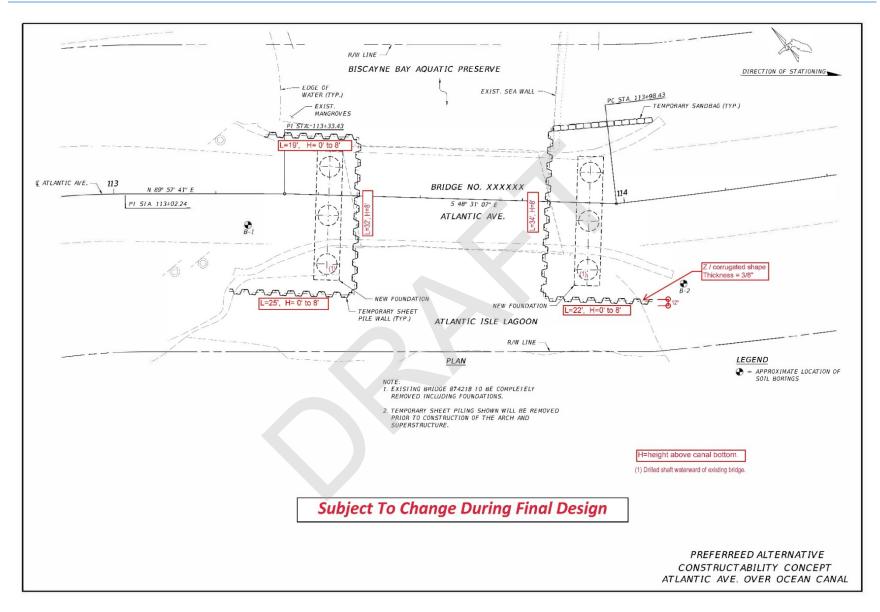
Figure 7-2. Preferred Alternative Constructability Concept

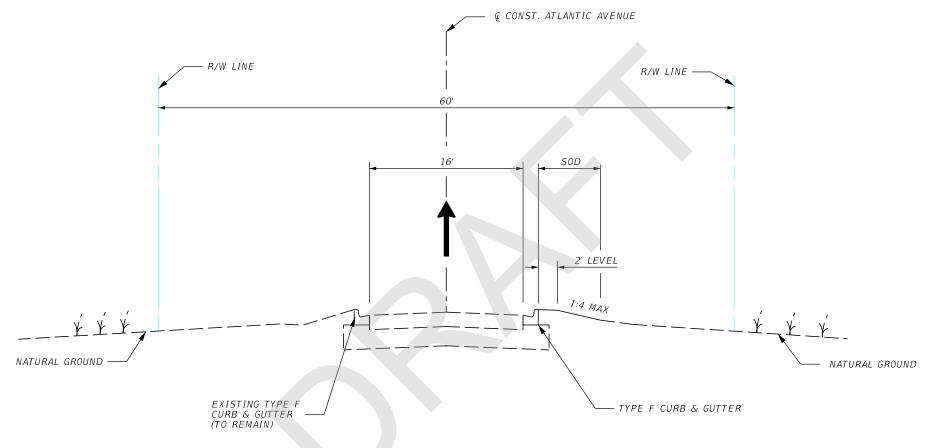
ROADWAY TYPICAL SECTION ATLANTIC AVENUE STA. 108+00 TO STA. 113+13.93 STA. 114+19.93 TO 115+80.00

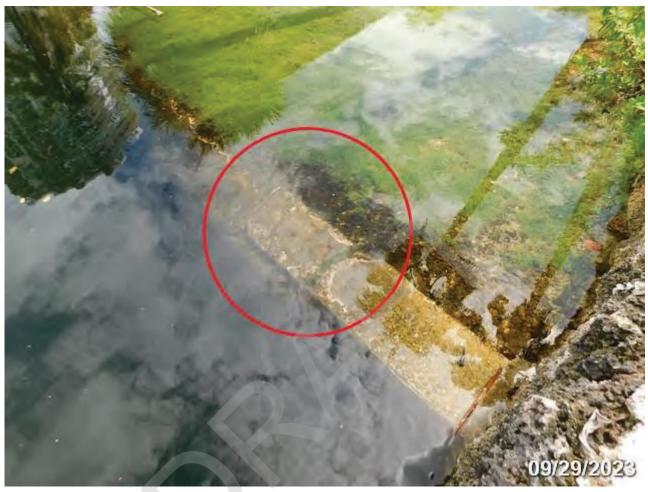
PHOTO 1: ELEMENT/ENV: 8477/4 Other Wingwalls/Retaining Wall

The seawall adjacent to the northeast corner of the bridge exhibits a fractured area 8ft. L, starting from the bridge.

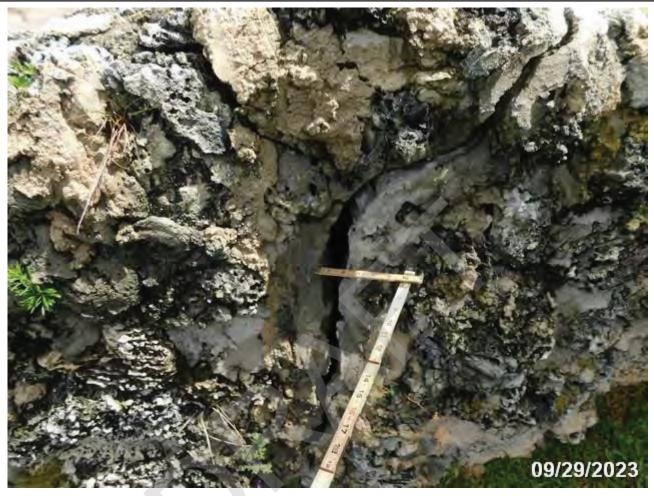
PHOTO 2: ELEMENT/ENV: 8477/4 Other Wingwalls/Retaining Wall

The SE retaining wall has several vertical cracks/gaps up to 2-1/4in. W for the entire length of the wall.

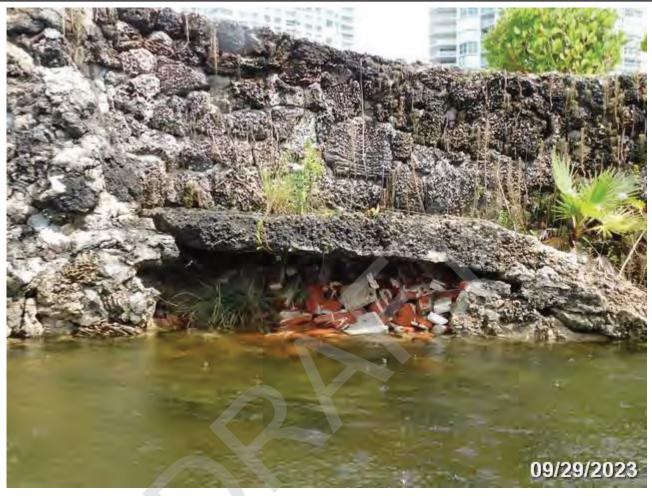
PHOTO 3: ELEMENT/ENV: 8477/4 Other Wingwalls/Retaining Wall

The SW retaining wall has failed and has an undermined/voided area up to 5ft. L x 2ft. H x 5ft. D.

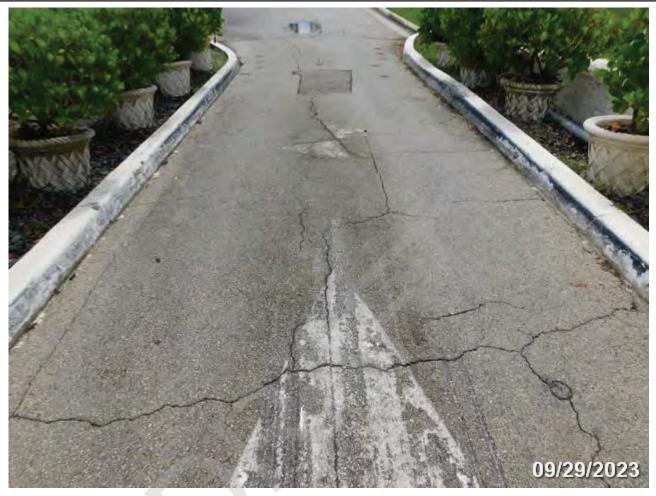
PHOTO 4: ELEMENT/ENV: 144/4 Re Conc Arch

The asphalt overlay exhibits multi-directional cracks up to 1/8in. W throughout the entire length of the bridge.

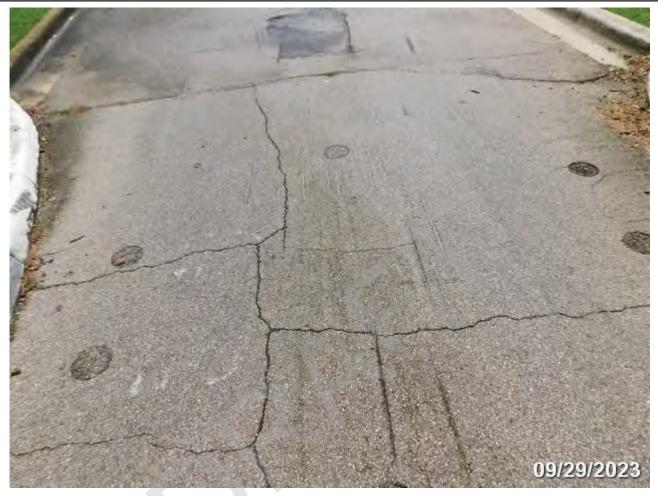
PHOTO 6: ELEMENT/ENV: 144/4 Re Conc Arch

The asphalt overlay exhibits several gauges up to 5ft. L x 2in. W x 1/2in. D at midspan at both ends of the bridge. Previously noted as seven gauges up to 40in. L x 2in. W x 1/2in. D.

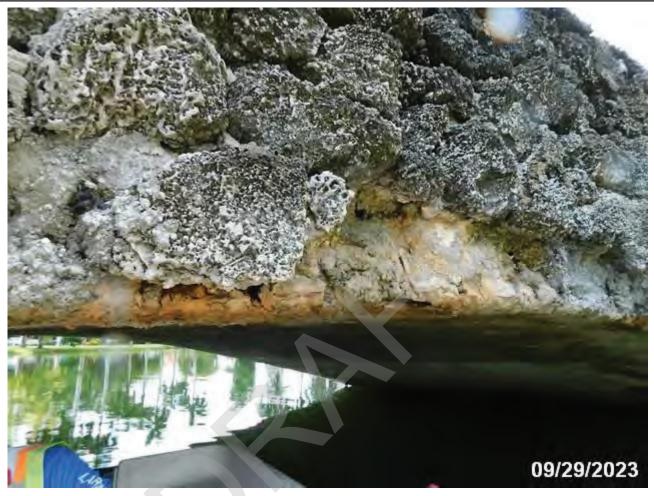
PHOTO 7: ELEMENT/ENV: 144/4 Re Conc Arch

There are areas of missing coral rocks along the north face of the arch.

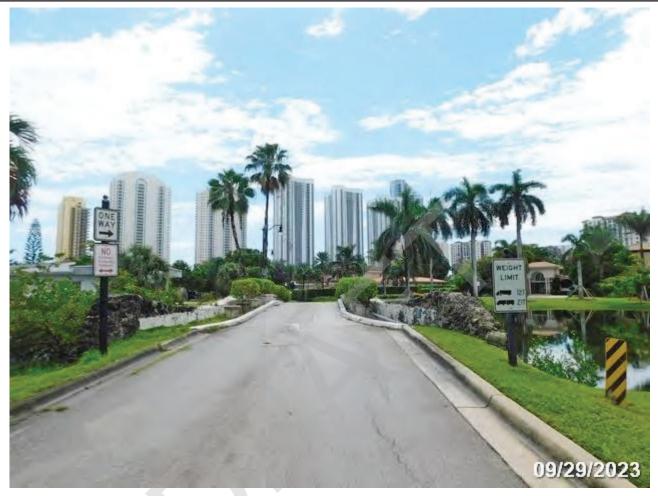
PHOTO 8: ELEMENT/ENV: 144/4 Re Conc Arch

The southwest object marker is substandard and the northwest marker is missing.

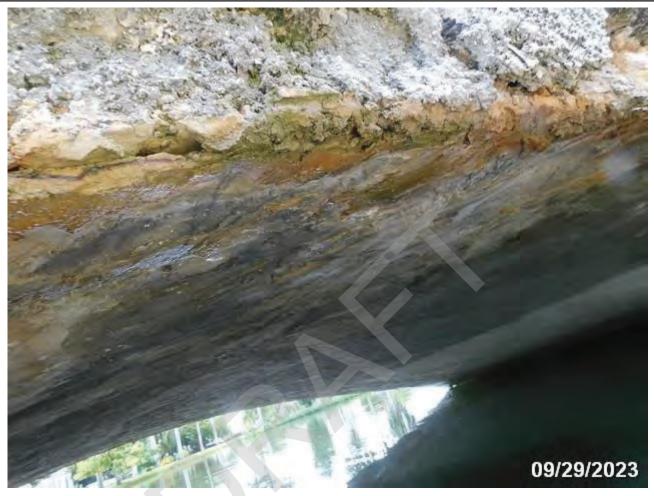
PHOTO 9: ELEMENT/ENV: 144/4 Re Conc Arch

The north bottom edge of the arch exhibits intermittent spalling throughout with exposed rebar having up to 100% S.L. along the full length of the arch.

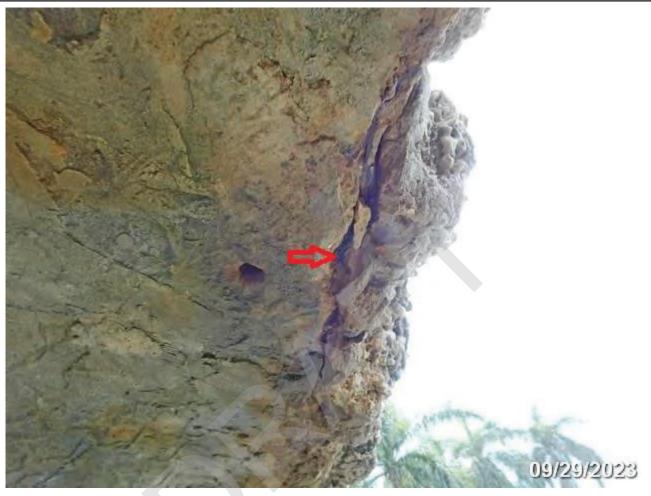
PHOTO 10: ELEMENT/ENV: 144/4 Re Conc Arch

The south side of the arch exhibits spalls/delamination and unsound repaired areas measuring up to 18in. L x 10in. W x 2in. D with minor exposed steel and areas of corrosion stains at random locations throughout the length of the arch along the fallen coral rock.

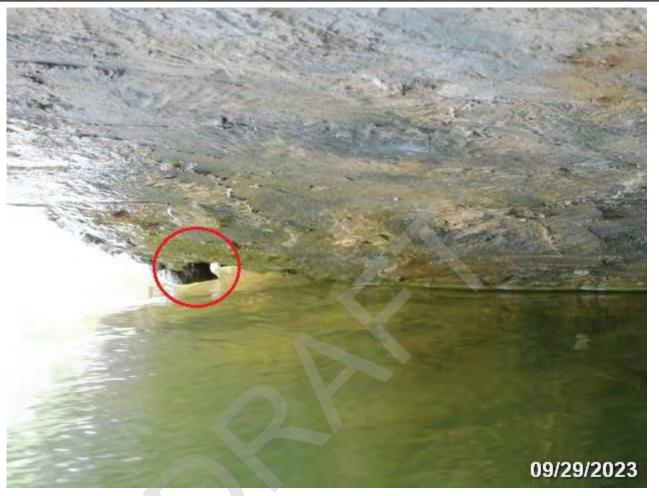
PHOTO 12: ELEMENT/ENV: 144/4 Re Conc Arch

The arch underside exhibits a spall 32in. L x 17in. W x 5in. D with no visible exposed steel, at the SW corner.

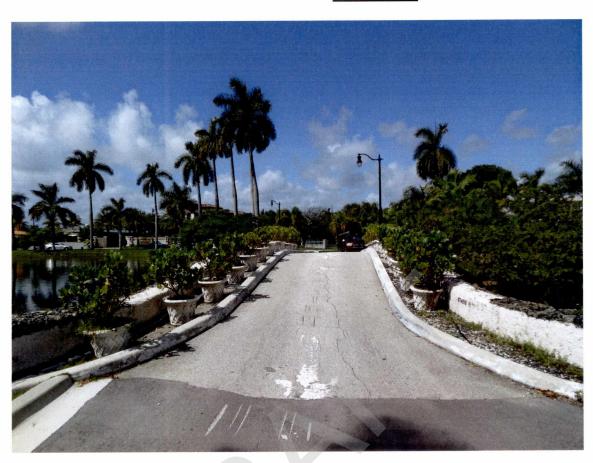
Longitudinal crack through asphalt on Bridge

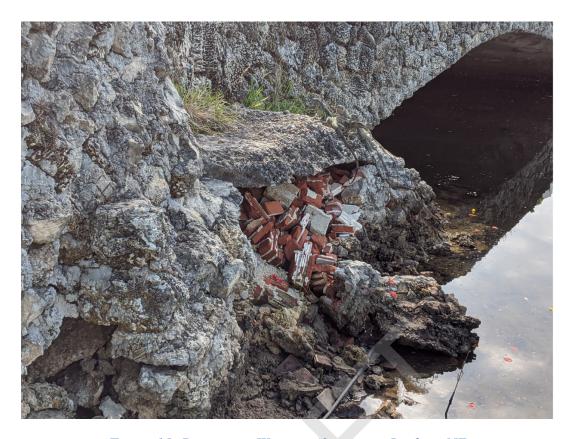
Figure 15: Damage to Western Abutment – Looking NE

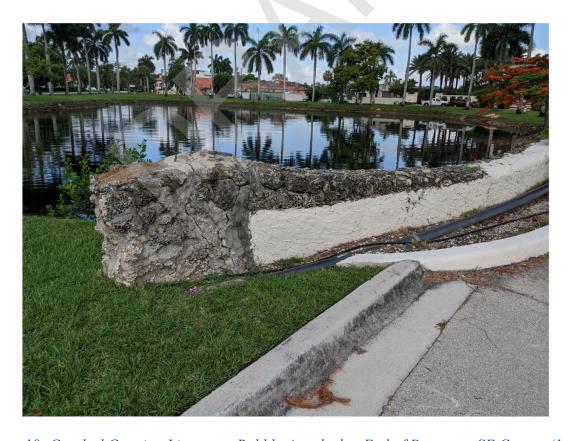
Figure 18: Cracked Coquina Limestone Rubble Attached to End of Parapet – SE Corner (1 of 2)

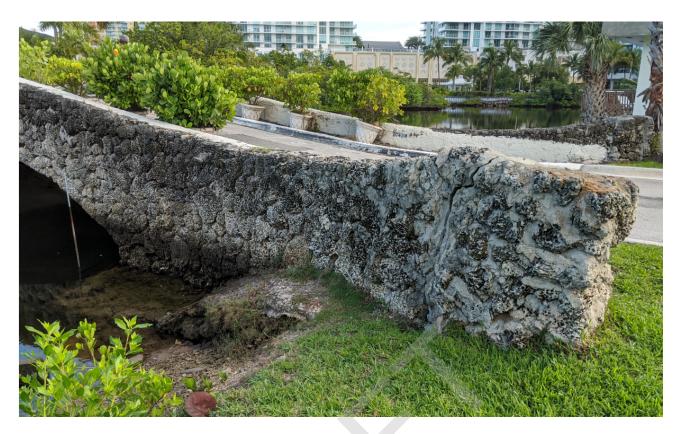
Figure 19: Cracked Coquina Limestone Rubble Attached to End of Parapet – SE Corner (2 of 2)

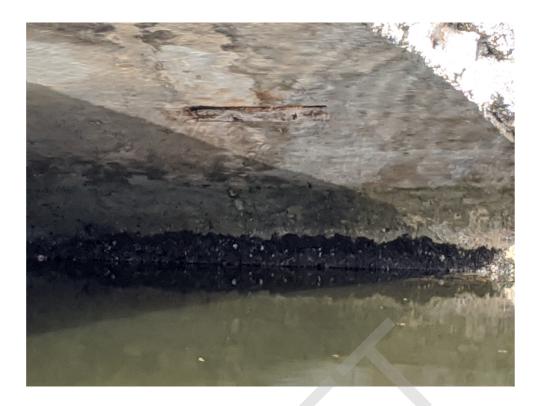
Figure 23: Damaged Stucco at Underside of Bridge Covered with Wooden Plank – Looking East

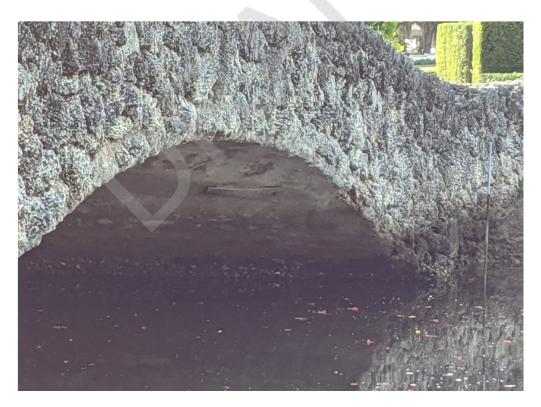
Figure 24: Damaged Stucco at Underside of Bridge Covered with Wooden Plank – Looking West
