**Atlantic Isle at West of SR A1A
Bridge No. 874218
Project Development and Environment Study**

Location Hydraulic Report

Atlantic Isle at West of SR A1A, Bridge No. 874218

Atlantic Avenue, 0.25 mile west of SR A1A

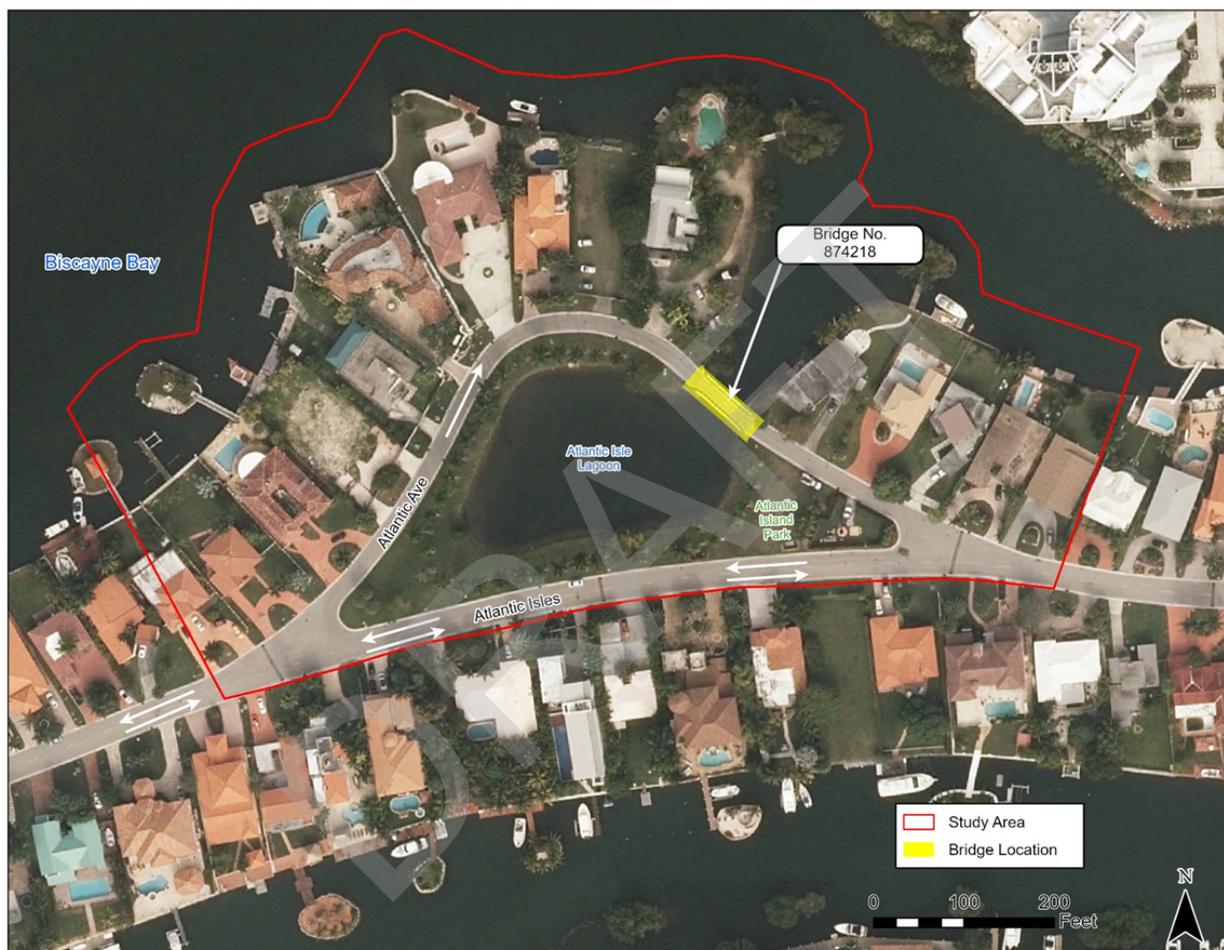
Figure 1-2 Project Study Area

The bridge is open to vehicular traffic that meets posted weight restrictions and is used for access to the residential properties on Atlantic Avenue. The Atlantic Avenue roadway typical section east and west of the bridge consists of 16 feet of pavement utilized by one-way traffic with curb and gutter on the outside. The posted speed limit along Atlantic Isle and Atlantic Avenue is 20 miles per hour. **Figure 1-2** shows the current traffic pattern at the project location, as well as the project study area. The project study area is within the historic triangular landscape of the Atlantic Island Park [Florida Master Site File (FMSF) No. 8DA6433], which is both privately and publicly owned.

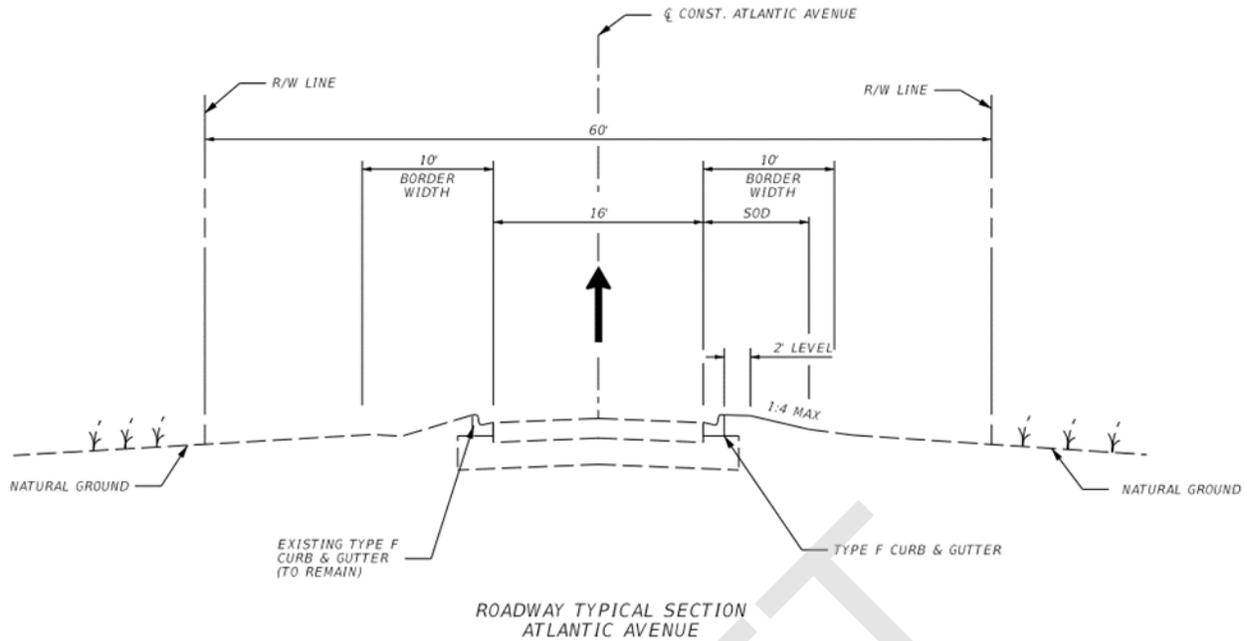
Figure 3-1. Existing Atlantic Avenue Roadway Typical Section

The eastern roadway departure of Atlantic Avenue from the Atlantic Isle Bridge is 16 feet wide and approximately 180 feet in length. Like the west approach, the roadway is bordered by a type “F” curb and gutter and drainage inlets on both sides of the roadway, as well as existing lighting on the north side. The total ROW width is 60 feet, with approximately 15 feet of horizontal clearance from the south side of the roadway to the tree line surrounding the Atlantic Isle Lagoon. Additionally, the east and west intersections of Atlantic Avenue and Atlantic Isles have no stop or yield conditions, which poses a safety issue. The existing typical section for Atlantic Avenue is presented on **Figure 3-1**.

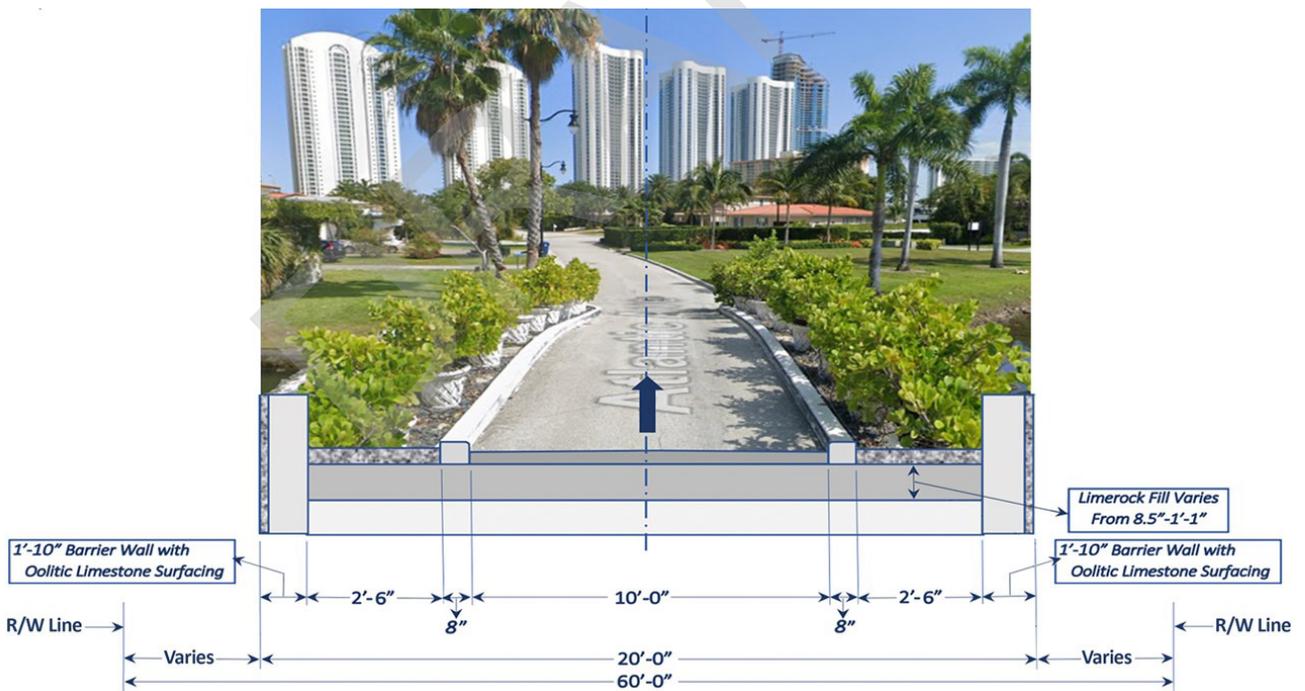
Figure 3-2. Existing Atlantic Avenue Bridge Typical Section

As depicted on **Figure 3-2**, the existing bridge typical section consists of one 10-foot-wide traffic lane and 8-inch-wide raised curbs on both sides. The overall width of the bridge is 20 feet, which accommodates the one-way travel lane centered over the bridge with type “D” curbs and a 2.5-foot-wide planter easement with a bed of river rock stone between the curb and the concrete arch walls on each side. The bridge spans approximately 43 feet over the waterway. The concrete arch walls rise above the roadway to provide parapets, which also serve as traffic barriers. The posted speed limit in the vicinity of the bridge is 20 mph.

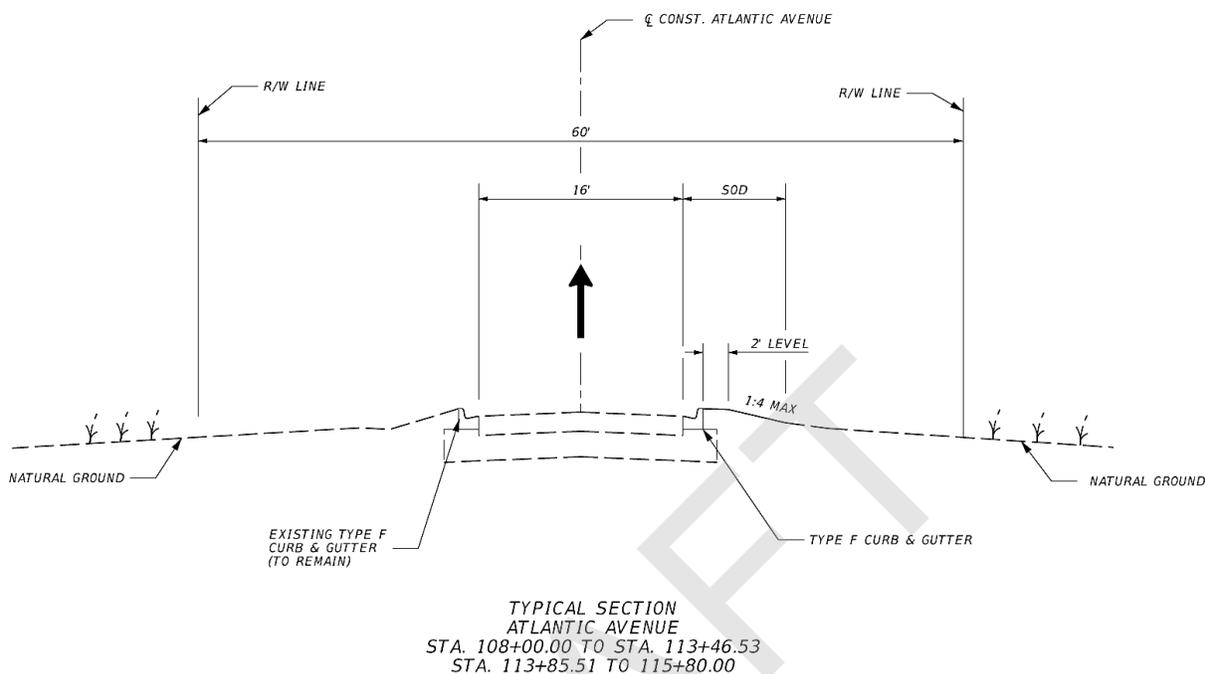
Figure 4-1. Proposed Atlantic Avenue Roadway Typical Section

The recommended typical section for the Atlantic Avenue includes one 16-foot-wide travel lane for one-way travel and remains within the existing 60-foot-wide ROW. **Figure 4-1** presents the proposed typical section.

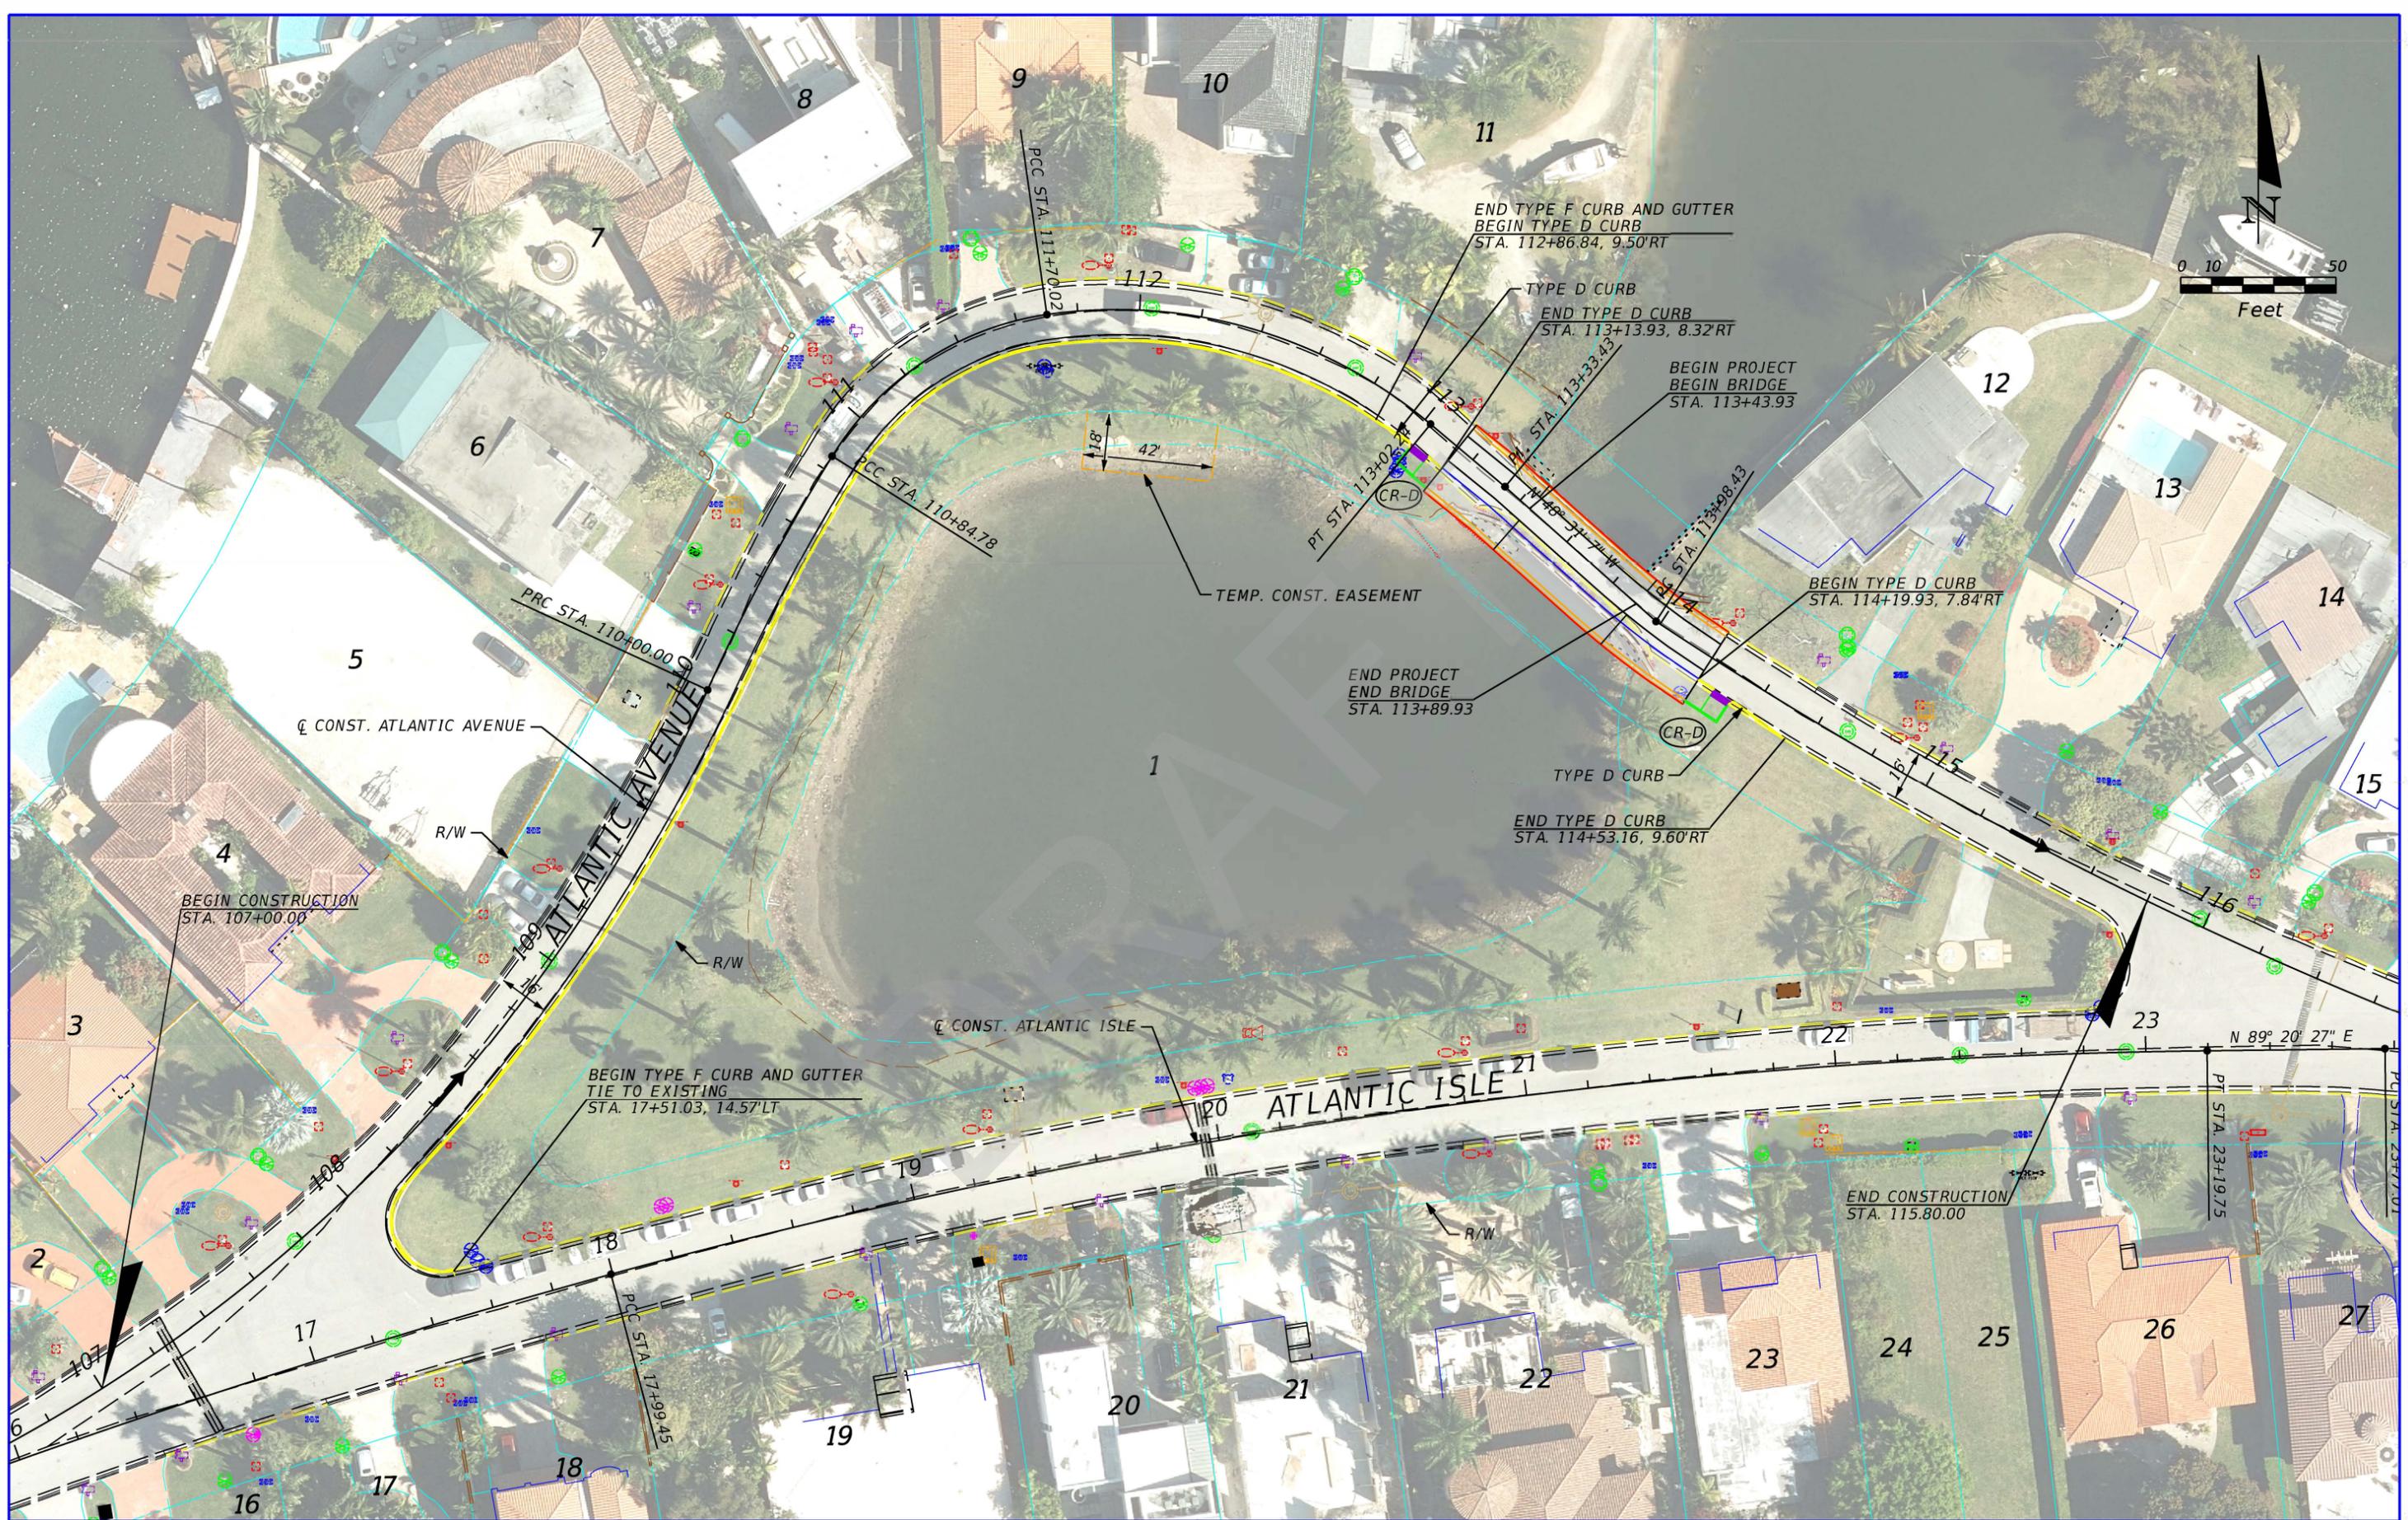
PLAN SHEET
BRIDGE REPLACEMENT (ALT 2)

BEGIN/END BRIDGE STATIONS SUBJECT TO CHANGE
 BRIDGE SHOWN IS ONLY TO DETERMINE VERTICAL CLEARANCE AND DOES NOT REPRESENT THE ACTUAL BRIDGE APPEARANCE

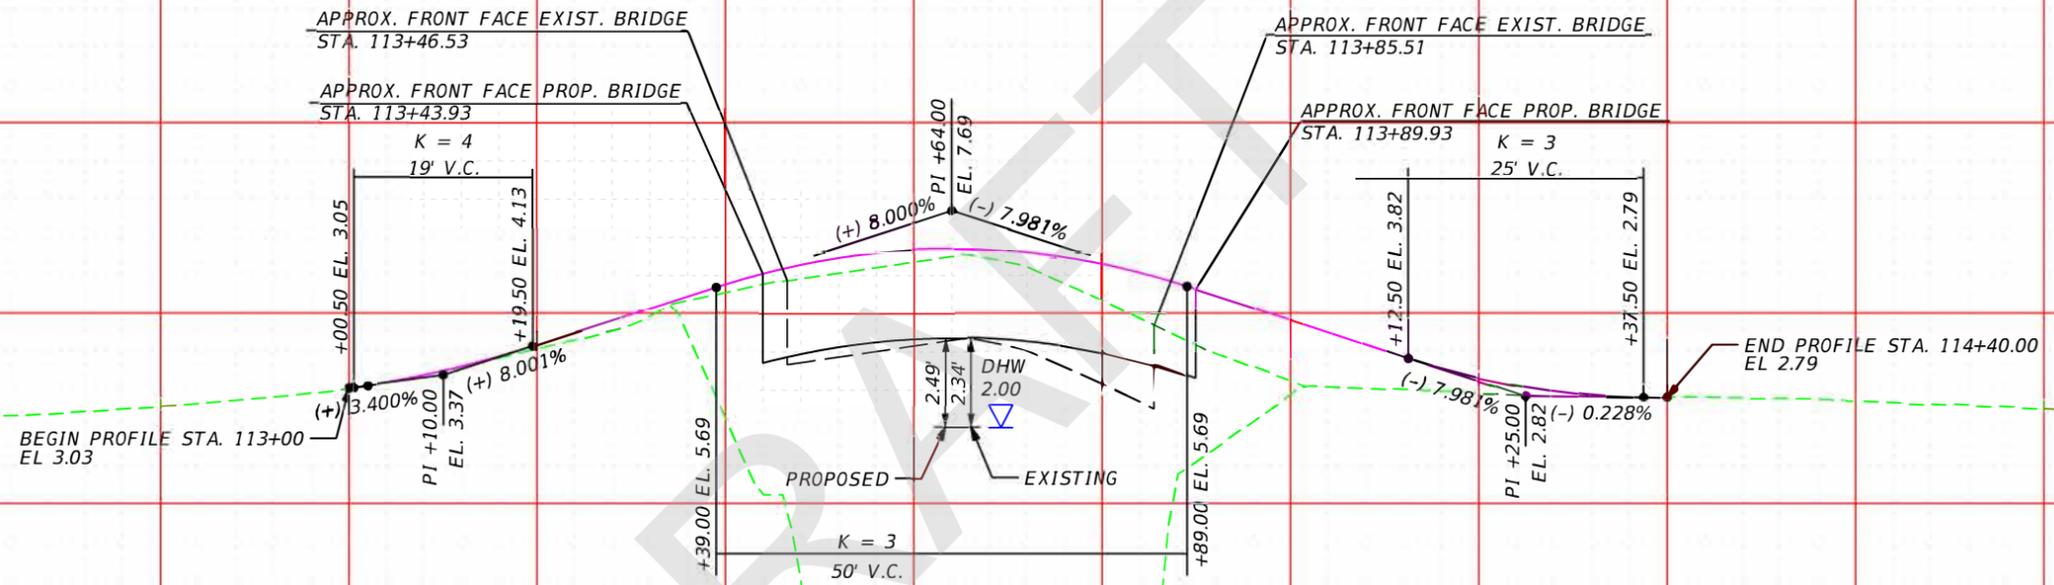
PROFILE SHEET
BRIDGE REPLACEMENT (ALT 2)

SCALE:
 1" = 20' HORIZONTAL
 1" = 5' VERTICAL

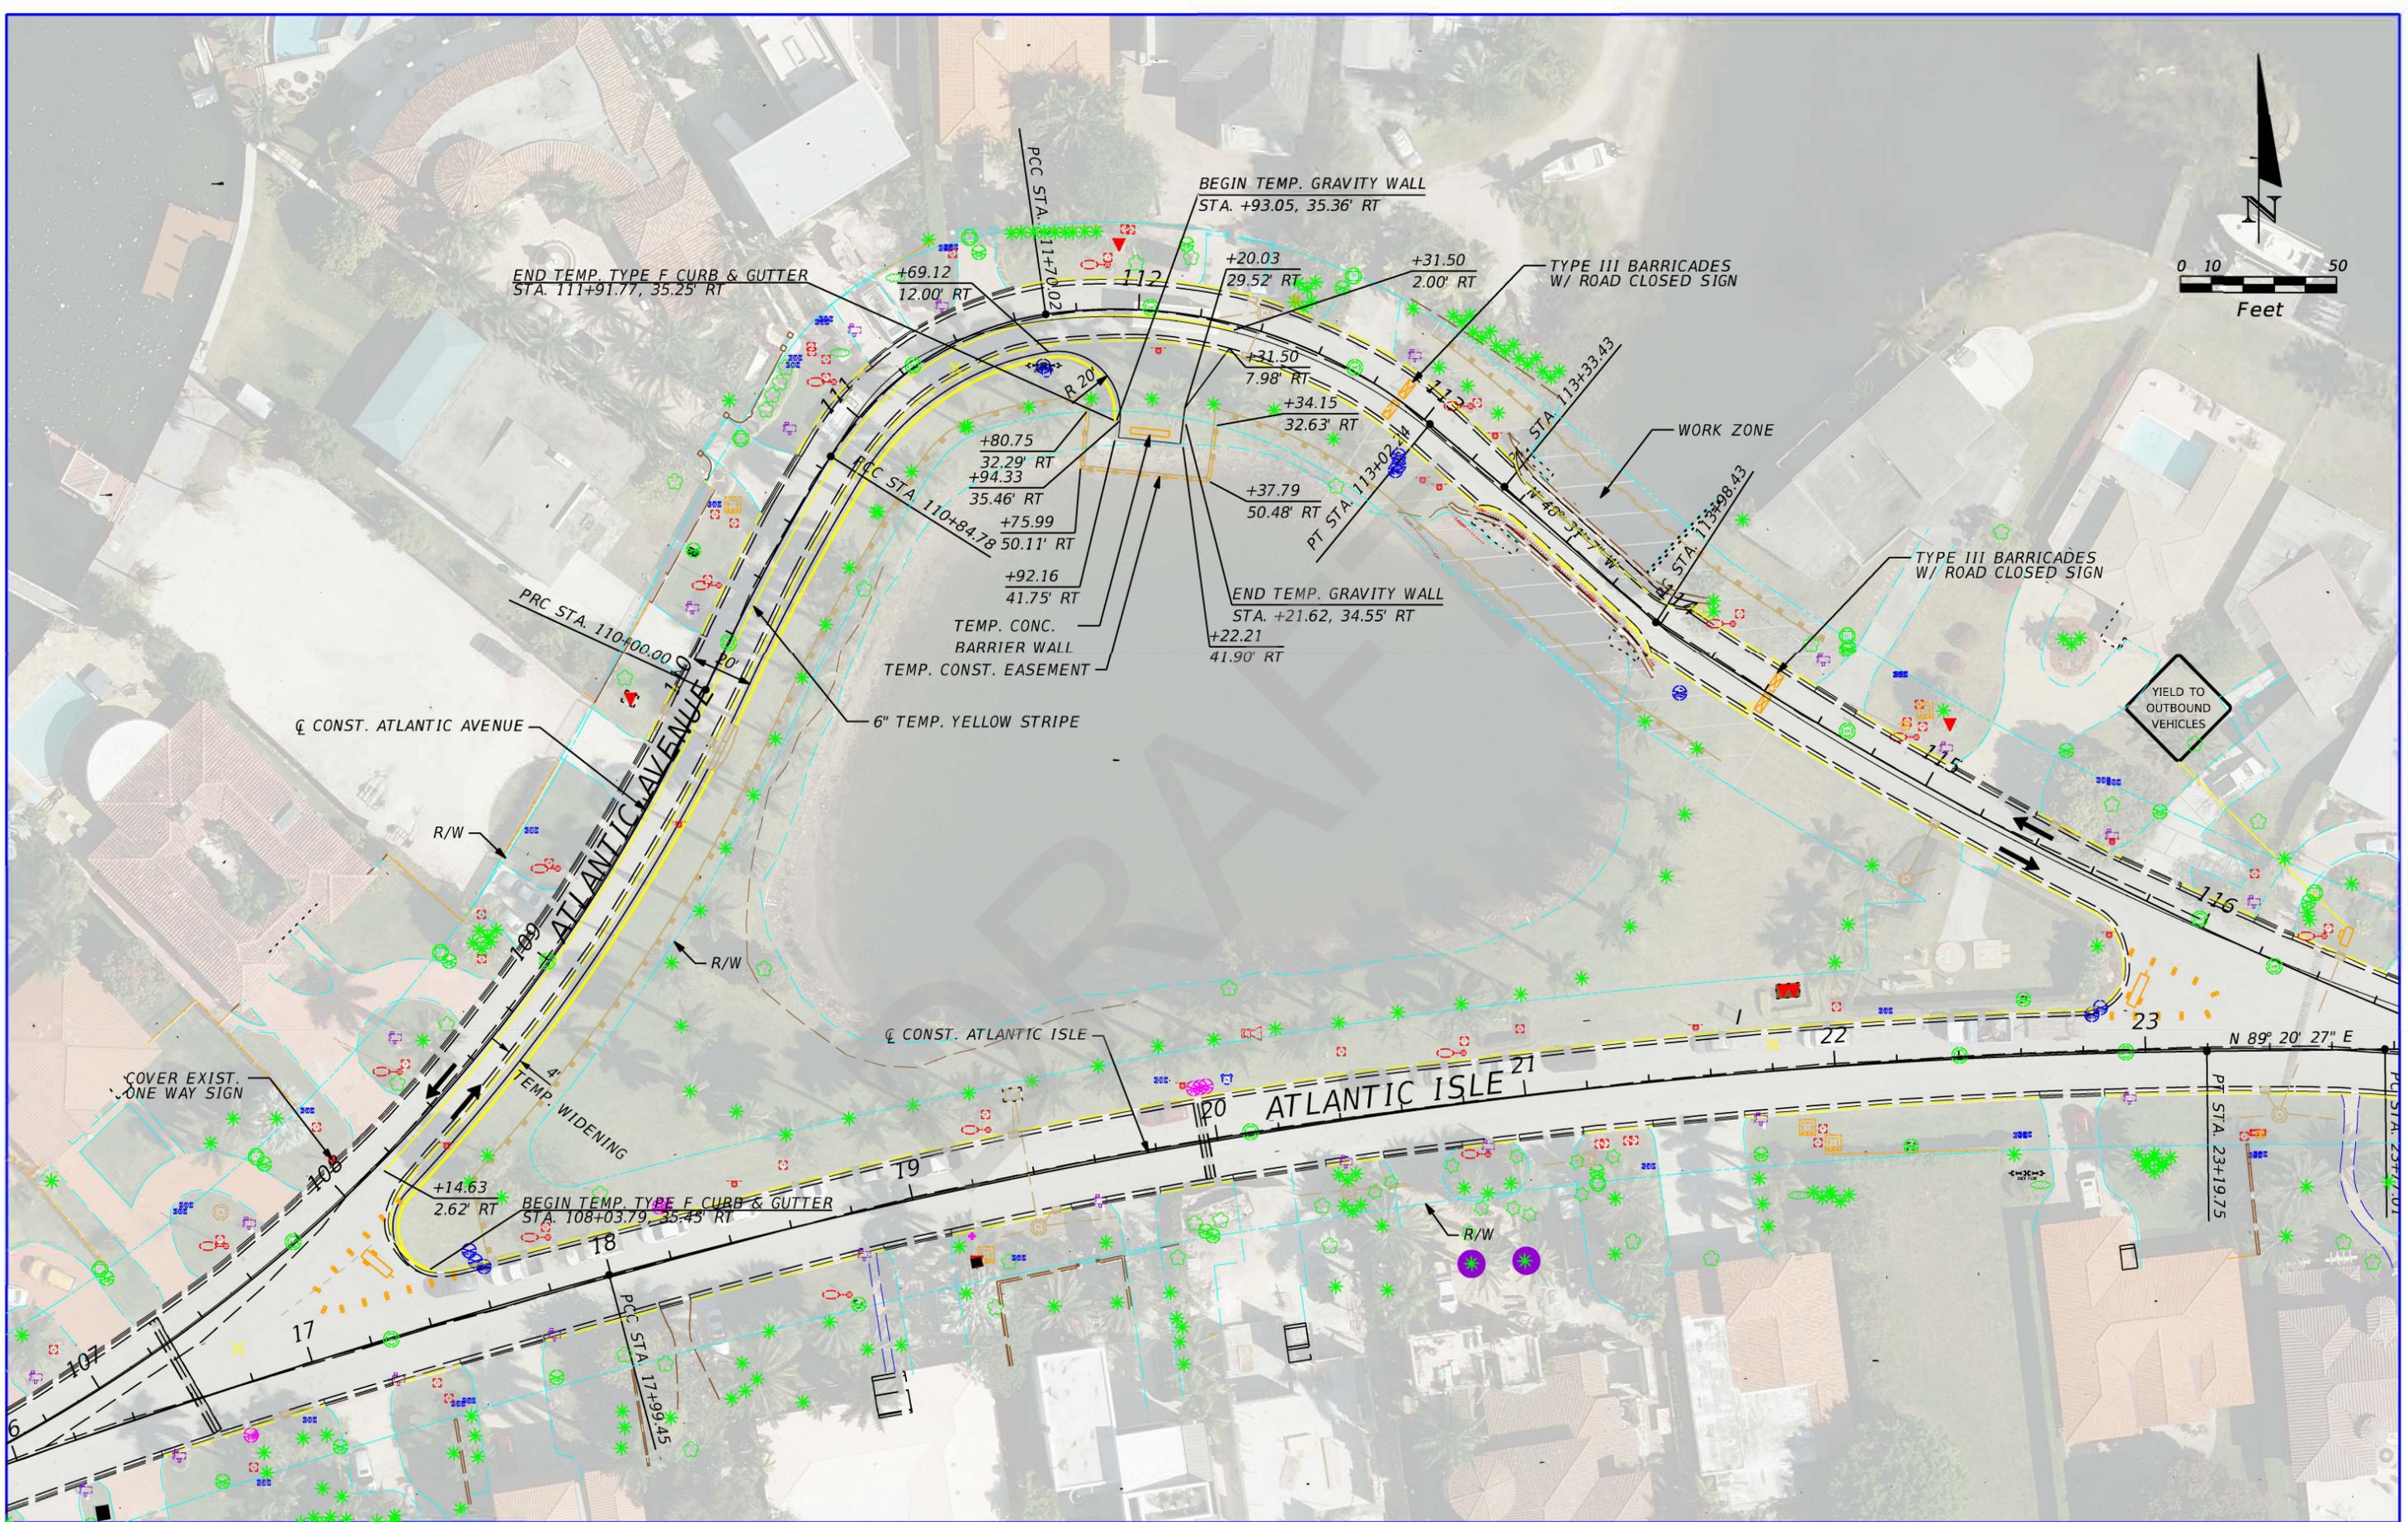
TRAFFIC CONTROL PLAN
BRIDGE REPLACEMENT (ALT 2)

- INSTALL TEMPORARY CONCRETE BARRIER WALL.
- SHIFT TRAFFIC TO THE LEFT SIDE OF THE ROADWAY.
- REMOVE TEMPORARY CURB & GUTTER, DRAINAGE, WIDENING AND TURNOUTS.
- CONSTRUCT NEW CURB AND GUTTER.
- REMOVE TEMPORARY CONCRETE BARRIER WALL.
- ALLOW FOR TWO-WAY TRAFFIC.

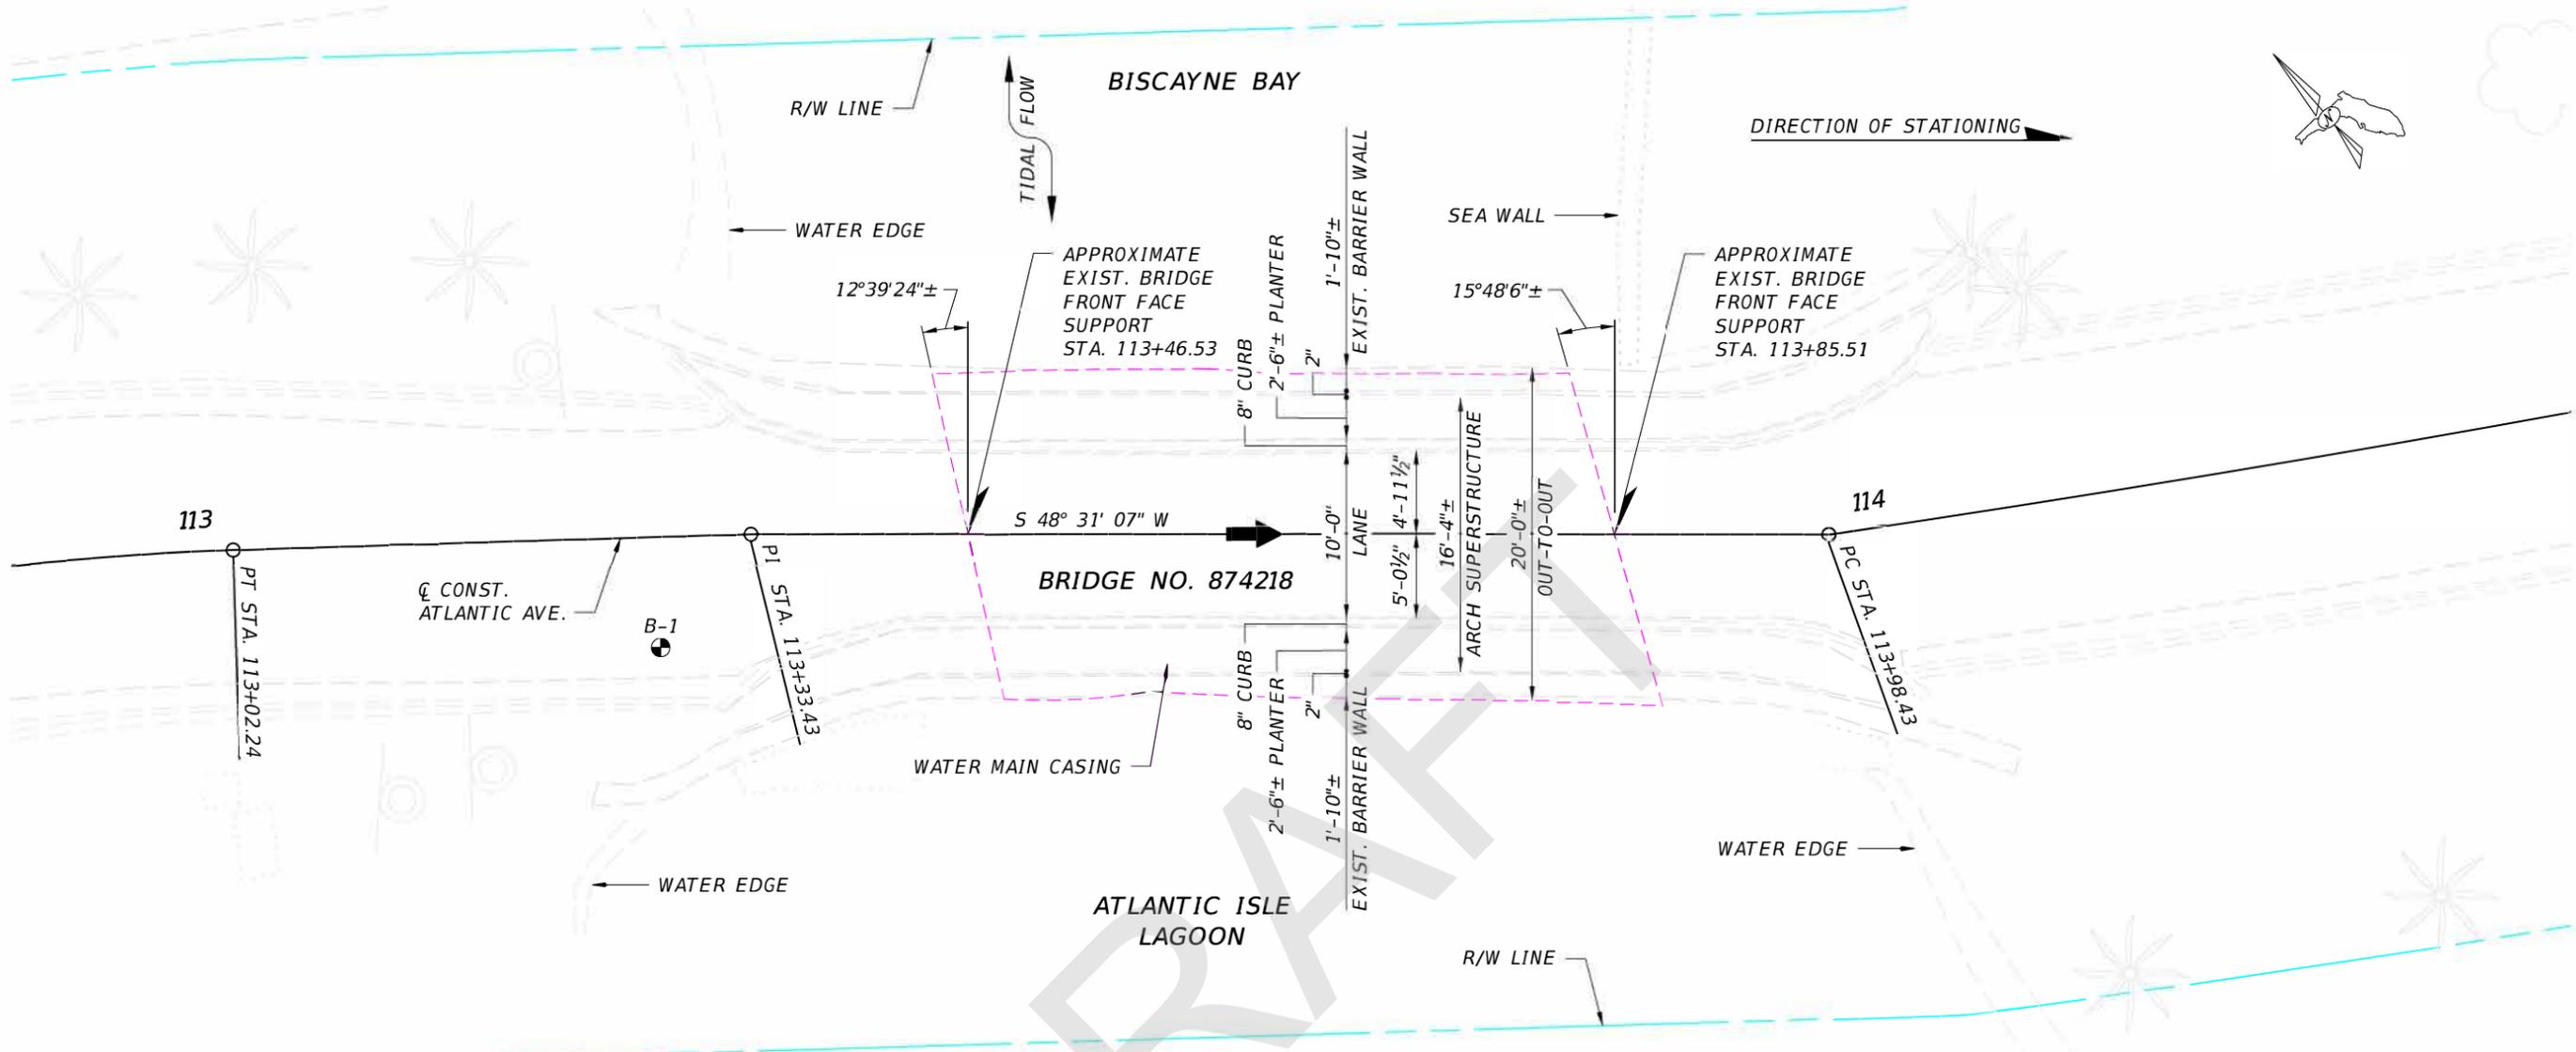
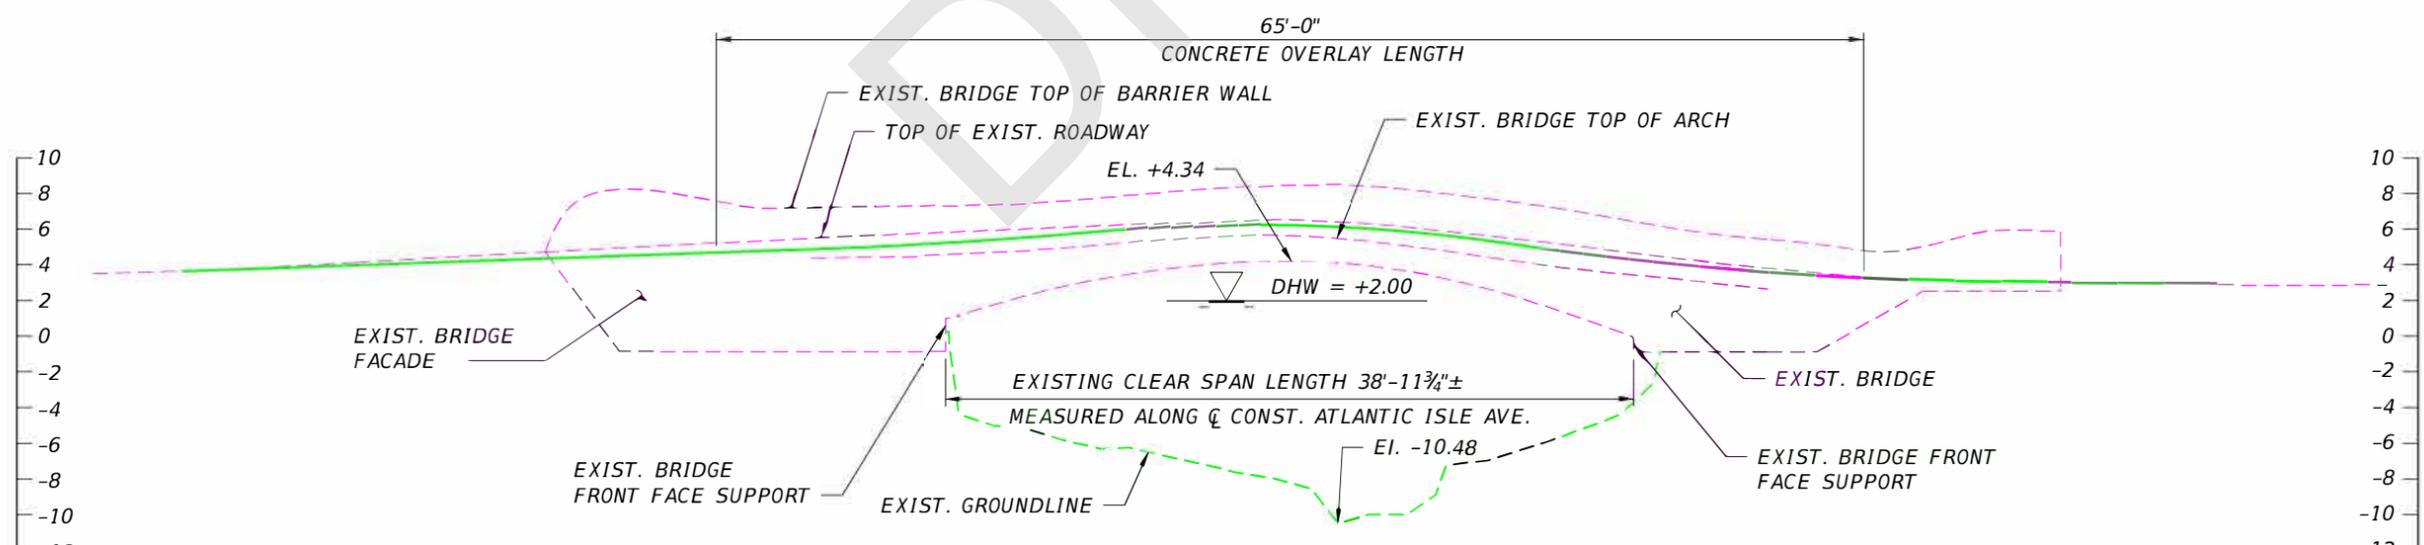
REVISIONS						DRAWN BY: EAG	STATE OF FLORIDA DEPARTMENT OF TRANSPORTATION			SHEET TITLE: EXISTING BRIDGE PLAN AND ELEVATION	REF. DWG. NO.
DATE	BY	DESCRIPTION	DATE	BY	DESCRIPTION		ROAD NO.	COUNTY	F INANCIAL PROJECT ID		
							N/A	MIAMI-DADE	430029-2-21-02	ATLANTIC AVE. OVER OCEAN CANAL	B1-4

PLAN

ELEVATION

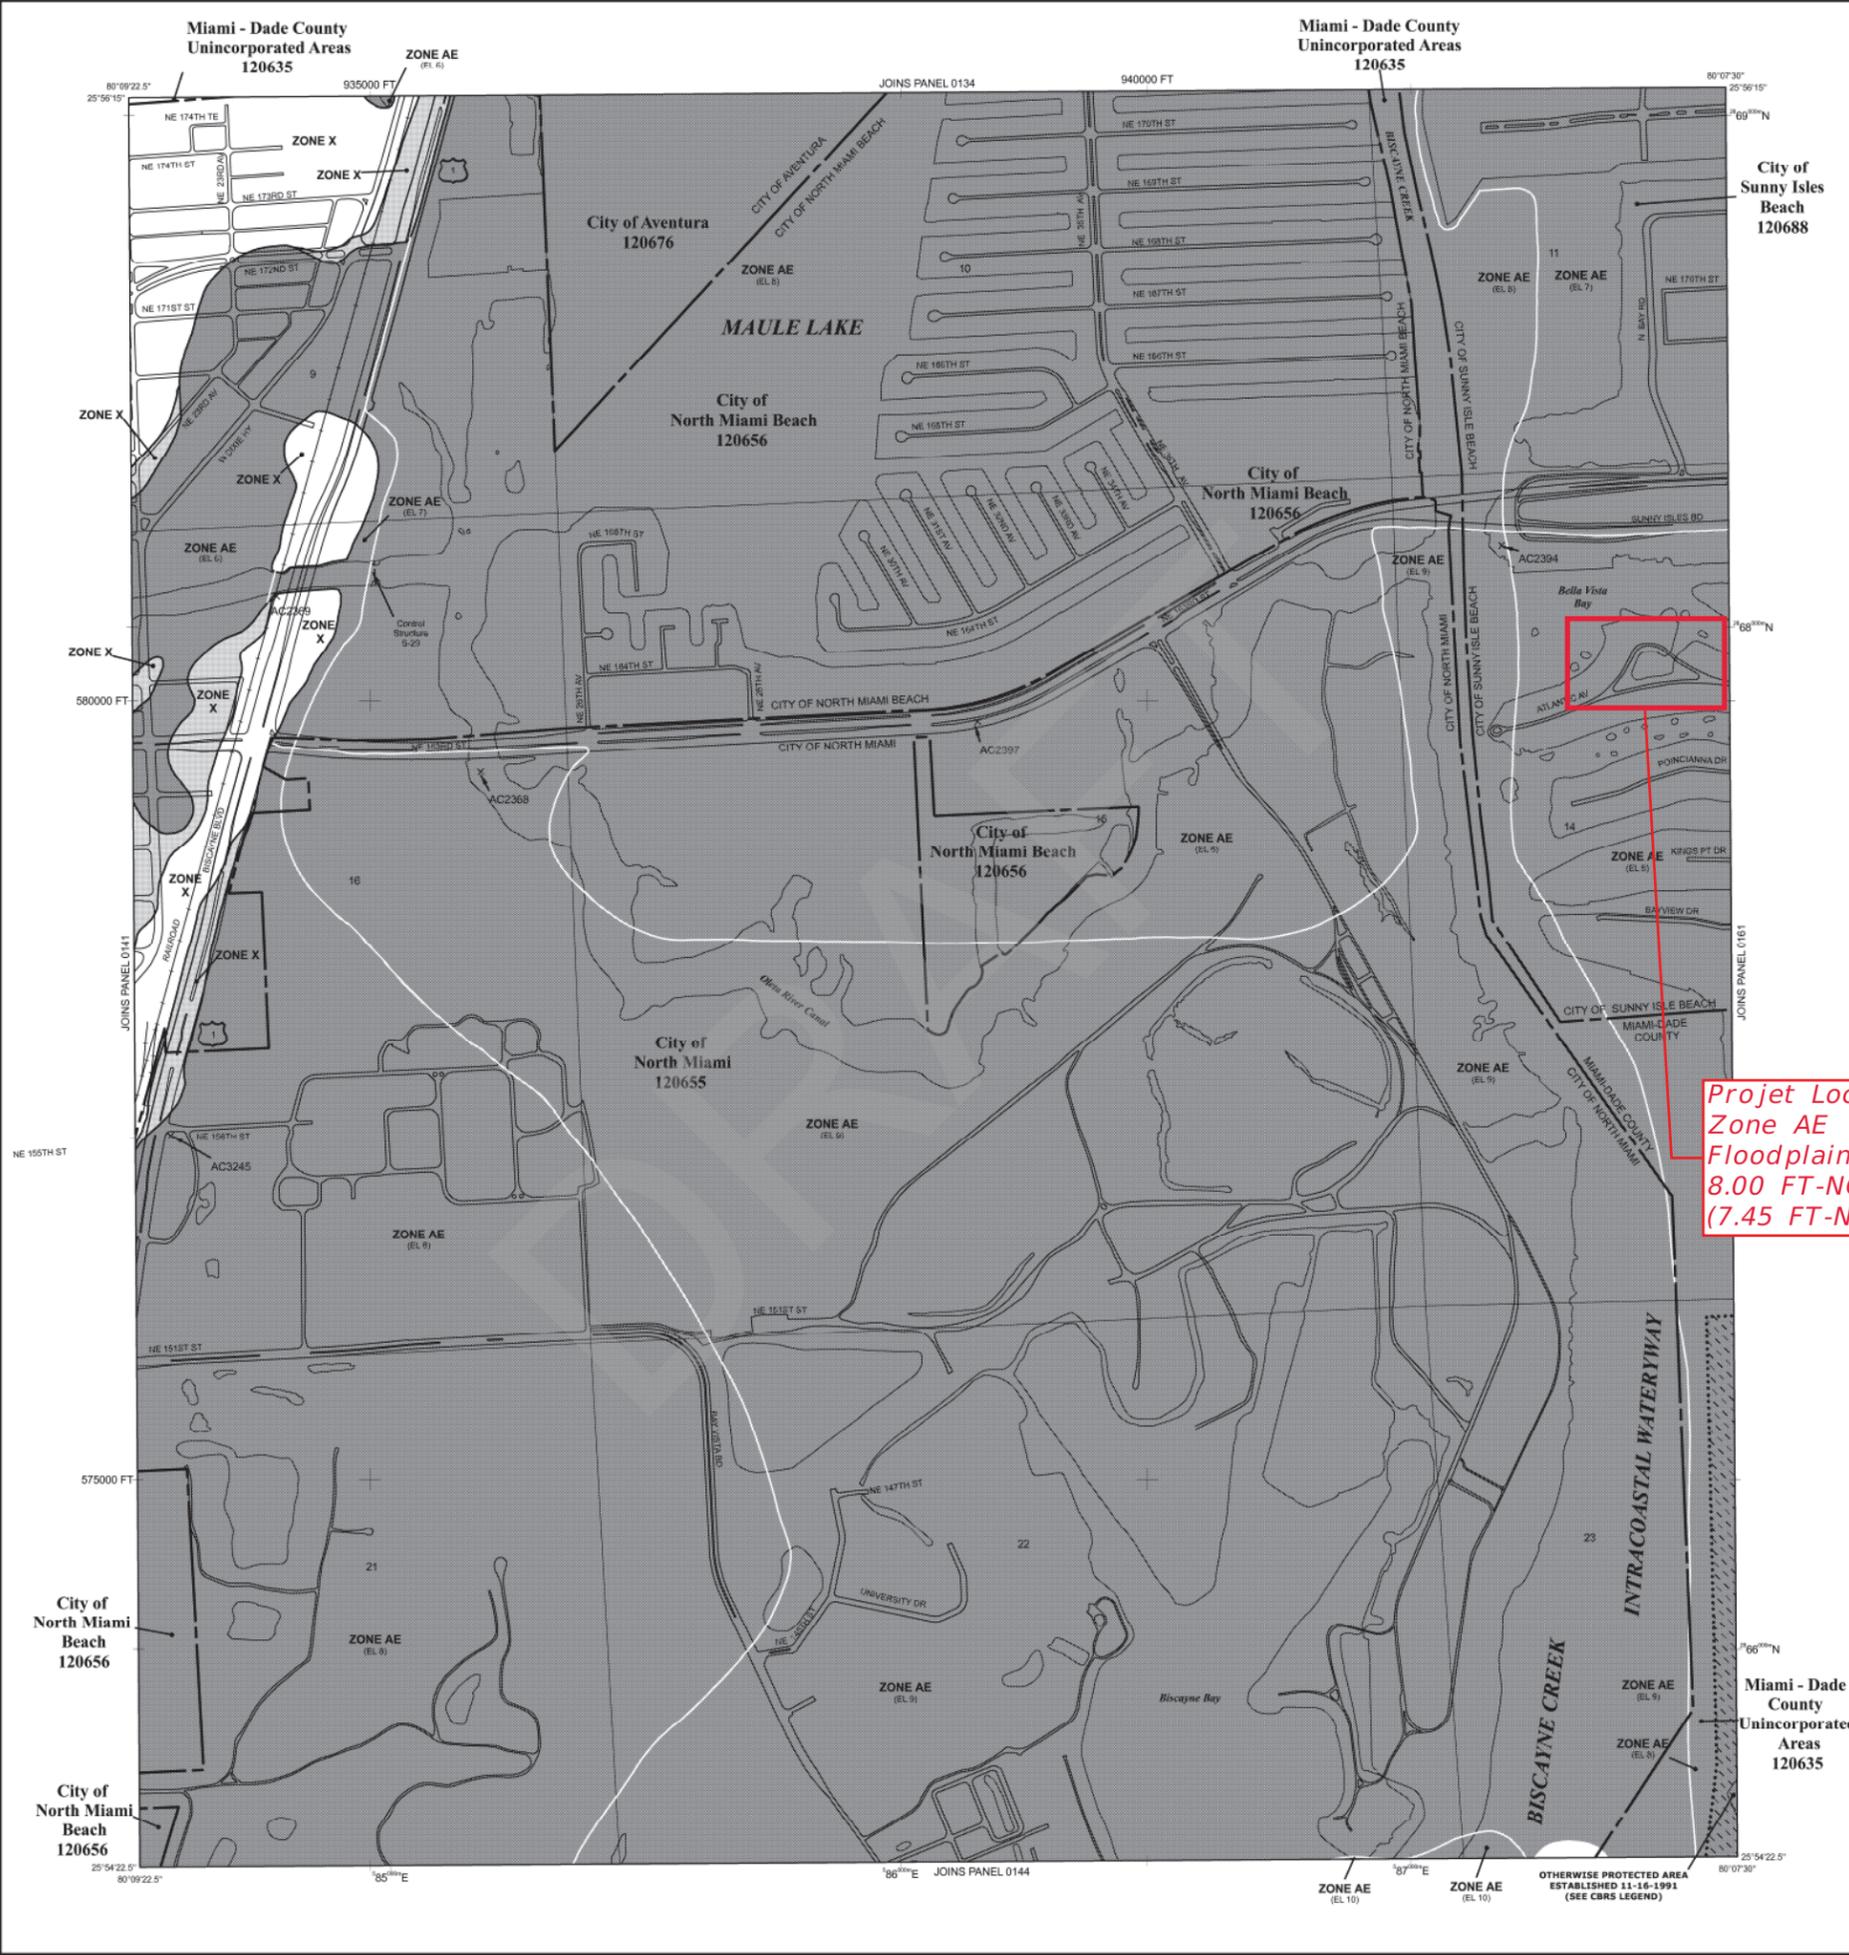
**Project Location
Zone AE
Floodplain El.
8.00 FT-NGVD
(7.45 FT-NAVD)**

According to the revised 2009 Federal Emergency Management Agency's Flood Insurance Rate Maps (FIRM) Community Panels 12086C0142L and 12086C0161L, the study area is located within Flood Zone AE, which represents an area within the Special Flood Hazard Area where base flood elevation (BFE) has been determined to be 8 ft NAVD88 (6.45 ft NGVD). The project is adjacent to the Bella Vista Bay within the City of Sunny Isle Beach and overflows into the Biscayne Bay Aquatic Preserve. There are no designated regulatory floodways within the project area. Refer to Appendix C for FIRM Maps.
