**Atlantic Isle at West of SR A1A
Bridge No. 874218
Project Development and Environment Study**

Location Hydraulic Report

Atlantic Isle at West of SR A1A, Bridge No. 874218

Atlantic Avenue, 0.25 mile west of SR A1A

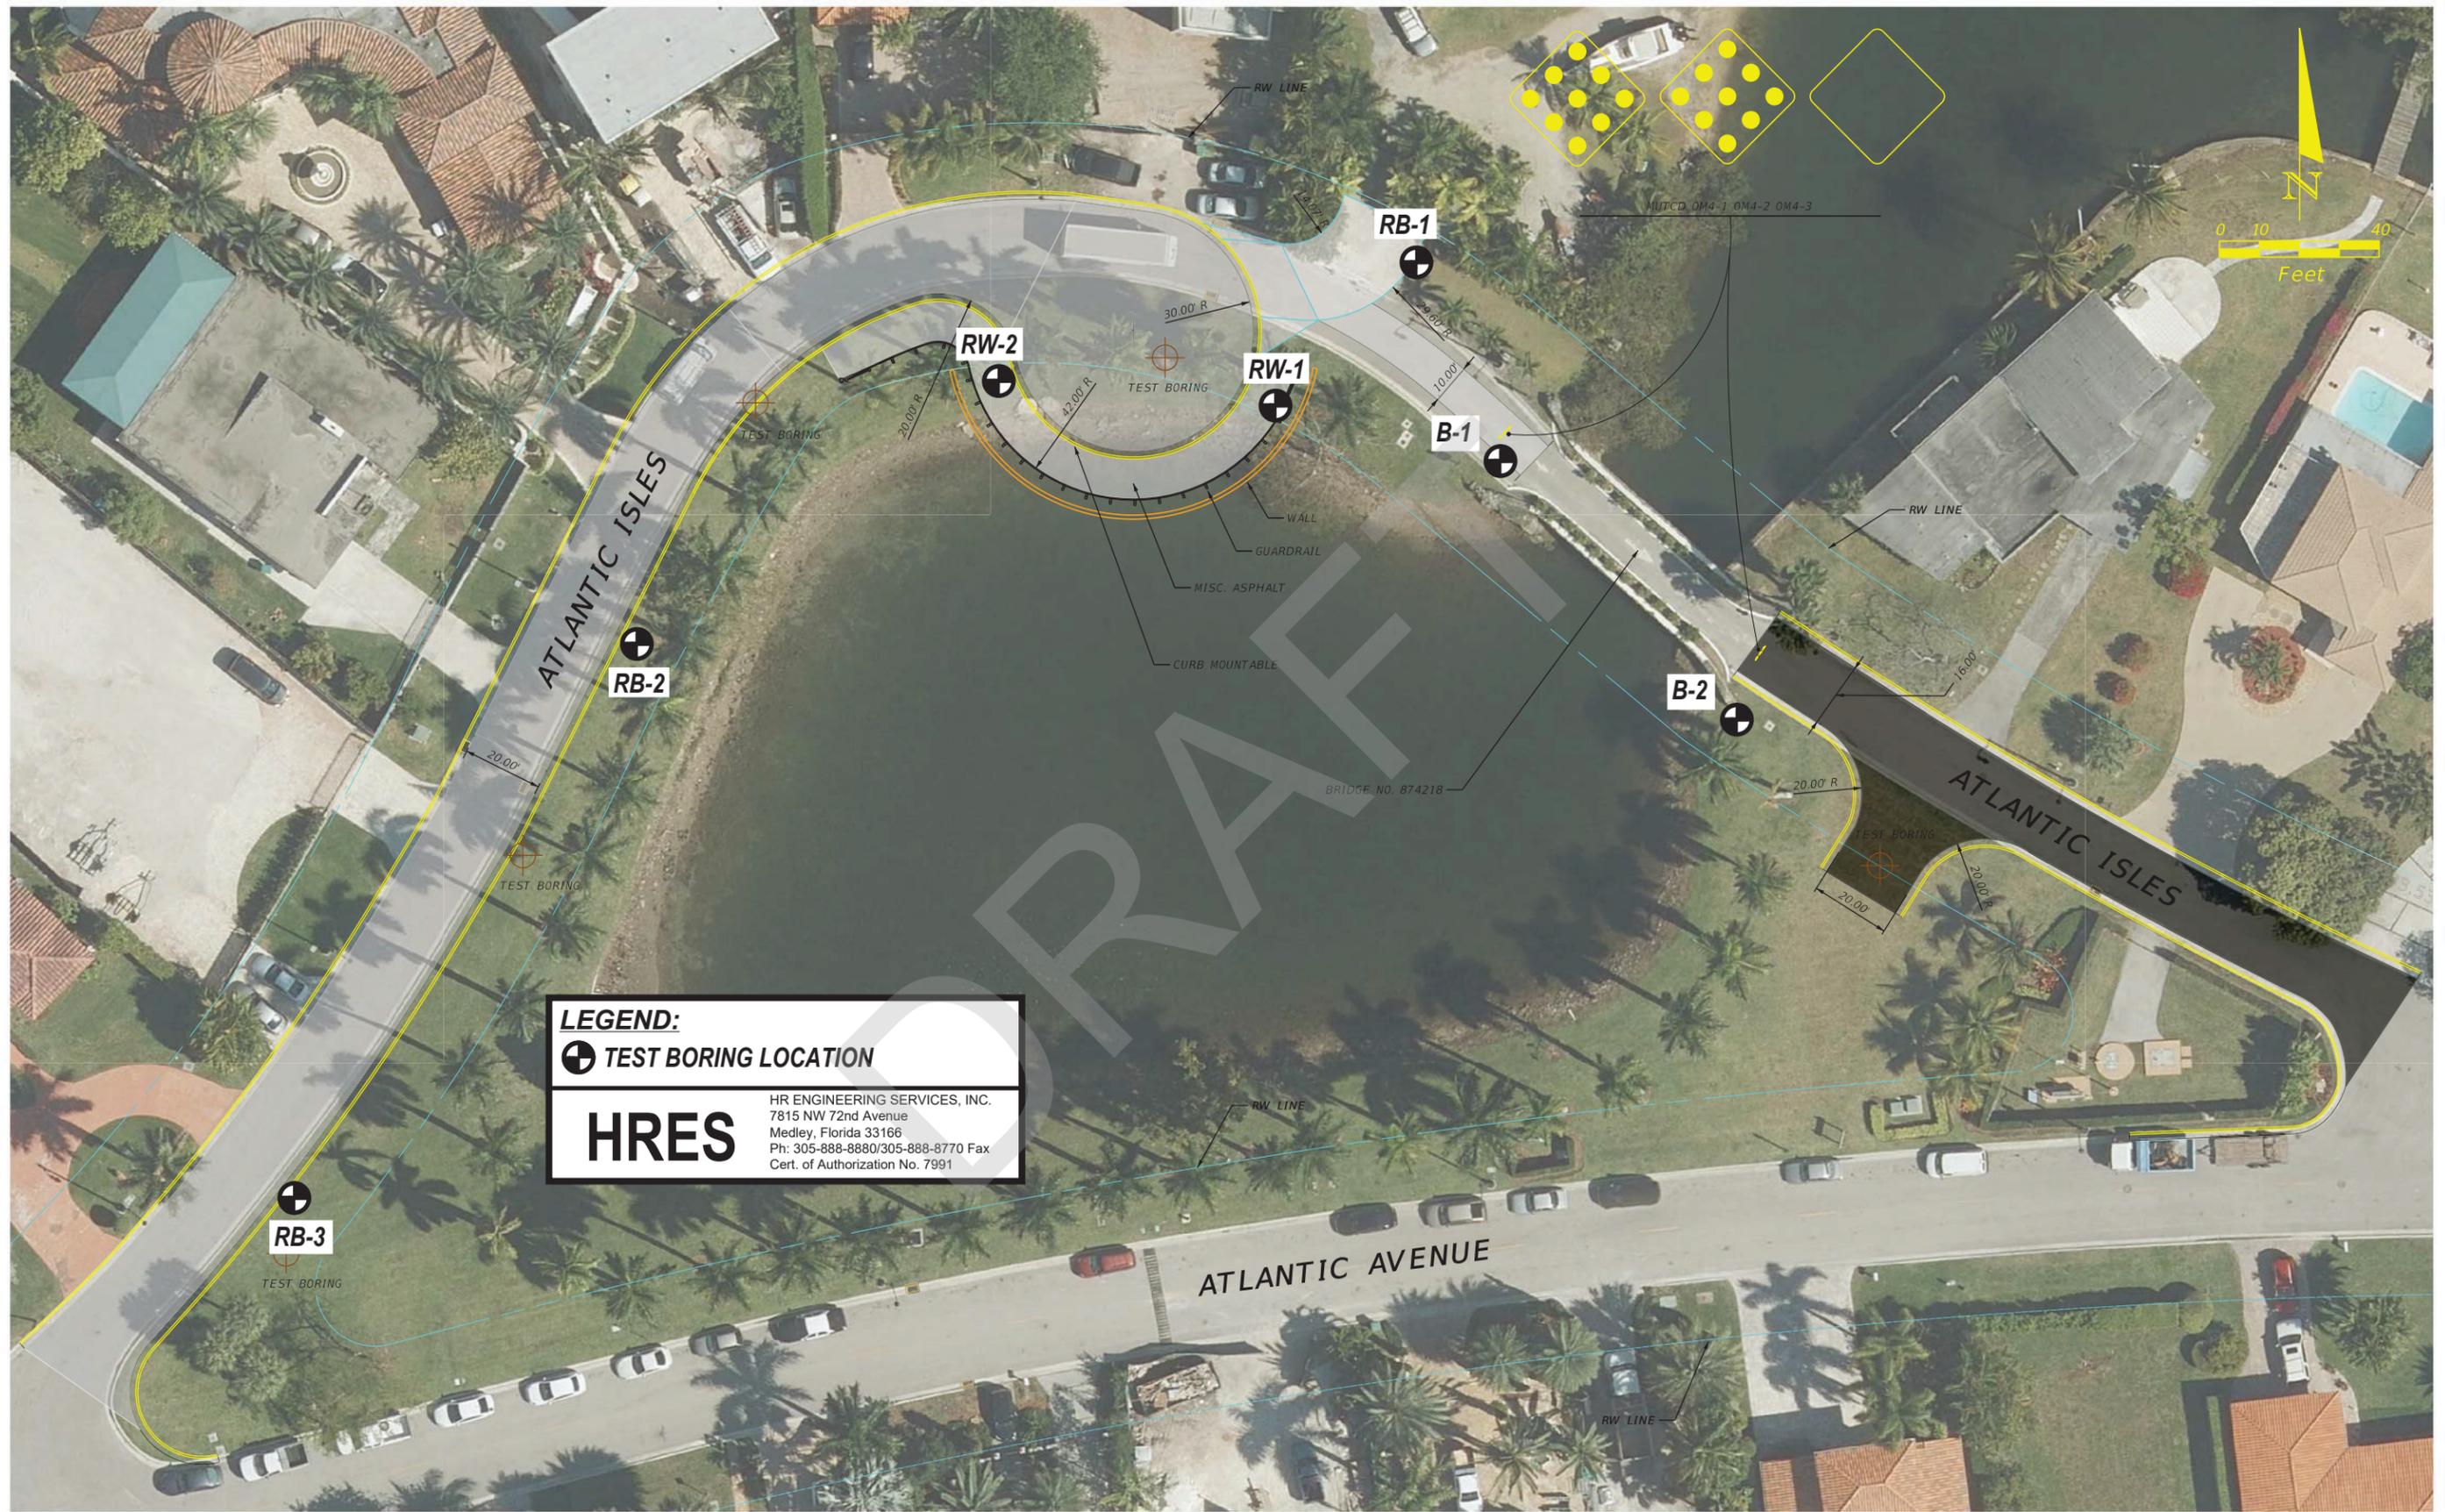
LEGEND:
 ⊕ TEST BORING LOCATION

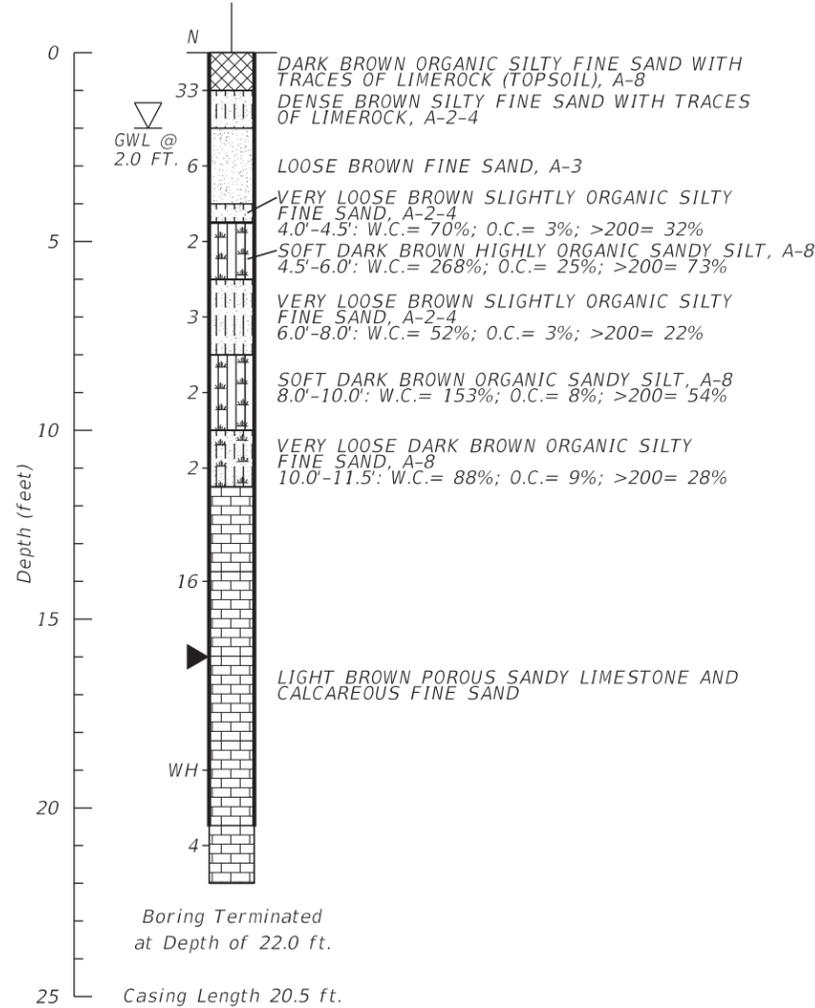
BOR # RB-3
 STA. NA
 OFF. NA
 DATE 5/13/2020
 DRILLER O. MEJIAS
 HAMMER AUTO
 RIG CME-55
 LATITUDE 25.92703°
 LONGITUDE -80.12716°

TOPSOIL		SILTY SAND
	SAND		SANDY SILT
	LIMESTONE		ORGANIC SILTY SAND
	ORGANIC SANDY SILT

A geotechnical evaluation was performed at the site in May 2020, to determine existing subsurface conditions in the vicinity of the existing bridge. As part of the evaluation, two test borings were performed, each to a depth of 80 feet measured from the existing ground surface. Exploration tests were performed at different core boring locations for soils information along the Atlantic Avenue/Isles and at the bridge approaches. Reference Appendix A for the map of core boring locations. The soil types encountered are presented in Table 3-2.

Stratum No.	USCS Classification	Soil Description
1	SM-OL	Dark brown organic silty fine sand
2	SP-SM	Loose to very loose brown fine sand with traces of limerock
3	SM-OL	Very loose dark brown organic silty fine sand
4	SP-SM	Loose gray fine sand with silt
5	ML-OL	Soft dark brown highly organic sandy silt
6	--	Light brown porous sandy limestone and calcareous fine sand
7	SP	Loose light gray fine sand
8	--	Light brown to gray porous sandy limestone and calcareous fine sand

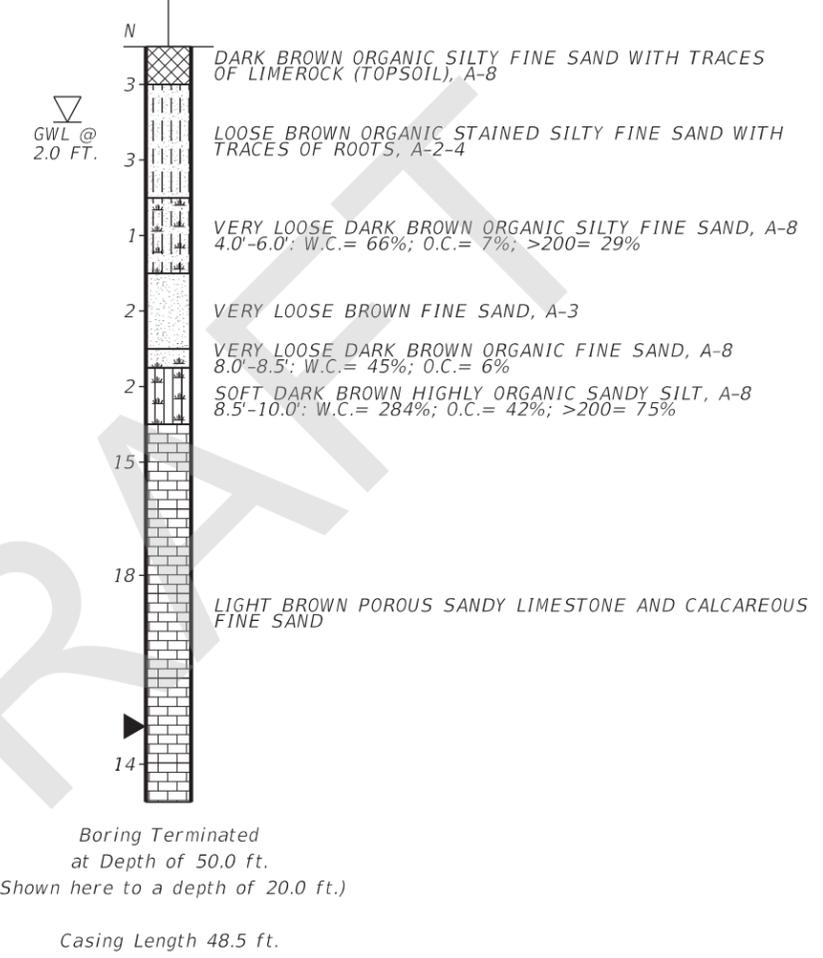
BOR # RW-2
 STA. NA
 OFF. NA
 DATE 5/12/2020
 DRILLER O. MEJIAS
 HAMMER AUTO
 RIG CME-55
 LATITUDE 25.92758
 LONGITUDE -80.12662

TOPSOIL		SILTY SAND
	SAND		SILT
	LIMESTONE		ORGANIC SILTY SAND
	ORGANIC SANDY SILT		ORGANIC SAND

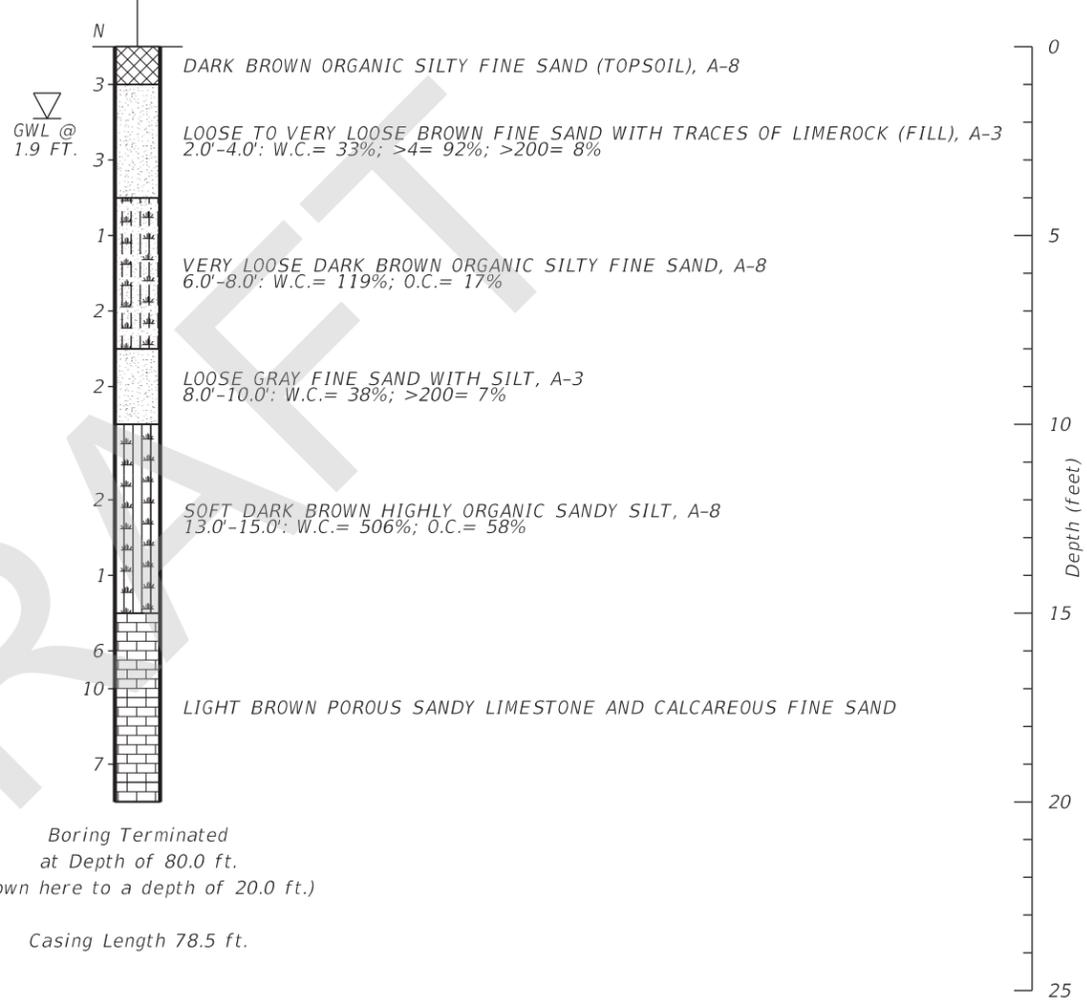
BOR # B-2
 STA. NA
 OFF. NA
 DATE 12/4/2017
 DRILLER O. MEJIAS
 HAMMER AUTO
 RIG CME-55
 LATITUDE 25.92733°
 LONGITUDE -80.12606°

TOPSOIL		SILTY SAND
	SAND		SILT
	LIMESTONE		ORGANIC SILTY SAND
	ORGANIC SANDY SILT

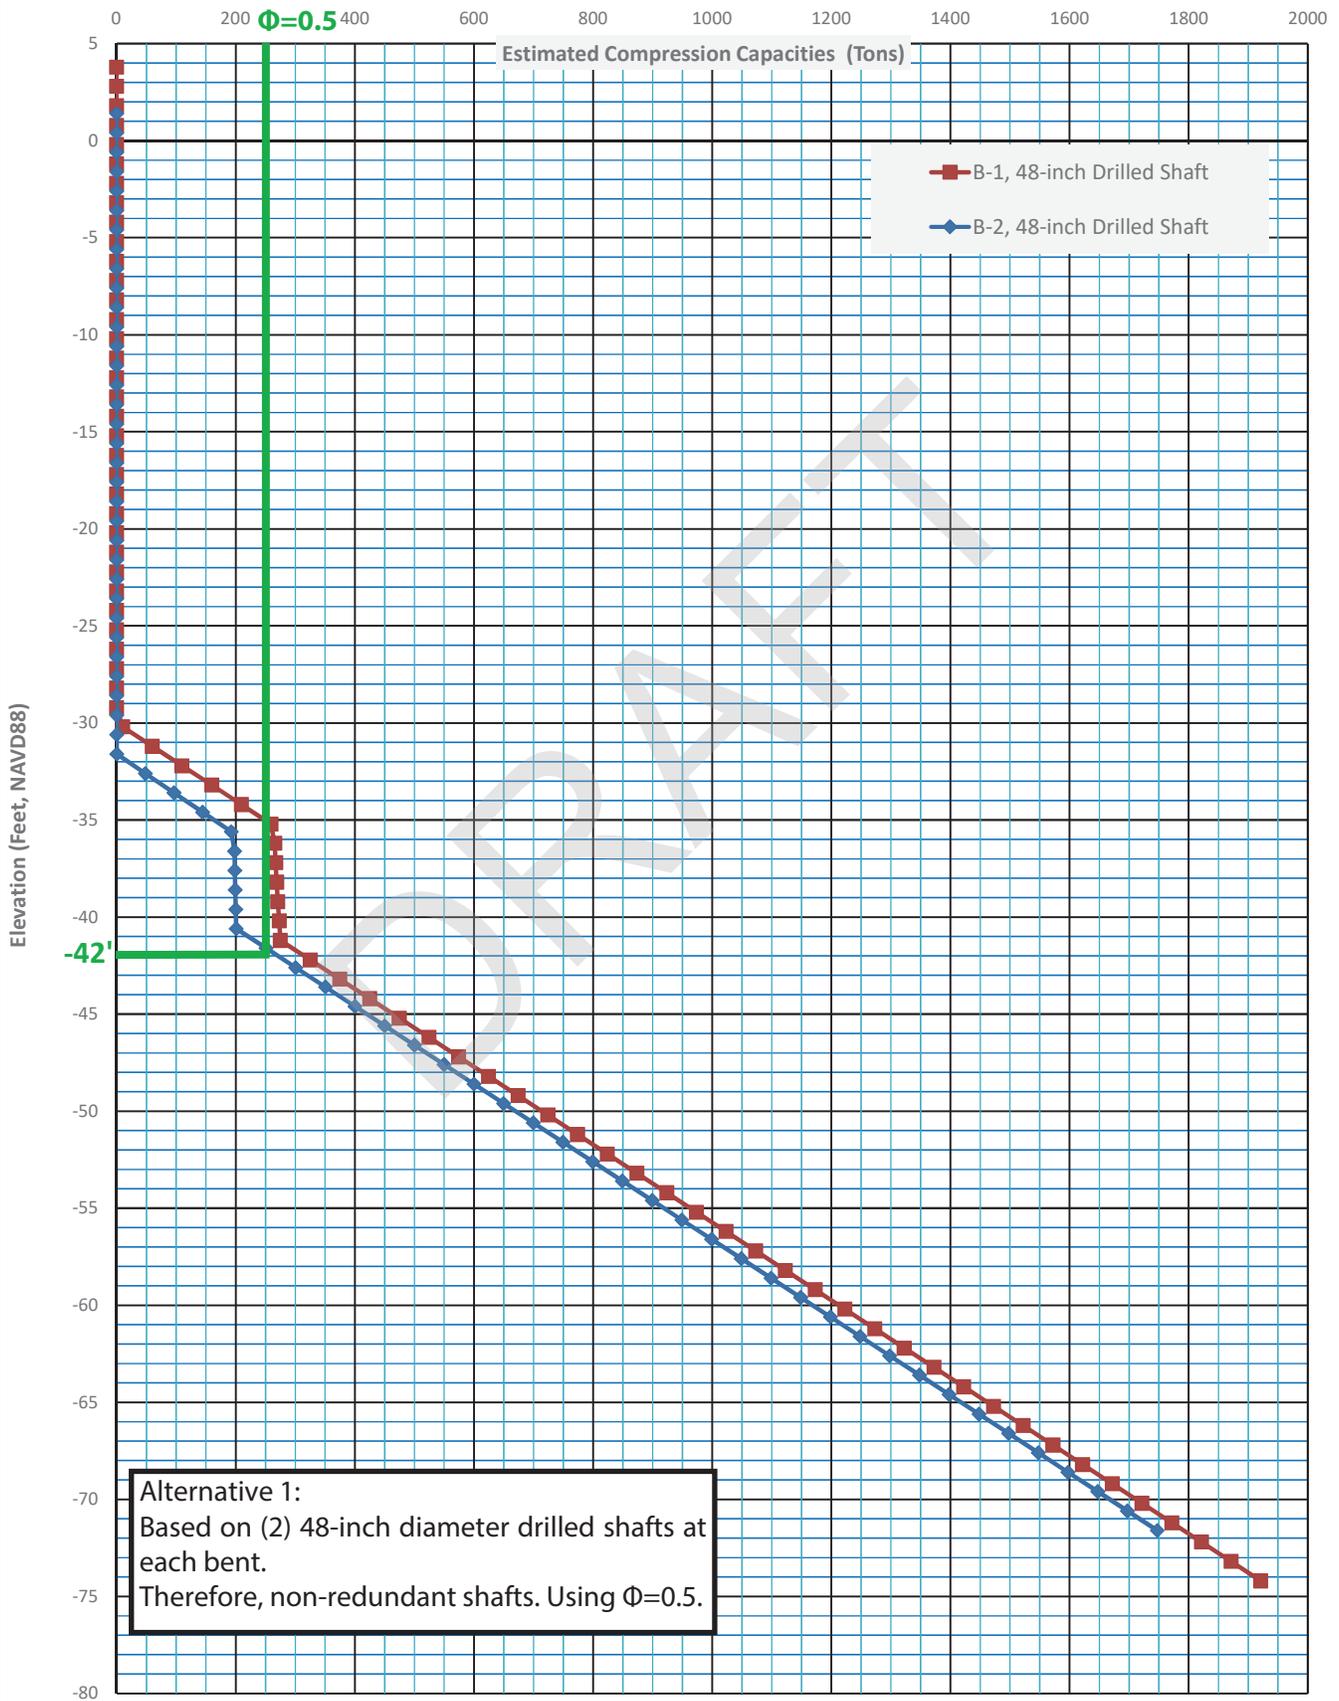
ATLANTIC ISLE BRIDGE
FPID No. 430029-2-22-02
HR ENGINEERING SERVICES, INC.
HRES PROJECT NO. HR20-1583R
ESTIMATED ULTIMATE COMPRESSION CAPACITIES FOR 48-INCH DIAMETER DRILLED SHAFT
TEST BORING B-1 AND B-2

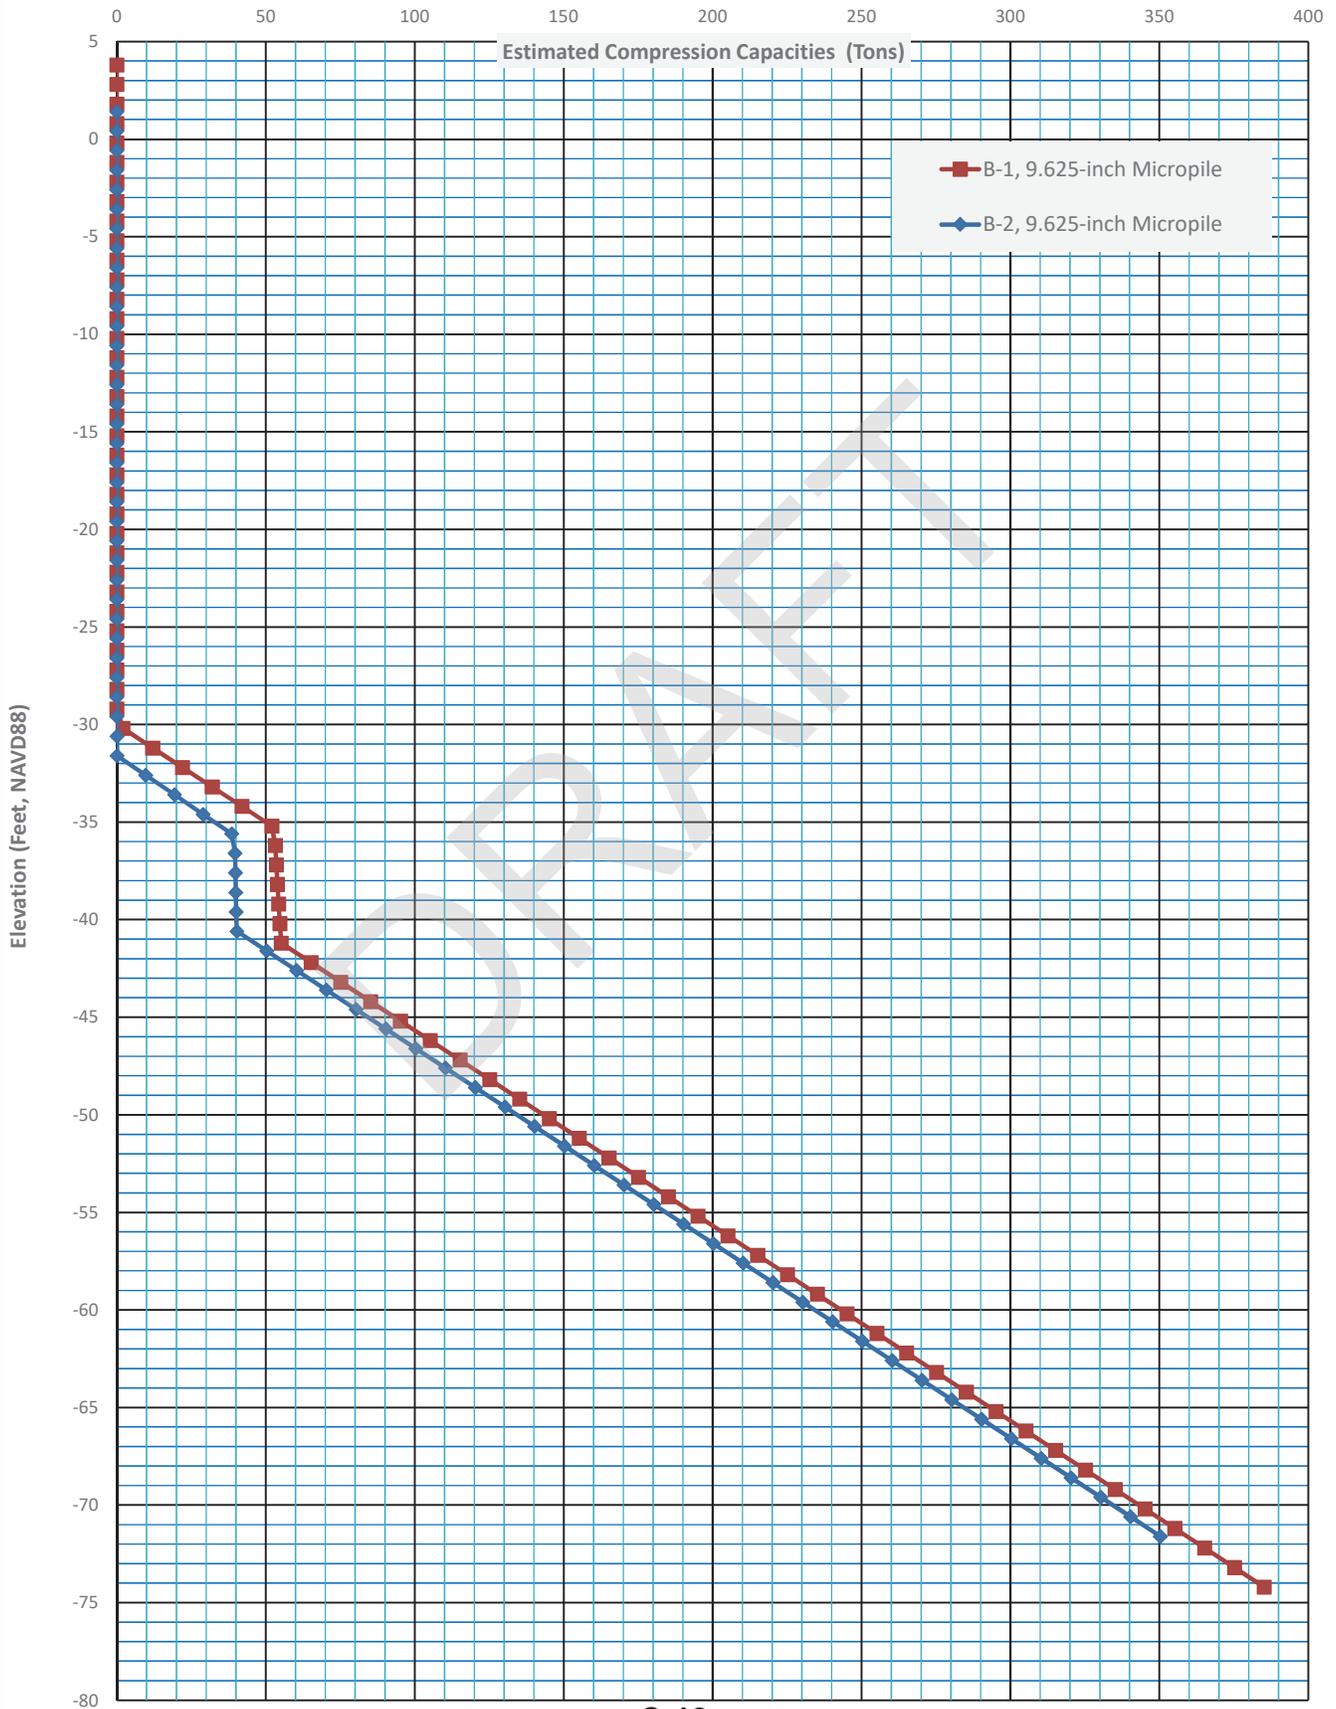
ATLANTIC ISLE BRIDGE
FPID No. 430029-2-22-02
HR ENGINEERING SERVICES, INC.
HRES PROJECT NO. HR20-1583R
ESTIMATED ULTIMATE COMPRESSION CAPACITIES FOR 9.625-INCH DIAMETER MICROPILE
TEST BORING B-1 AND B-2

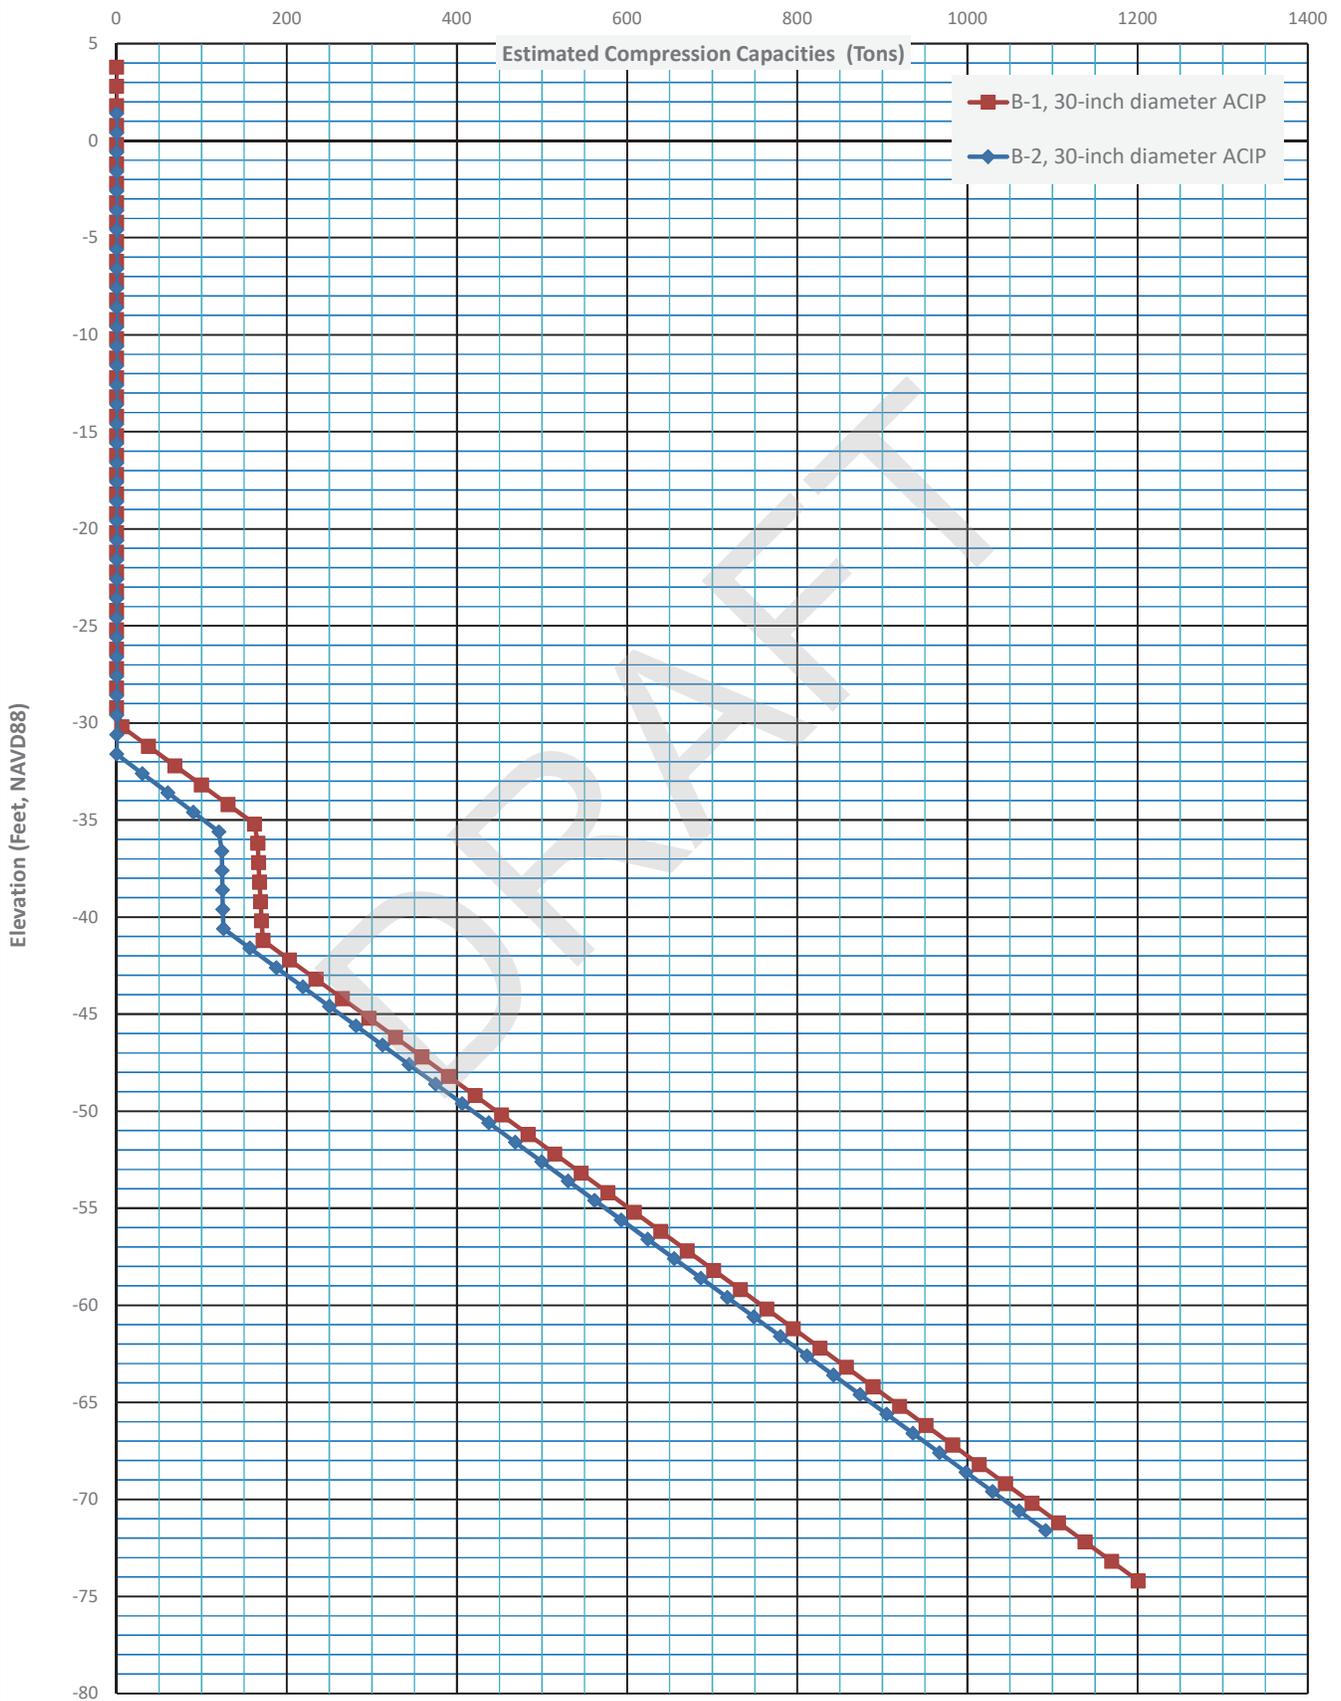
ATLANTIC ISLE BRIDGE
FPID No. 430029-2-22-02
HR ENGINEERING SERVICES, INC.
HRES PROJECT NO. HR20-1583R
ESTIMATED ULTIMATE COMPRESSION CAPACITIES FOR 30-INCH DIAMETER AUGERCAST PILES
TEST BORING B-1 AND B-2

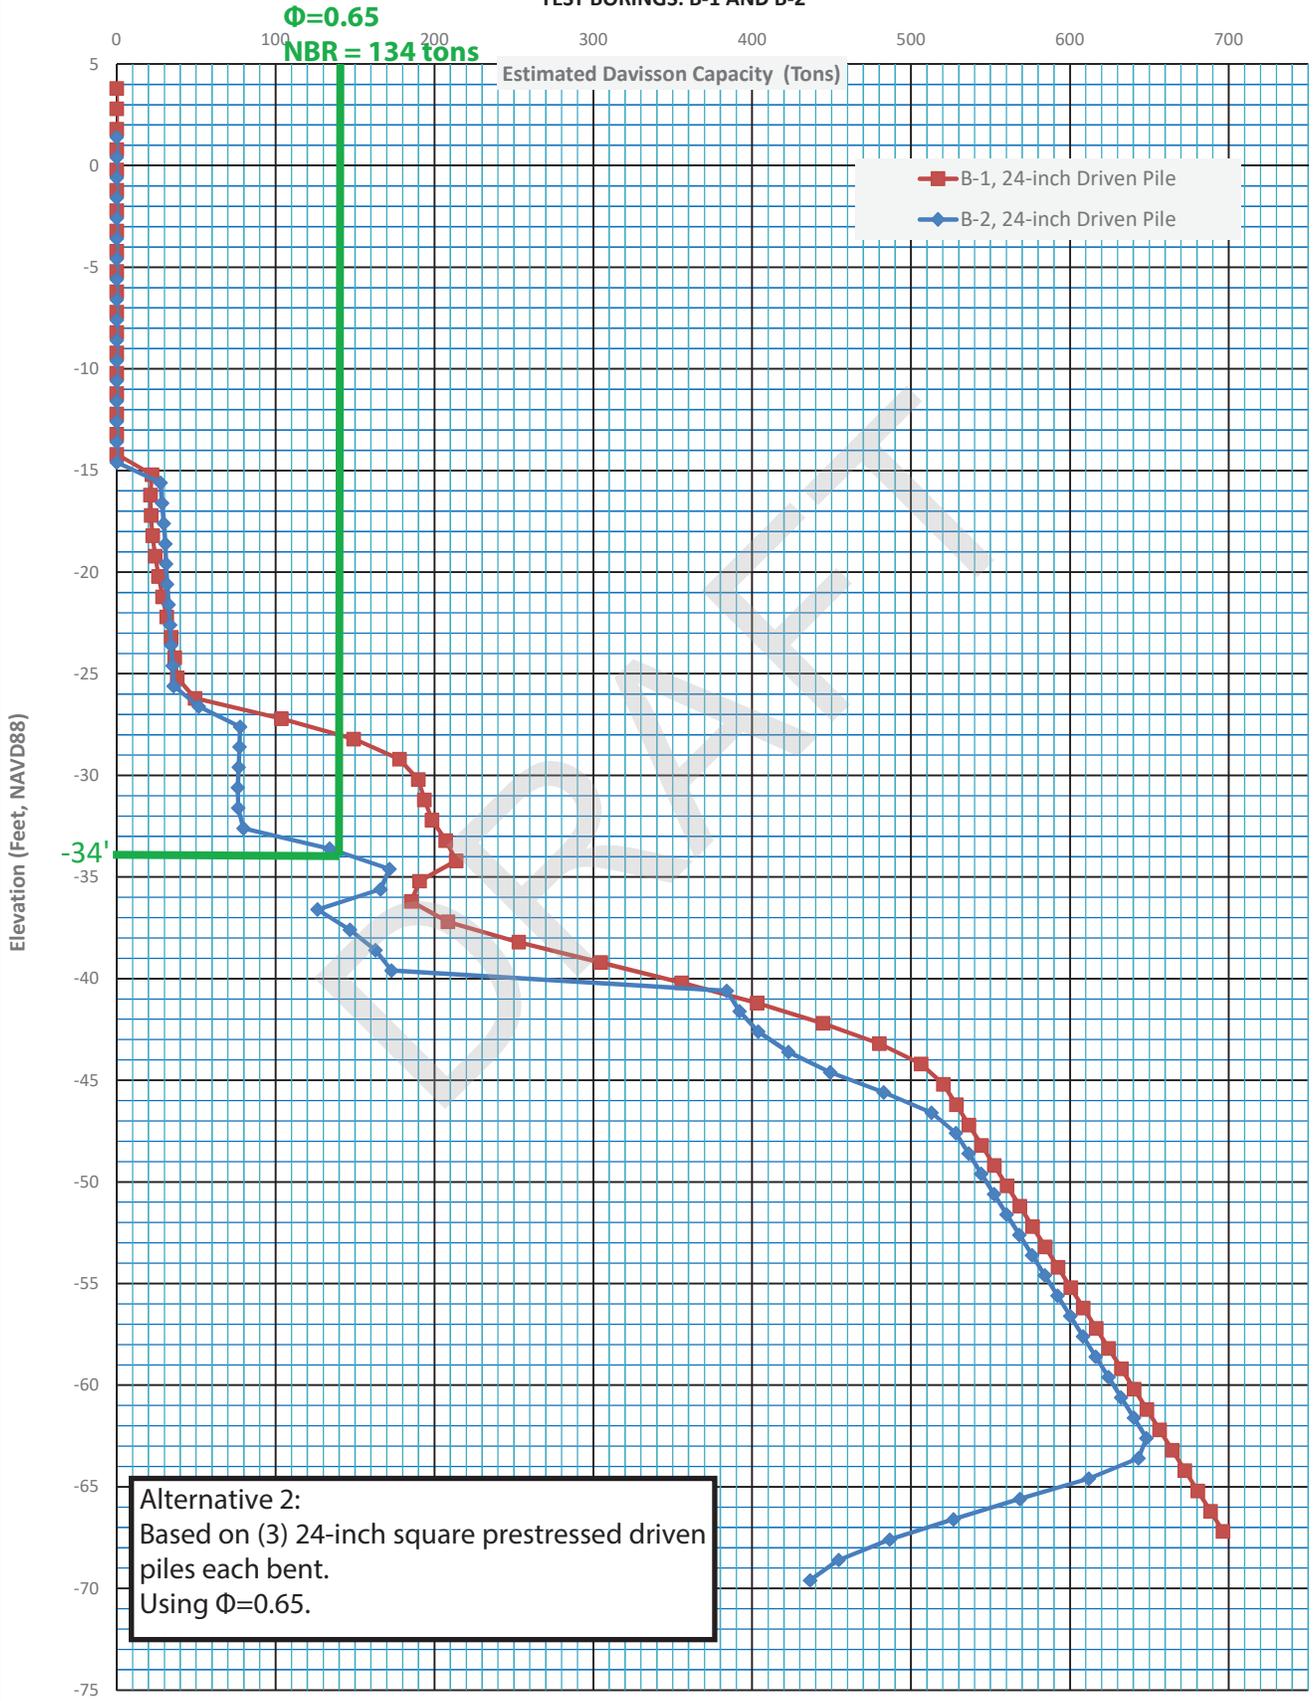
ATLANTIC ISLES LAGOON BRIDGE
 FPID No. 430029-2-22-02
 HR ENGINEERING SERVICES, INC.
 HRES PROJECT NO. HR20-1583R
 DAVISSON CAPACITIES FOR 24-INCH SQUARE CONCRETE DRIVEN PILES
 TEST BORINGS: B-1 AND B-2
